## **Cultural Heritage Impact Assessment**

John Fleming House, 9151 Huntington Road, Lot 15, Concession 9, City of Vaughan, Regional Municipality of York, Ontario

18107463-R02-Rev1

13 March 2020

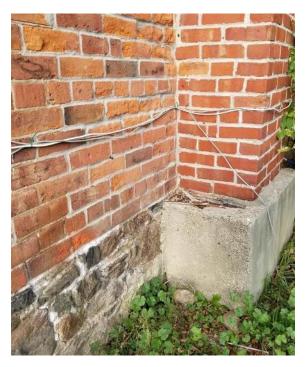
Over the Main Block is a low hip roof with projecting eaves on all sides and covered by asphalt shingles. A contemporary aluminum rain catchment system runs along all sides of the roof, with a gutter at the northwest corner. A truncated chimney is visible on the exterior side right, on the south wall, which was reconstructed in the past in slightly different bricks than the rest of the façade, and the base and top of the chimney is covered by cement (Figure 24). Evidence of brick placement in the south wall indicates the chimney was altered during its life.

Figure 24: Chimney on the south façade of the Main Block.

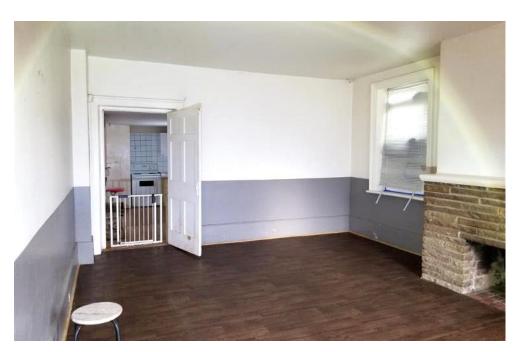
On the south half of the first level, is a single room with a large fieldstone fireplace centred on the south wall (Figure 32). The fireplace veneer consists of machine cut stone, covering the original fieldstone. There is a window on the south and west walls, with wide moulded wood frames and thin wood sills (Figure 32). A door at the east end of the room leads into the East Wing. The wood frame around the door is similar to the moulded wood frame as the windows in the room (Figure 33).

Figure 32: Facing south in the south room on the ground floor, Main Block.

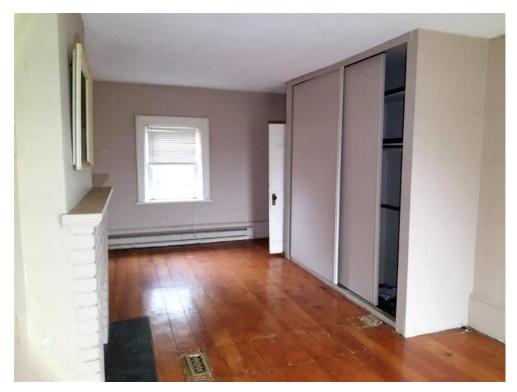
Figure 37: North room on the second storey. A closet was added when the function of the room changed.

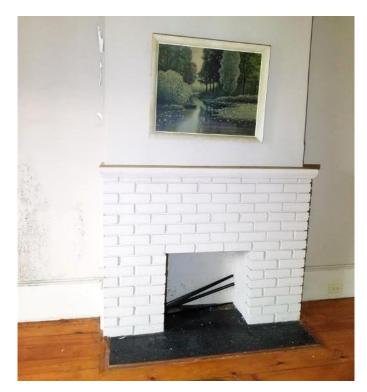
Figure 38: Relic fireplace in the north room.

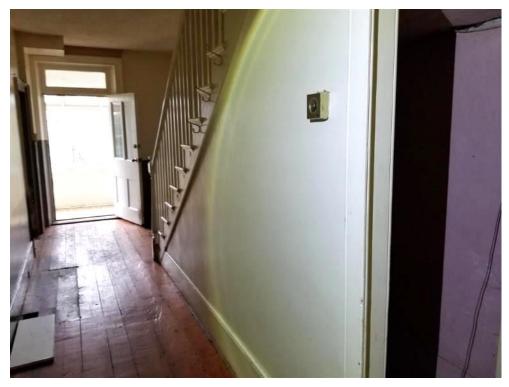
The Main Block has a full basement that is accessible from the first level hall (Figure 44). The basement is comprised of a single rectangular room with coursed rubble walls and a cement floor. A large central fieldstone fireplace is on the south wall with a wood mantel beam to function as part of the winter kitchen (Figure 45).

Figure 44: Opening to the basement stairs, below the main stairs in the Main Block.

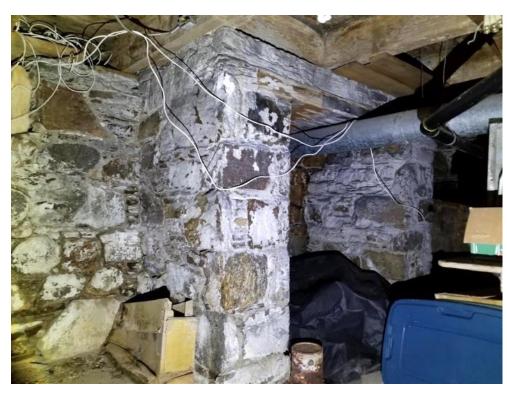
Figure 45: Stone fireplace in the basement below the Main Block, on the south wall of the foundation.

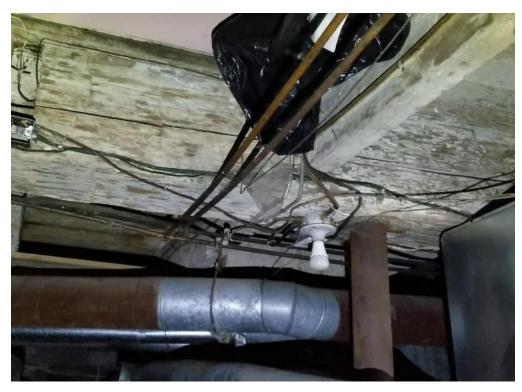
There are two windows on the west wall and one window on the east and south walls (Figure 46). All the basement windows were small and rectangular, likely one or two panes, although no frames have survived. Running east-west through the centre of the basement's ceiling is a large summer beam, as a central support for the floor above (Figure 47).

Figure 47: Close up of the summer beam running east-west across the basement ceiling.

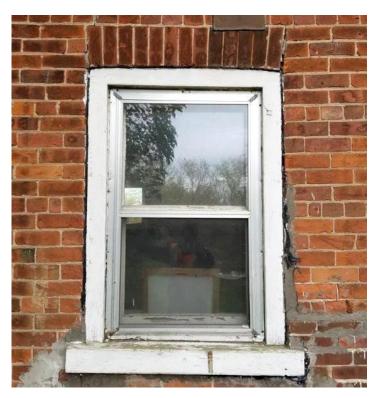
The walls are constructed from red brick laid in 1:5 Common Bond. There is a window on the north and south walls. Windows are 1-over-1 segmental head with a wood frame and wood lug sill, with aluminum external storm windows, and each window has a straight brick voussoir above the frame (Figure 48). The gable roof has projecting eaves and verges, with plain metal soffits and fascia, and a metal rainwater catchment system on the eaves. The gable end of the roof has metal return eaves, and a large chimney extending from the east wall of the East Wing (Figure 49). The size of the chimney is indicative of its early age and would have originally been fed by a large cooking hearth rather than a stove (Goldsmith Borgal & Company Ltd. Architects 2017)

Figure 48: Typical window on the East Wing, north façade.

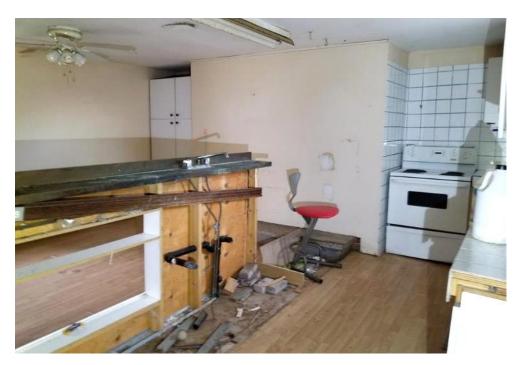
Both door frames on the west wall have moulded trim, and the door frame on the south wall has plain trim. There is a window on the north and south walls. The room has some of its cabinetry, however, none of the surviving elements appear to be contemporaneous to the original construction (Figure 52). Laminate flooring covers the room, and the baseboards are shorter than those found in the Main Block. A portion of the kitchen walls is faced with white and blue tiles. A doorway on the south wall opens into the South Addition.

Figure 52: Interior of the East wing facing the east wall. Covered hearth in the centre of the wall.

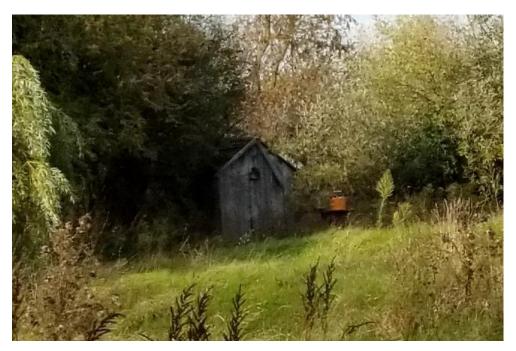
This mid-20<sup>th</sup> century outbuilding is a small wooden shed with a gable roof. It is located north of the farmhouse on the east side of the current driveway and is currently in a state of collapse. It has a medium gable roof and vertical wood panelling on the exterior walls.

Figure 59: View of the North Outbuilding, looking north.

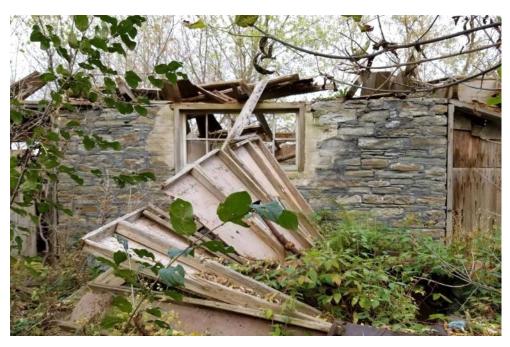
All that remains of the barn is a portion of the stone foundation. The coursed stone foundation presents asymmetrical fenestration with 10-pane fixed wood windows with flat head openings and no exterior decoration (Figure 60 and Figure 61). Exterior doors on the surviving west wall are plain wood. Interior beams which would have supported the floor above have decayed and cracked, and there is not much left inside the barn (Figure 62 to Figure 64).

Figure 60: West façade of the stone barn foundation.

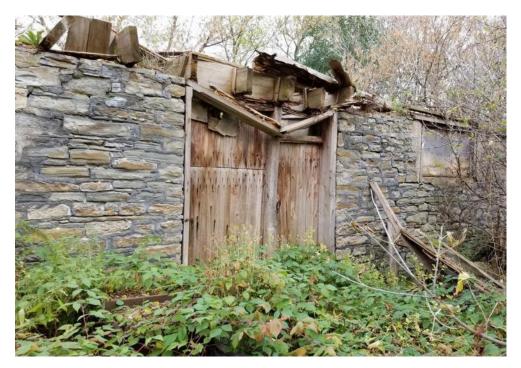
Figure 61: West façade and doors of the stone barn foundation.

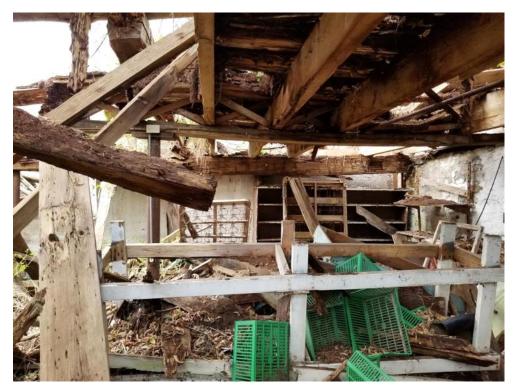
Figure 63: Interior southeast corner of the barn.
