Revised  
Heritage Evaluation of Existing Structures  
10568 Islington Avenue, Kleinburg, ON  
In the City of Vaughan

Phillip H. Carter Architect and Planner  
And  
Paul Oberst Architect

December 2019

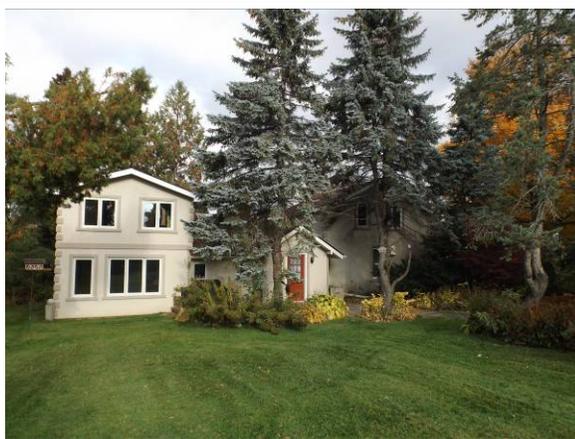
Figure 1. Original house in the shade to the right. Additions to the left.

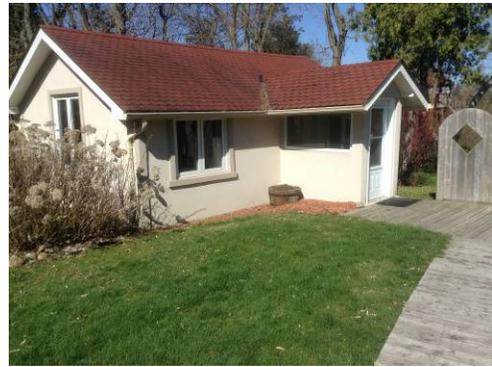
In our opinion, the small size and particularly the low eaves and ceiling (7 ft.) make it unlikely that the building housed a working smithy. You couldn’t walk a horse into the building. There is currently no chimney.

Figure 6. View of the secondary dwelling from the southeast.

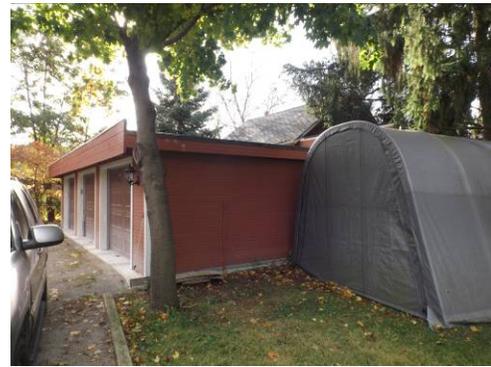
The siding on the garage and the shed-roof extension on the drive shed being 1x6 v-joint material in contrast to the 1x4 boards on the drive shed. This suggests that the extension is contemporaneous with the garage. The uniform exterior of the drive shed conceals the construction beneath, where the lower level appears to be of plank-on-plank construction, while the upper level is barn framed with posts, braces, and infill studding, resting on a header on top of the lower wall. Our timber specialist, Vic Snow, tells us that there are some similarly constructed barns in King Township. There is no stone foundation evident, and the lower boards on the south end of the west wall are bowed and deteriorated (see Figure 13).

Figure 9. View from the north. Garage to the left, drive shed rising to its rear.

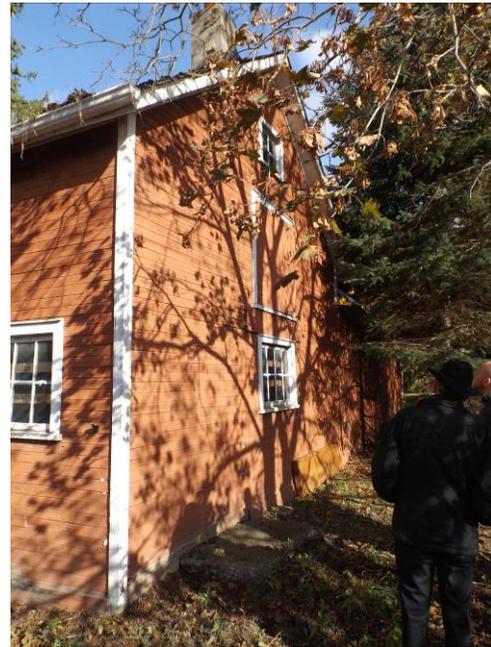
The drive shed has plain white corner boards, and small Georgian-sash windows set in simple board frames, including one very small window to the loft at each gable end. The windows and frames are white. There is an internal single-flue chimney near the south wall and west of the ridge that rises from the ground. It may be that this chimney served a forge, and that a blacksmith shop was operated here.

Figure 10. The south end of the drive shed. The garage is visible behind the pine tree.

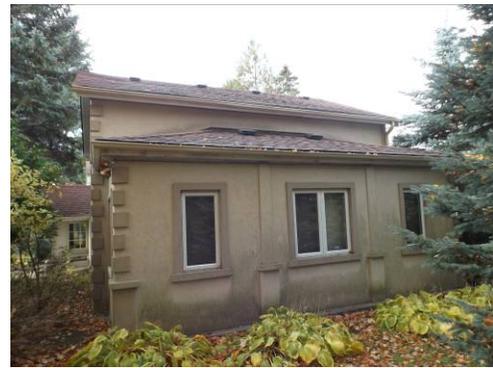
Figure 15. East (front) of the house showing enclosed verandah.

3. The original architectural character of the principal dwelling has also been concealed by its recent EIFS stucco finish, the erection of additions in the middle and back of the building, and the fitting of modern replacement doors and windows and their trim. There are no longer any heritage-defining characteristics on the exterior of the building other than the basic shape of the main front portion of the original house. The original tail is buried in the later additions, and no longer legible.

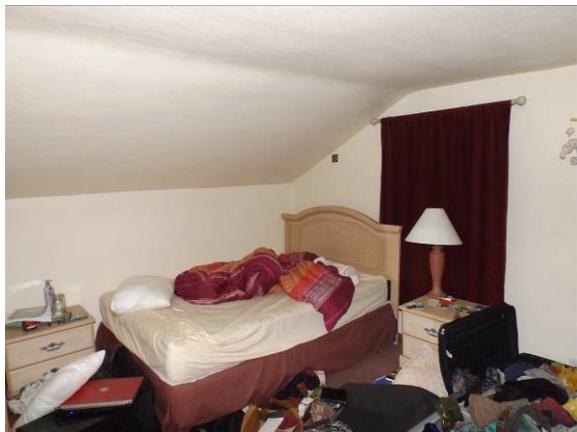
Figure 25. Second floor, southeast corner. Roof slope evident, and original window opening behind the curtain.

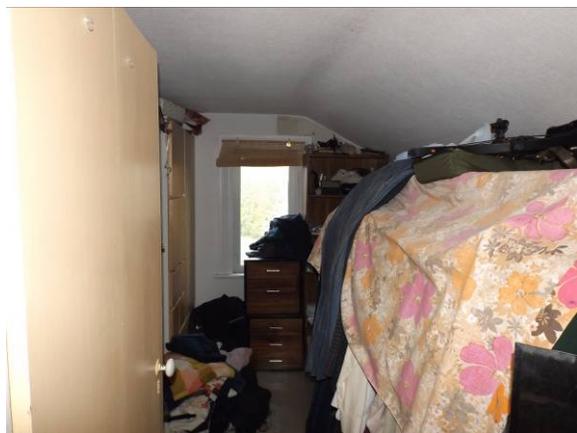
Figure 26. Second floor, northeast corner. Tiny bedroom, roof slope evident, original window opening in the far wall.

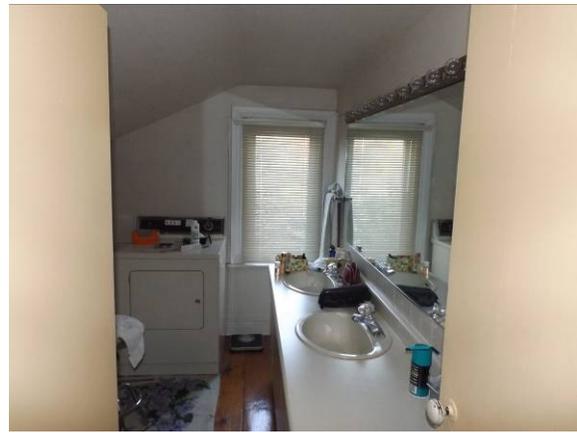
Figure 27. Second floor, northwest corner contains bathroom. Roof slope and original window opening are evident, as well as wide-plank pine floor.

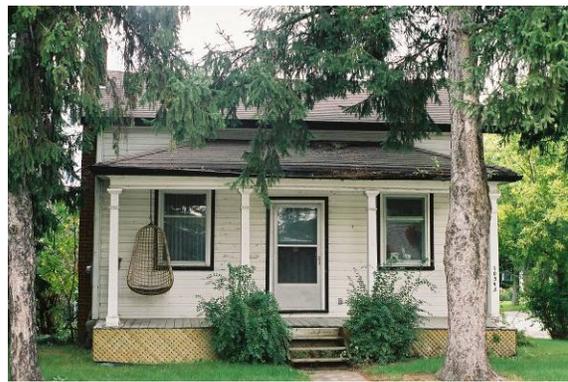
Figure 40. 10545 Islington Avenue, almost directly across the street from the south end of the property. The house is very similar to the principal dwelling at 10568, and informs our reconstruction.

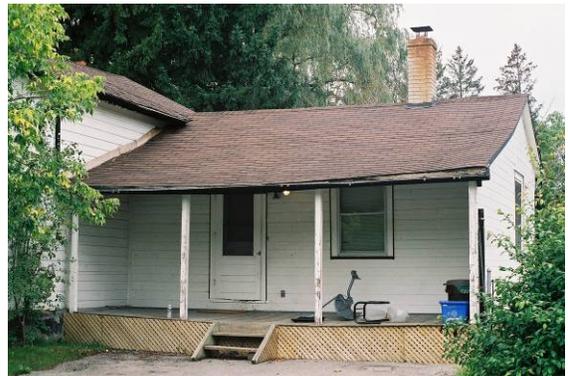
There is an existing basement under the middle of the building. We assume that this defines the extent of the original kitchen tail of the house. There is a stone stair descending to this basement from a location outside of the kitchen tail. This is not uncommon in houses of this age, and there is a window (now blind) on the south side of the stair, we conjecture that this stair was enclosed under a porch.

Figure 41. Kitchen tail with porch at 10545 Islington. We believe that 10568 was similarly configured.
