46 CENTRE STREET, VAUGHAN CONSERVATION PLAN

REV. I - FINAL

AUGUST 13, 2020

COMMON
BOND
COLLECTIVE

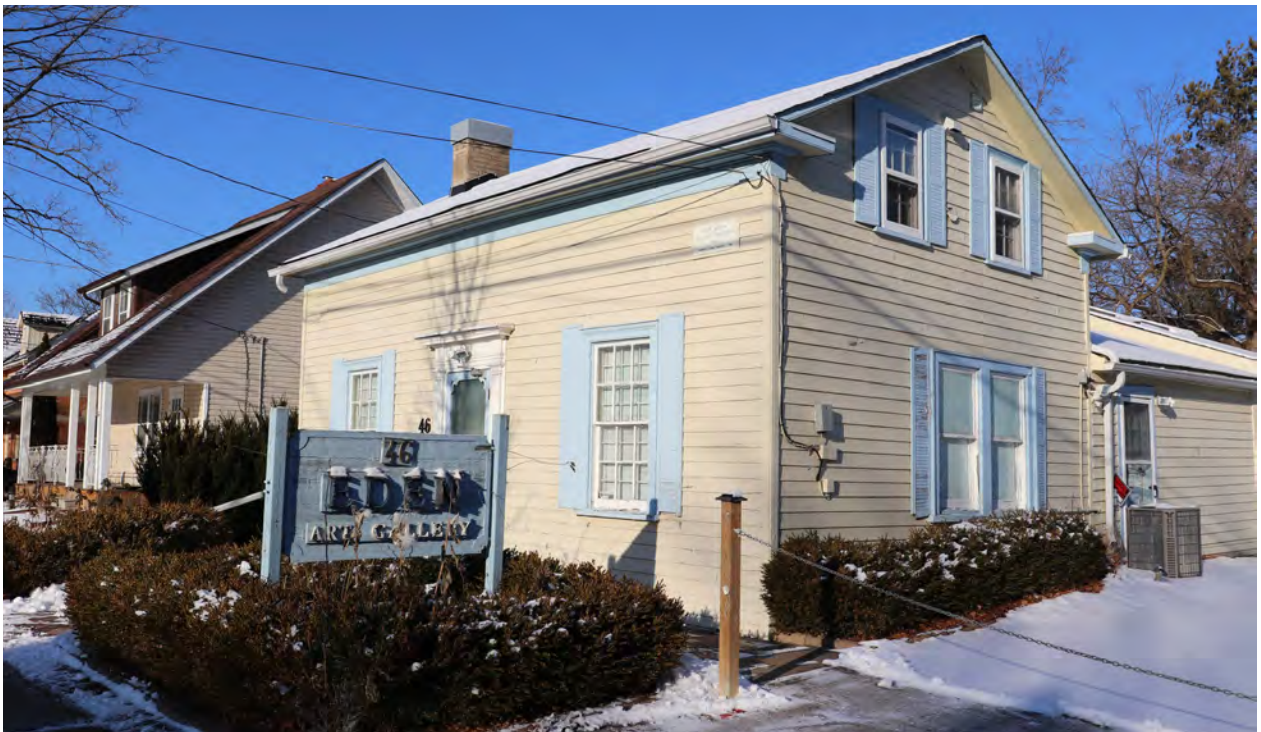
The original settlement house (referred to as Main House in this report) is a 1½ storey wood structure likely constructed prior to 1845 (Figure 4). It has several 19th century additions immediately north, and a larger late 20th century gable-roofed addition (Figure 5). Originally constructed as a residence, the building was converted to support commercial uses and is currently vacant.

Figure 4: Looking northwest, the original Main House construction is comprised of the gabled mass fronting Centre Street (CBCollective, 2020).

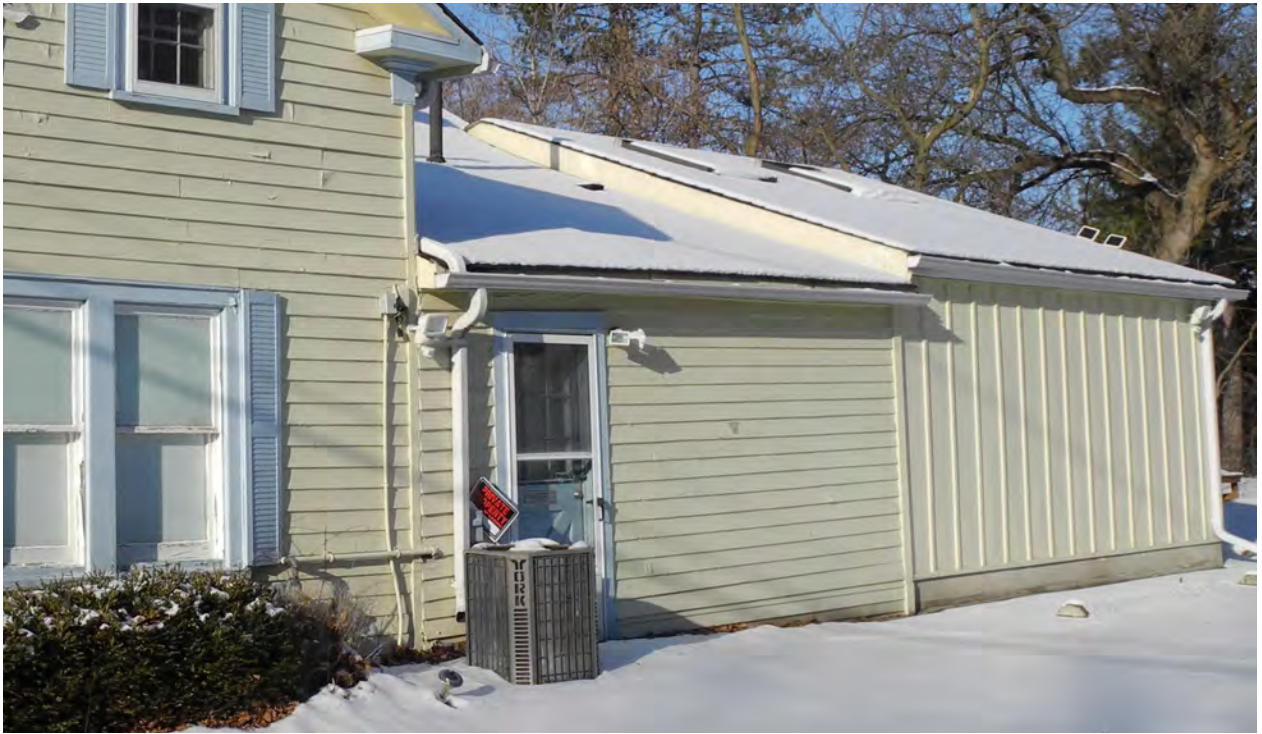
Figure 5: There are at least three different additions to the north of the Main House, two of which are seen in this photograph (CBCollective, 2020).
