**ENVIRO TREE CARE**  
1048 Broadview Ave Unit 1008  
Toronto, Ontario M4K 2B8  
Phone: 647-393-8733 Fax: 905-707-8734  
E-mail: [envirotreecare@yahoo.ca](mailto:envirotreecare@yahoo.ca)  
Website: [www.envirotreecare.ca](http://www.envirotreecare.ca)

This arborist report is written to supplement the Town of Vaughan Private Tree By-Law application for Development.

The property is located at 7714 Yonge Street, Thornhill.

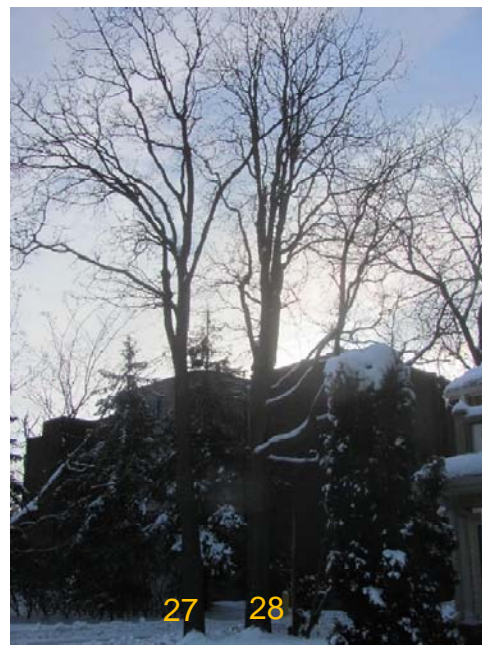
25	Sugar Maple	33	2.4	P	1	R	severely topped, hazardous
26	Sugar Maple	39	2.4	P	1	R	severely topped, hazardous
27	Black Walnut	43	3.0	F	1	P	
28	Black Walnut	53	3.6	F	1	P	
29	Black Walnut	57	3.6	F	1	P

Tree number 25 and 26 are not in good shape. Their removal would be prudent.
