**Re: Heritage Vaughan Committee – April 21, 2021, 2298118 Ontario Inc.
7714 Yonge Street, City File DA.14.009; Reginal File SP-V-016-14**

Arborist Report

7714 Yonge Street, Vaughan, ON

7 March 2017, revised 1 April 2021

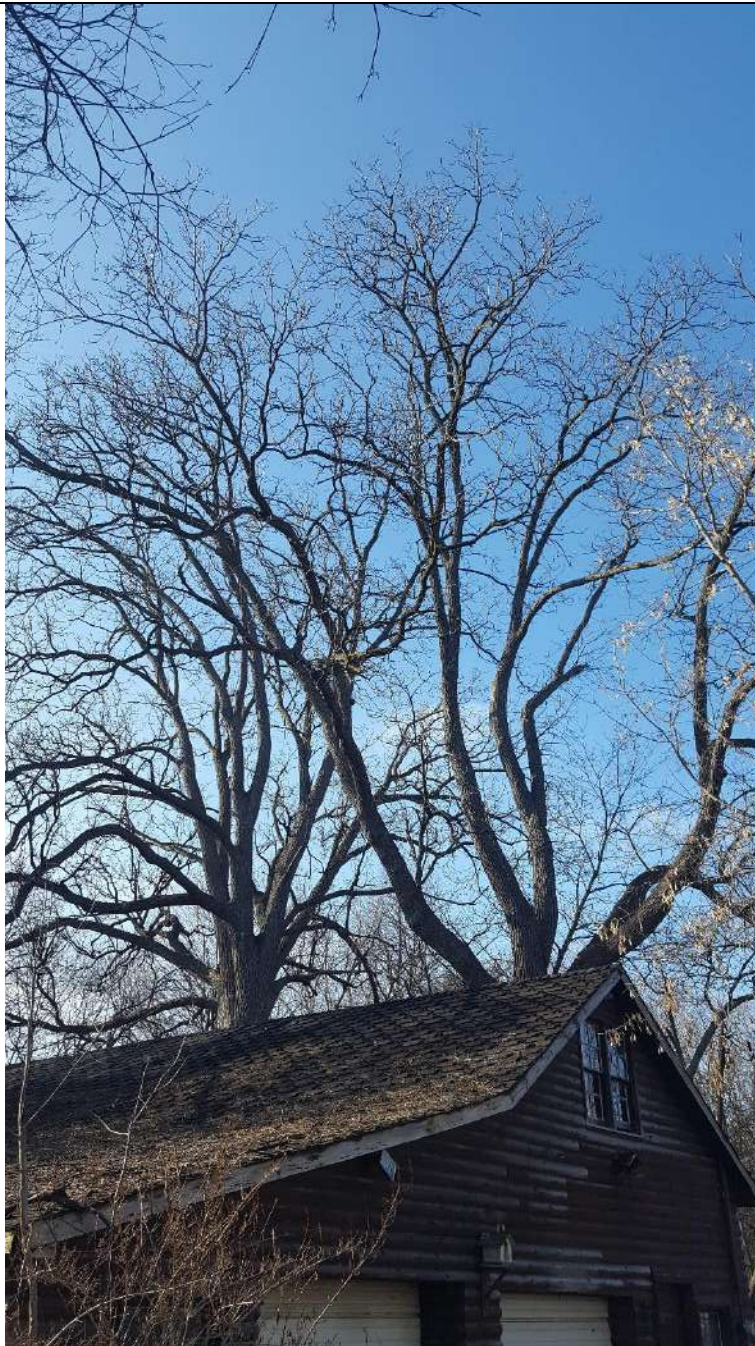
An existing garage is located within the driplines of Trees 9 and 12. The preservation of these trees may be possible if the existing base of the garage is used or is removed gently using hand tools only, being careful not to damage the roots. Demolition of the existing garage should be completed using hand tools or light equipment only. Tree protection hoarding around this tree must be installed immediately

Any potential injury to neighbouring and shared trees should be discussed and accepted by the neighbouring property owner prior to development. Trees 2, 7, 11, 13, 17, and 22, are in poor condition or potentially hazardous and the appropriate neighbours should be notified. The tree protection hoarding for trees to be preserved should consist of a wood frame made of 2" x 4"s with plywood hoarding, to be installed according to the detail shown on the Tree Preservation Plan (Figure 1). The tree protection barriers should be installed prior to demolition and construction and remain in place throughout the construction process, as specified in the Tree Preservation Plan (Figure 1). No grade changes, storage of materials or equipment is permitted within the tree protection zone (TPZ). The tree protection hoarding detail and tree protection notes, are shown on the Tree Preservation Plan (Figure 1). Dripline distances are shown in Table 2 of this report.

Photo 5 Trees 9 and 11 (left to right)

It is recommended that the proposed parking area and walkway within the driplines of Trees 9 and 12 be installed using a combination of geocell and permeable materials to minimize soil compaction, and allow for water infiltration, and as close to existing grades as possible. Any work within the driplines of trees must be supervised by a Certified Arborist. These trees should be monitored for changes in health, condition and structural stability by a Certified Arborist during and following construction. The supervising Arborist must confirm that the trees are safe to be retained.

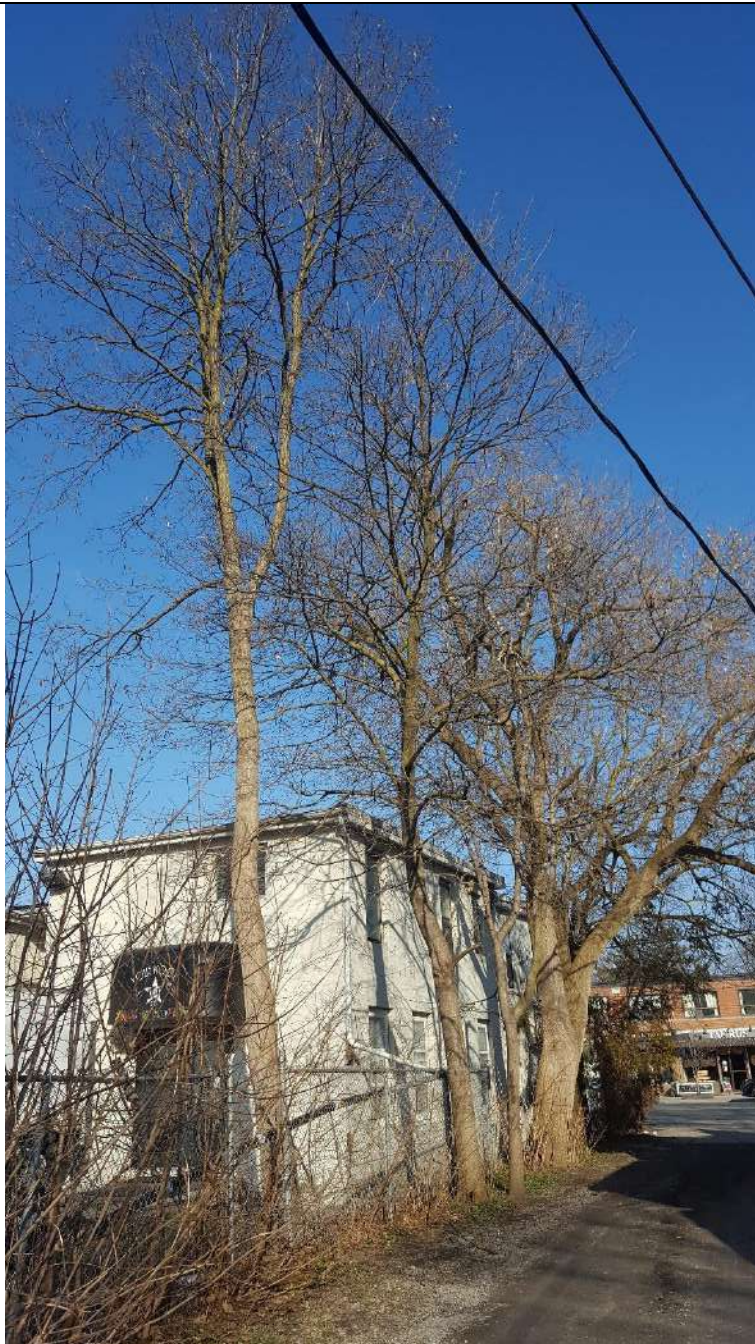
Photo 8 Trees 14, 15, 16, 17 (left to right)

Trees 2, 11, 13, 17, 20, 22, and 28 are in poor and declining condition and are recommended for removal regardless of the proposed construction. Trees 2, 7, 11, 13, 17, and 22, are located on neighbouring property or are shared trees. Trees within striking distance of the proposed development are recommended for removal to prevent injury/damage to persons/property. The neighbouring property owner should be notified of the condition of these trees and co-ordinate their removal. The removal of neighbouring and shared trees will require permission from the neighbouring property

Encroachment into the driplines of Trees 1, 12, 14, 18, 31 to 35, 37, and 38, will be required to accommodate the proposed parking area, walkway, and/or hardscape. Any required excavation should be conducted by hand, air spade or hydro-vac to expose roots for assessment and pruning. It is recommended that the proposed surfaces within the driplines of these trees to be installed using a combination of geocell and permeable materials to minimize soil compaction, and allow for air and water infiltration, and as close to existing grades as possible. Any work within the dripline of trees should be supervised by a Certified Arborist. The Arborist must confirm that the trees may be safely retained. Refer to the Arborist report for additional details.

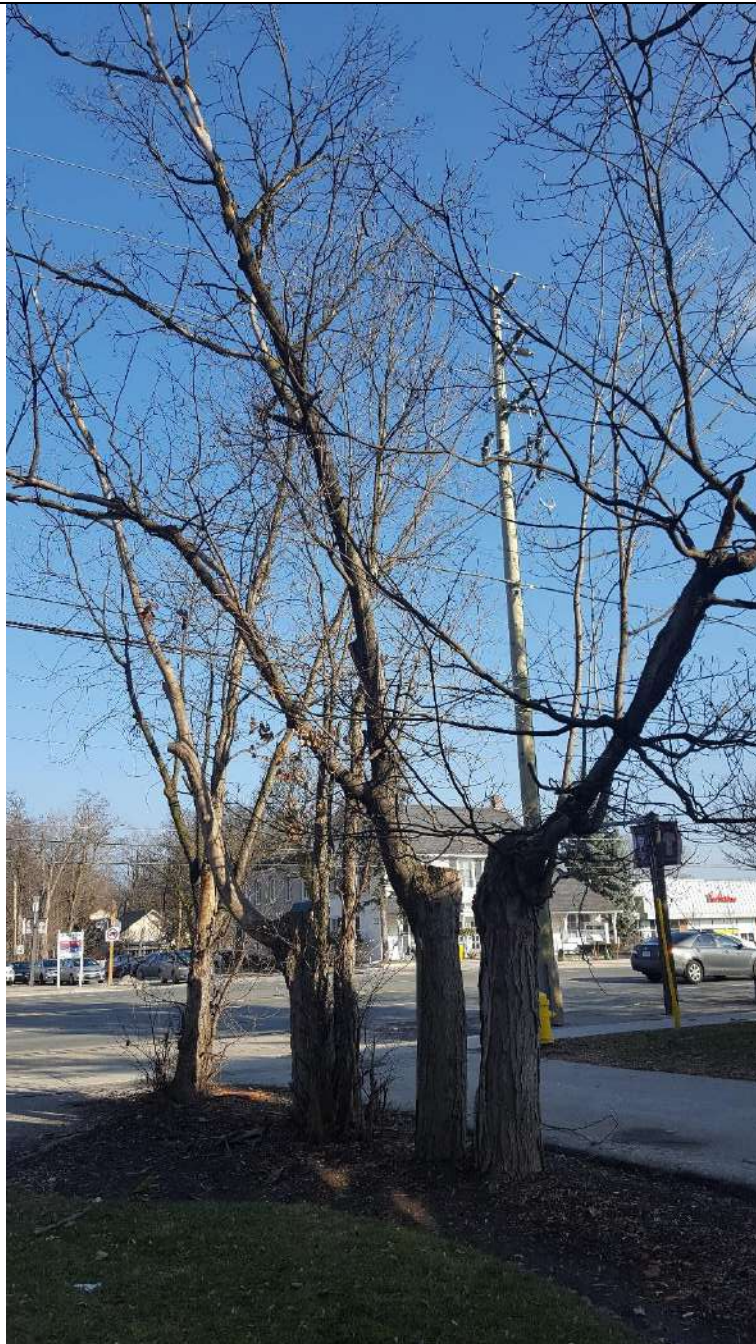
Photo 11 Tree 20, dead tree, 21 and 22 (left to right)

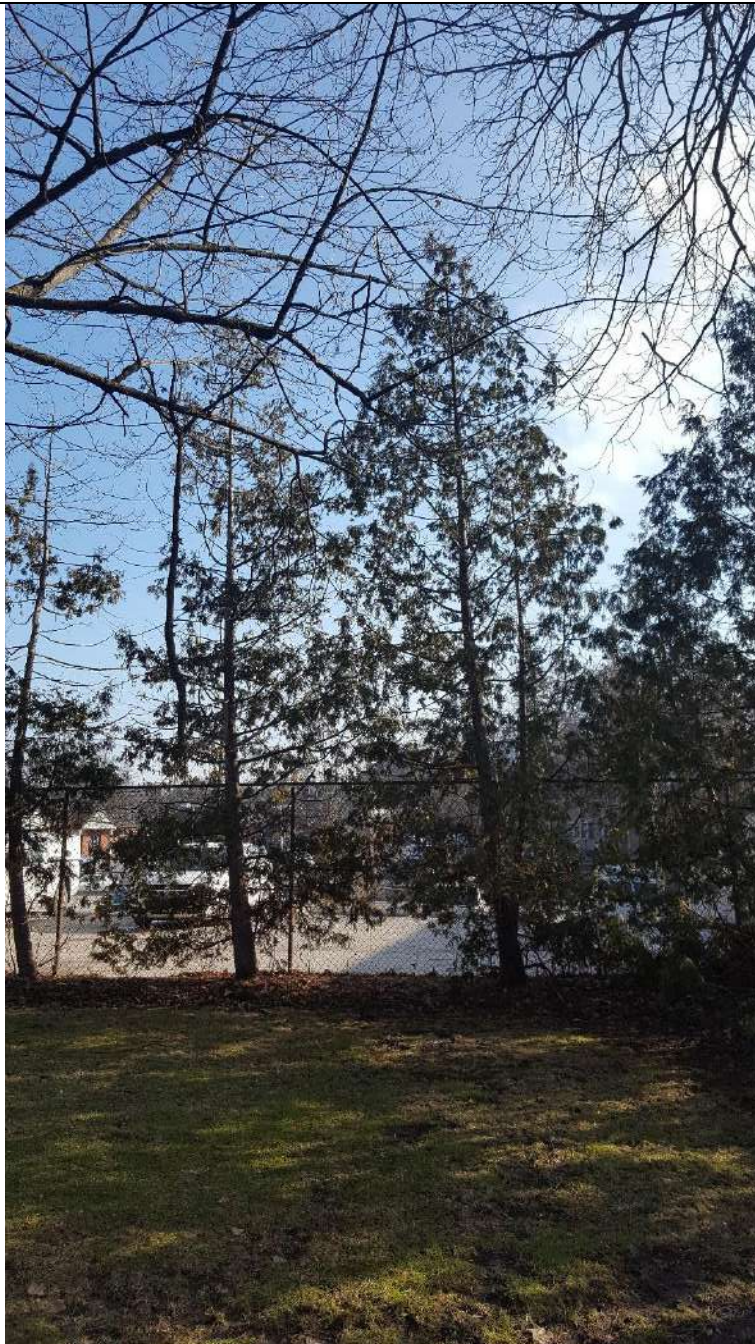
Encroachment into the driplines of Trees 1, 12, 14, 18, 31 to 35, 37, and 38, will be required to accommodate the proposed parking area, walkway, and/or hardscape. Any required excavation should be conducted by hand, air spade or hydro-vac to expose roots for assessment and pruning. It is recommended that the proposed parking area within the driplines of these trees to be installed using a combination of geocell and permeable materials to minimize soil compaction, and allow for water infiltration, and as close to existing grades as possible. Any required root pruning should be conducted by a Certified Arborist following good arboricultural standards. Any work within the dripline of trees should be supervised by a Certified Arborist. These trees should be monitored for changes in health, condition and structural stability by a Certified Arborist during and following construction. The supervising Arborist must confirm that the trees are safe to be retained. Cabling of the union of Tree 42 is recommended.

Photo 17 Trees 34, 35, 36 (left to right)

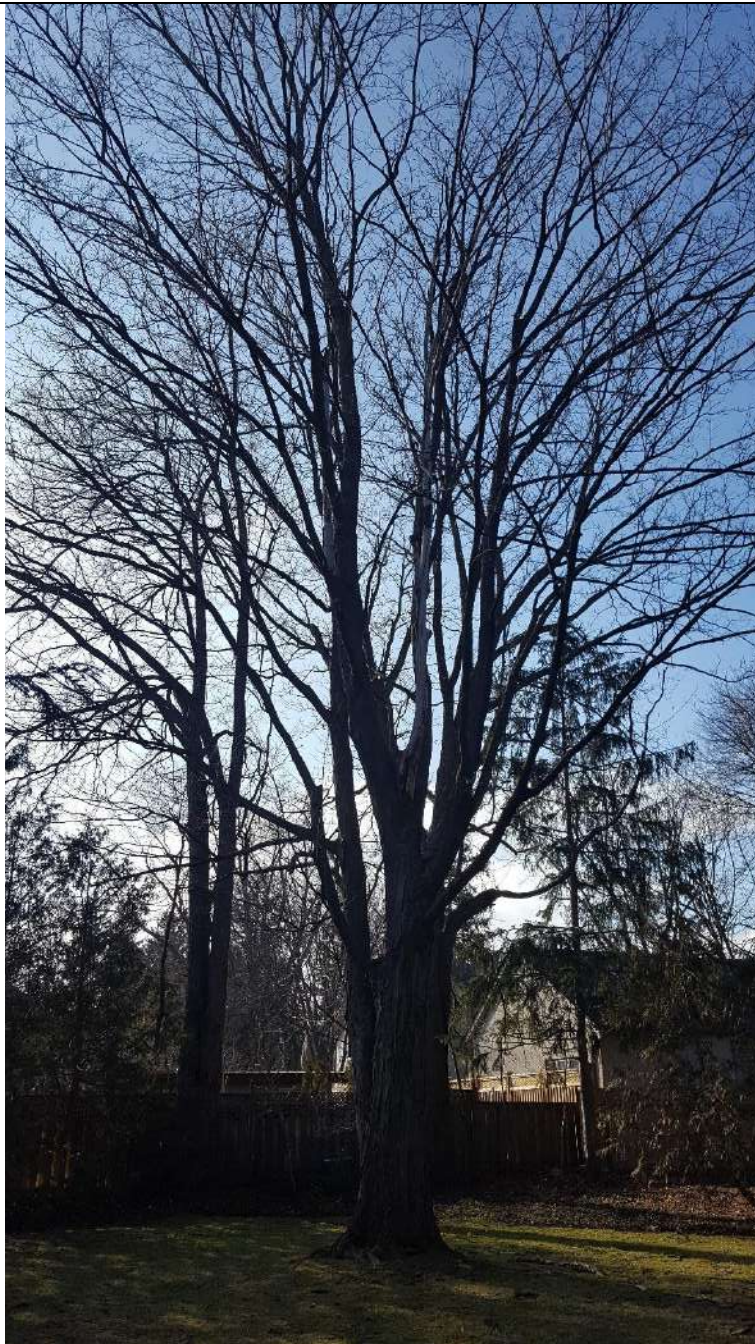
Photo 19 Trees 41, 42, 36 and 44 (left to right)
