**CITY OF VAUGHAN  
HERITAGE VAUGHAN COMMITTEE  
AGENDA**

**248 - 260 Woodbridge Avenue  
Woodbridge Heritage Conservation  
District (HCD)  
City of Vaughan**

Revised  
Heritage Evaluation of Existing Structures  
10568 Islington Avenue, Kleinburg, ON  
In the City of Vaughan

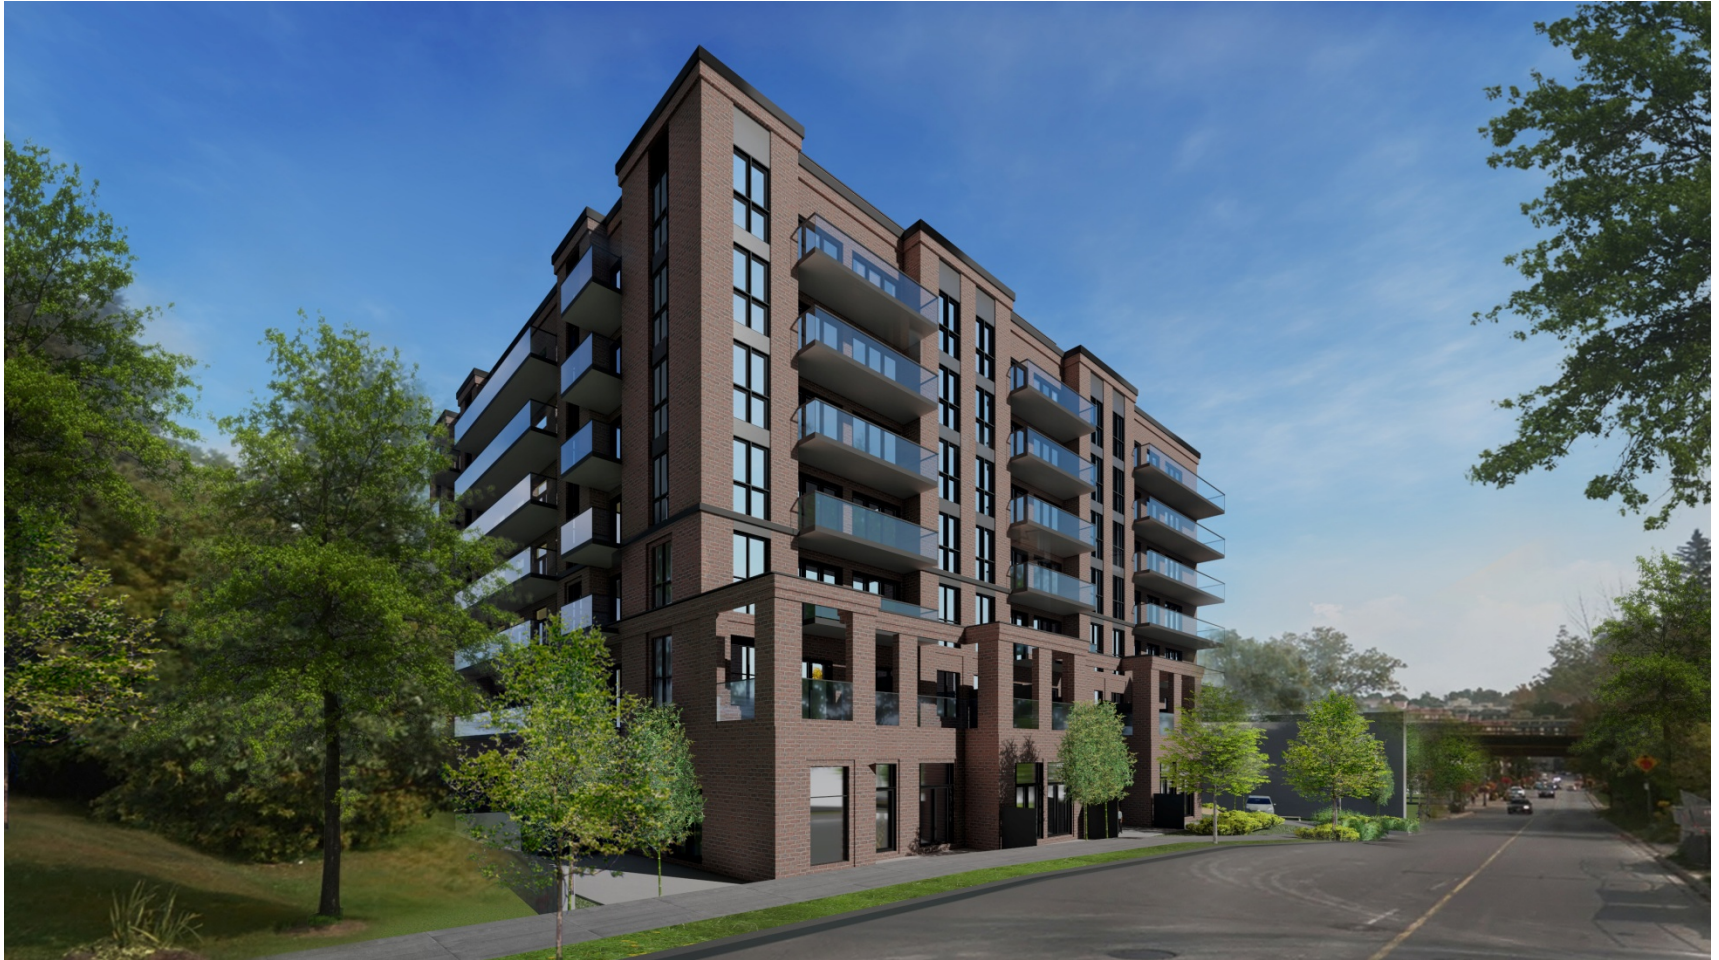
Looking northeast – crash wall and railway in background

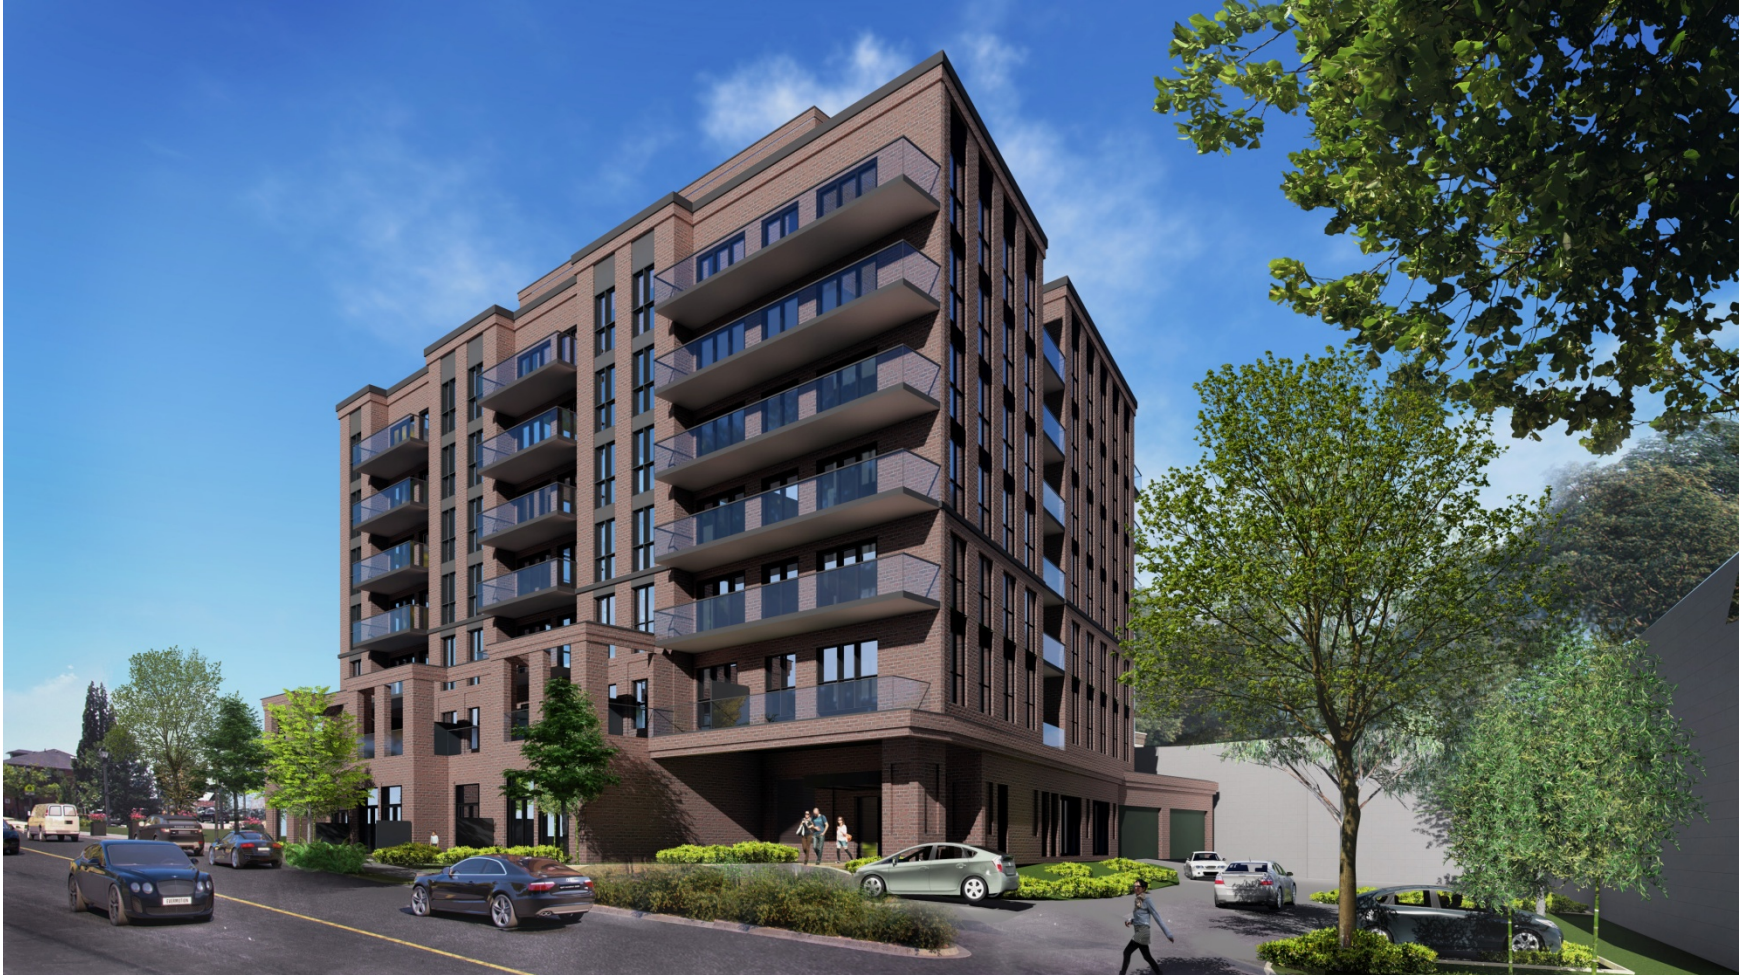
Looking northwest

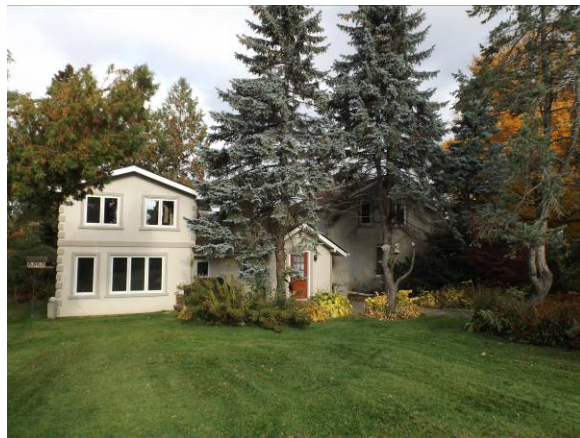
Figure 1. Original house in the shade to the right. Additions to the left.

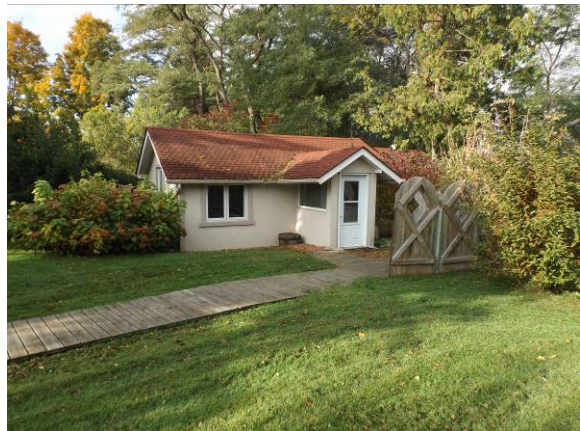
Figure 2. The secondary dwelling.

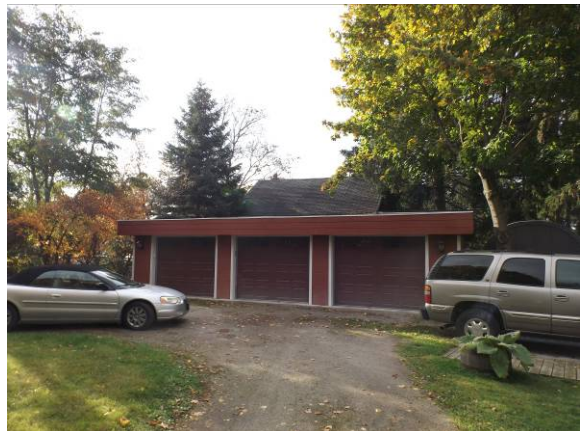
Figure 3. The garage, with the roof of the drive-shed rising behind it.

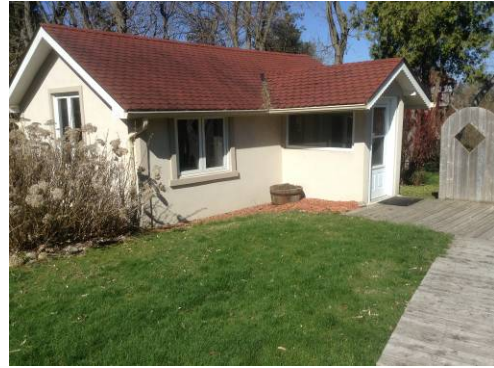
Figure 6. View of the secondary dwelling from the southeast.

In our opinion, the small size and particularly the low eaves and ceiling (7 ft.) make it unlikely that the building housed a working smithy. You couldn't walk a horse into the building. There is currently no chimney.

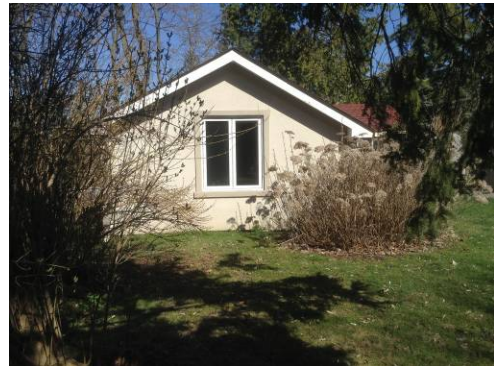
Figure 7. The north of the lower and smaller northern wing.

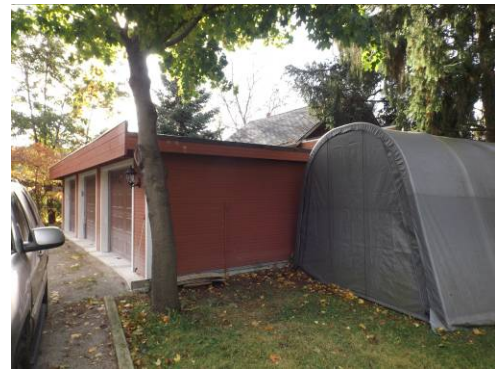
Figure 9. View from the north. Garage to the left, drive shed rising to its rear.

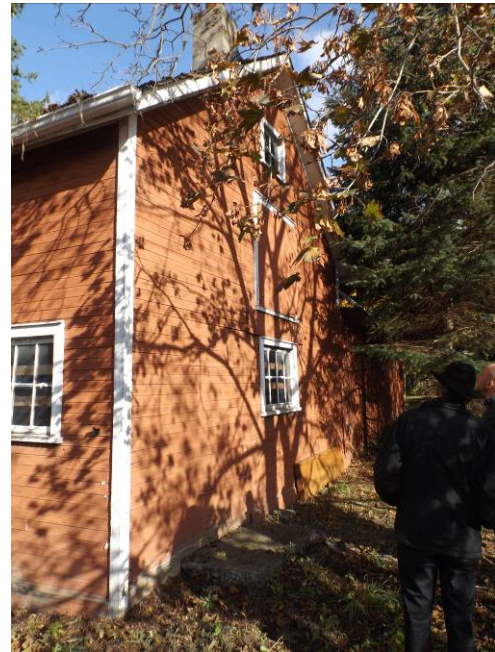
Figure 10. The south end of the drive shed. The garage is visible behind the pine tree.

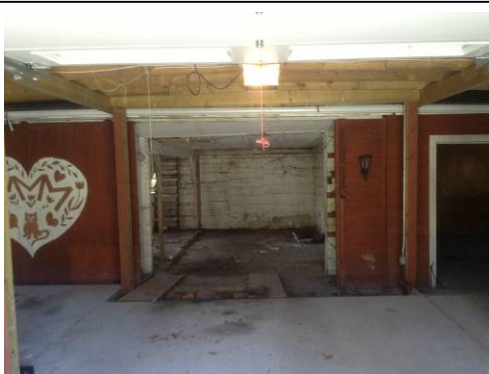
Figure11. Looking through the garage into the drive shed. Ladder to loft is visible at the left of the opening into the drive shed.

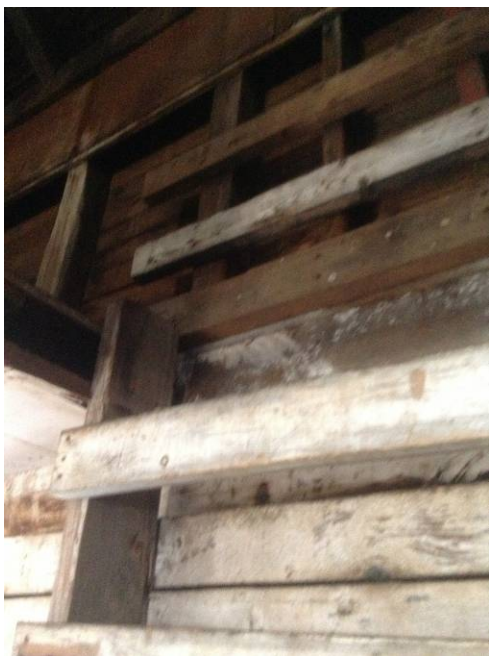
Figure 12. Top of the ladder shows large header on top of lower plank on plank wall, supporting frame of loft level. It's possible that the loft was added later.

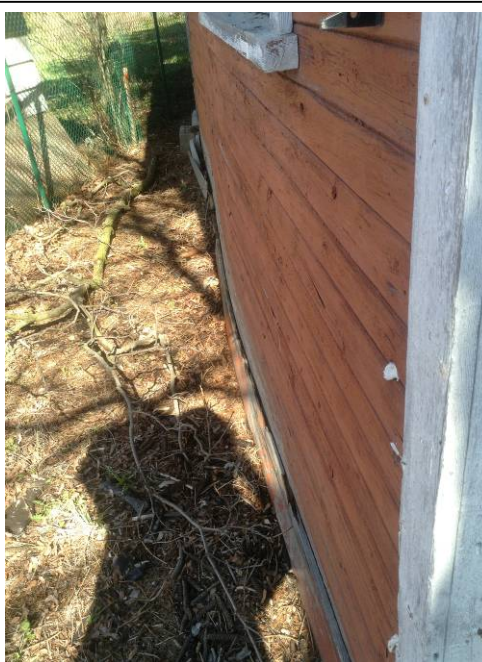
Figure 13. There is a significant bow at the base of the west wall near the south corner.

The siding on the garage and the shed-roof extension on the drive shed being 1x6 v-joint material in contrast to the 1x4 boards on the drive shed. This suggests that the extension is contemporaneous with the garage. The uniform exterior of the drive shed conceals the construction beneath, where the lower level appears to be of plank-on-plank construction, while the upper level is barn framed with posts, braces, and infill studding, resting on a header on top of the lower wall. Our timber specialist, Vic Snow, tells us that there are some similarly constructed barns in King Township. There is no stone foundation evident, and the lower boards on the south end of the west wall are bowed and deteriorated (see Figure 13).

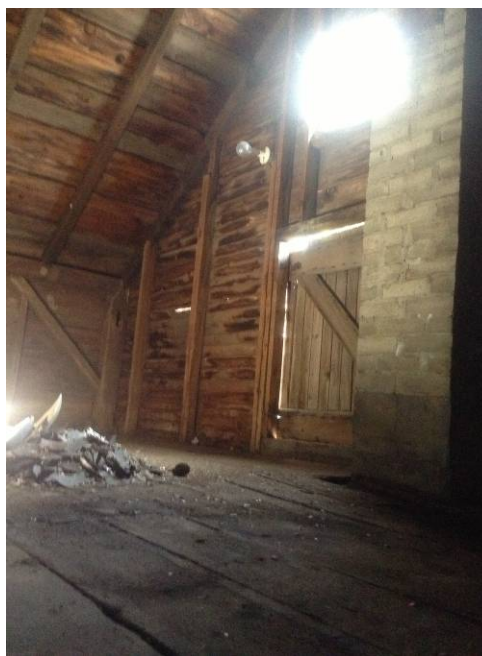
Figure 14. The upper level is barn framed with corner posts, braces, and infill studding. Brick chimney is visible on the right. It is at the centre of the south gable. Water damage to the sheathing boards is visible. Daylight is coming through one gap to the left. Note brick chimney to right of loading door.

The drive shed has plain white corner boards, and small Georgian-sash windows set in simple board frames, including one very small window to the loft at each gable end. The windows and frames are white. There is an internal single-flue chimney near the south wall and west of the ridge that rises from the ground. It may be that this chimney served a forge, and that a blacksmith shop was operated here.

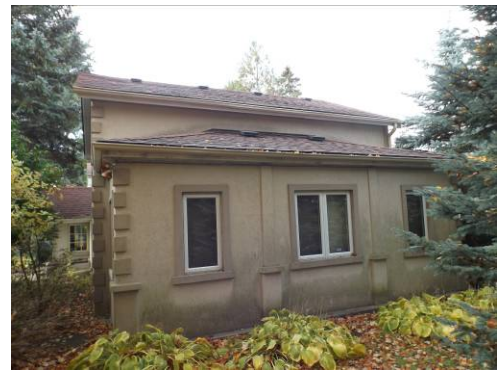
Figure 15. East (front) of the house showing enclosed verandah.

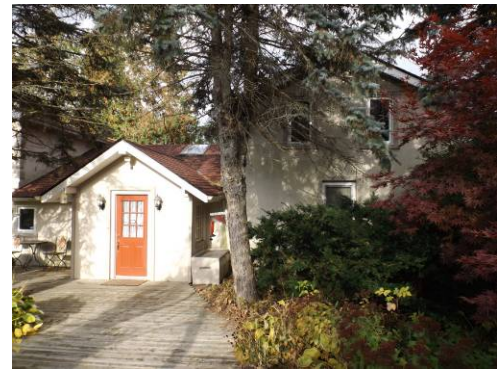
Figure 16. South side of the original house to the right. One-storey connection, with principal entry to the right.

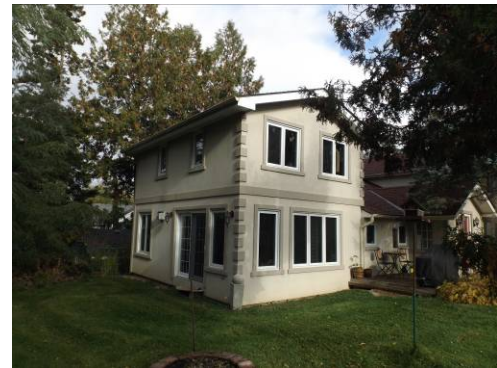
Figure 17. Southwest corner of rear 2-storey addition. One-storey connection and entry gable is visible to the right.

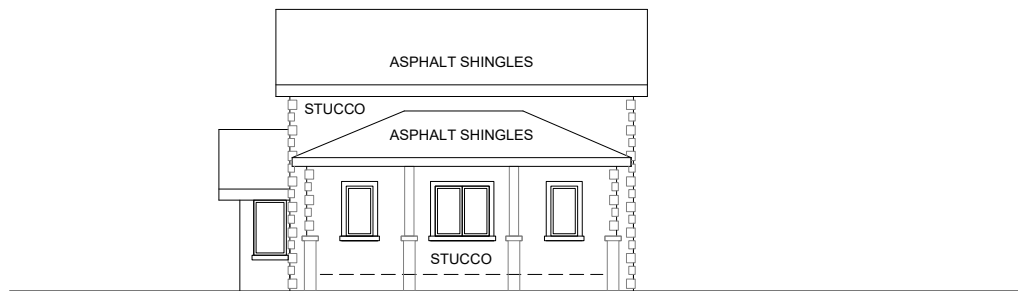
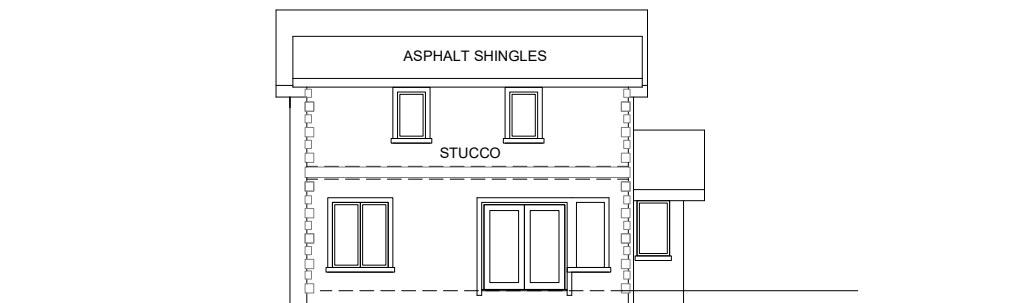
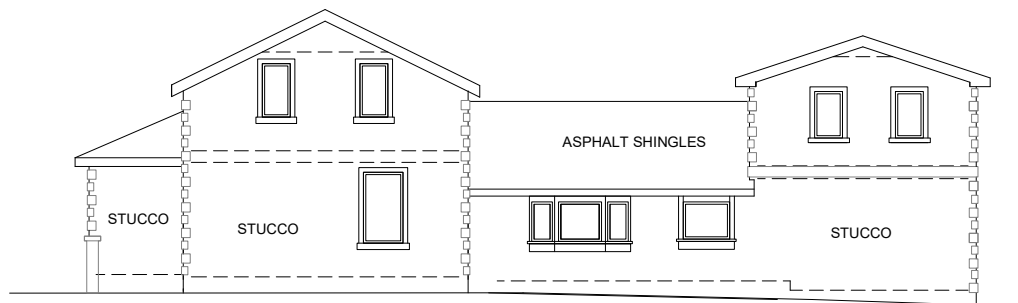
Figure 19. Existing Elevations

EAST (FRONT) ELEVATION

SOUTH ELEVATION

WEST (REAR) ELEVATION

NORTH ELEVATION

The following pages show measured drawings of the current building and photographs of the interior of the building.

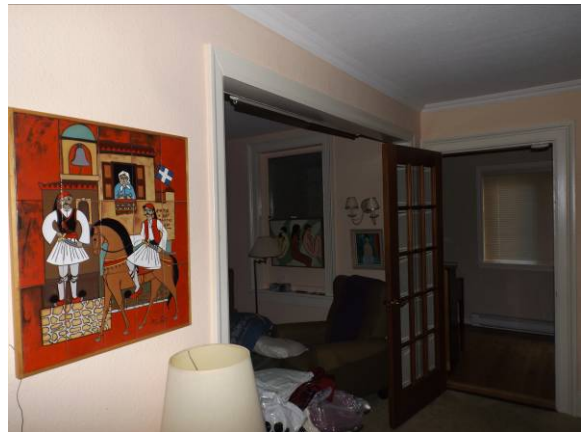
Figure 22. Ground floor, front and centre. The window seen in the previous photo is on the left. The central door leading onto the verandah is on the right.

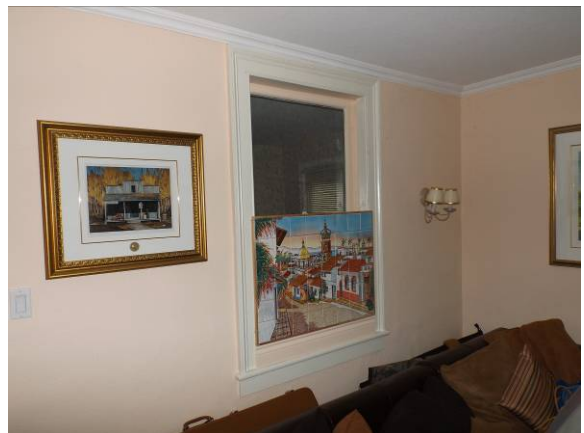
Figure 23. Ground floor, southeast corner. The window is the same one shown in the previous picture.

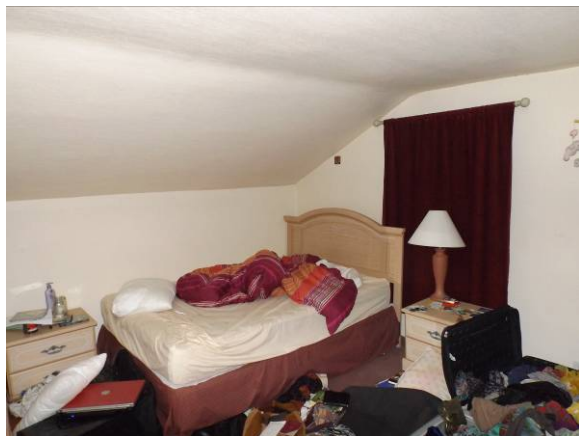
Figure 25. Second floor, southeast corner. Roof slope evident, and original window opening behind the curtain.

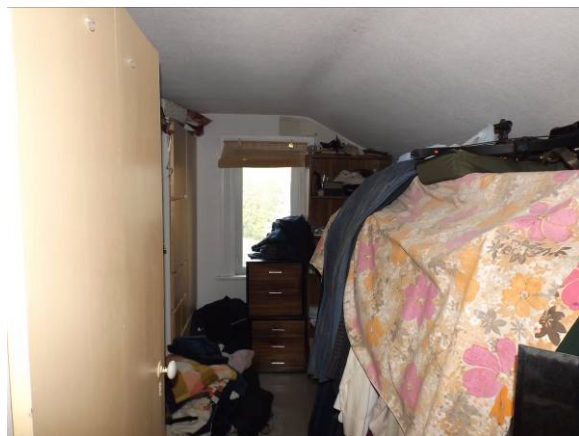
Figure 26. Second floor, northeast corner. Tiny bedroom, roof slope evident, original window opening in the far wall.

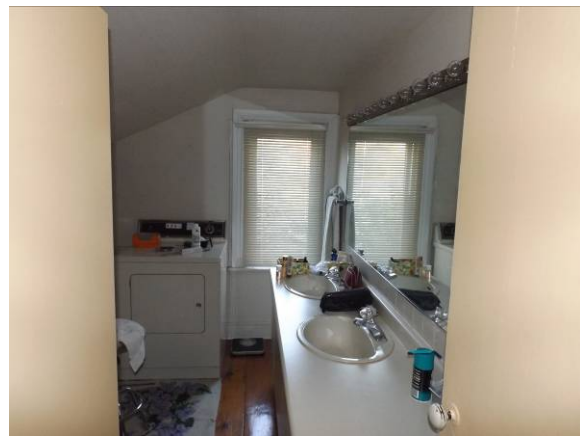
Figure 27. Second floor, northwest corner contains bathroom. Roof slope and original window opening are evident, as well as wide-plank pine floor.

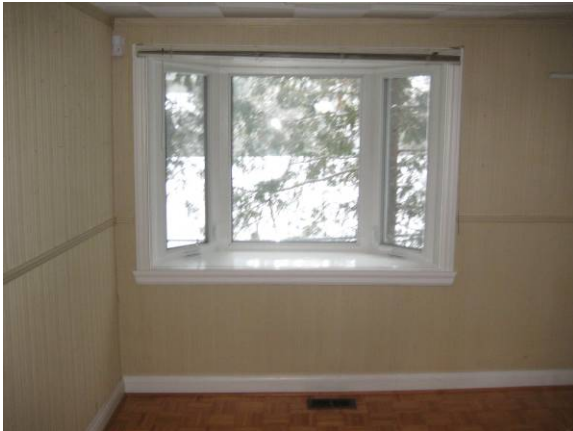
Figure 29. Bay window in north wall of middle dining room. It's visible in Figure x, before the furnishings were removed. Second floor, southwest corner, top of the stair.

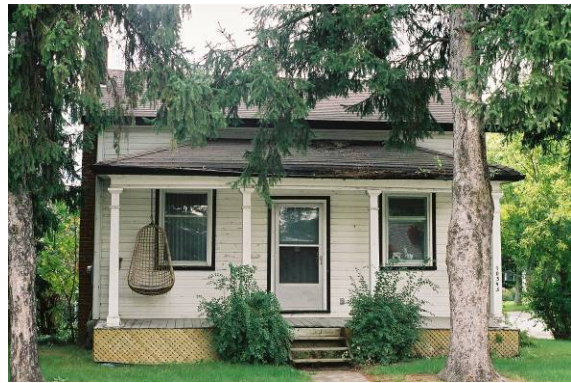
Figure 40. 10545 Islington Avenue, almost directly across the street from the south end of the property. The house is very similar to the principal dwelling at 10568, and informs our reconstruction.

The house has the general form of vernacular Loyalist cottage. It is very similar in layout and footprint to the house across the street at 10545 Islington Avenue. We conjecture that the front verandah, now awkwardly enclosed, was similar to that found across the street. The siding we found under the recent stucco is identical to that found across the street.

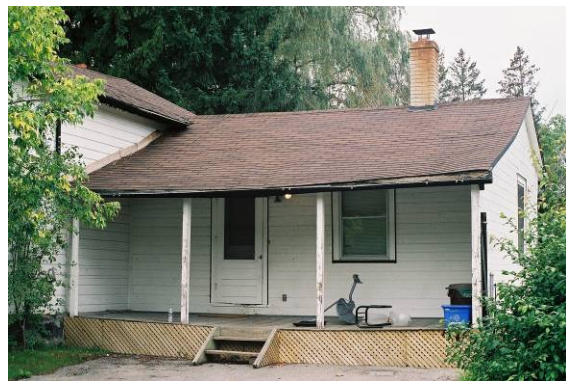
Figure 41. Kitchen tail with porch at 10545 Islington. We believe that 10568 was similarly configured.

There is an existing basement under the middle of the building. We assume that this defines the extent of the original kitchen tail of the house. There is a stone stair descending to this basement from a location outside of the kitchen tail. This is not uncommon in houses of this age, and there is a window (now blind) on the south side of the stair, we conjecture that this stair was enclosed under a porch.

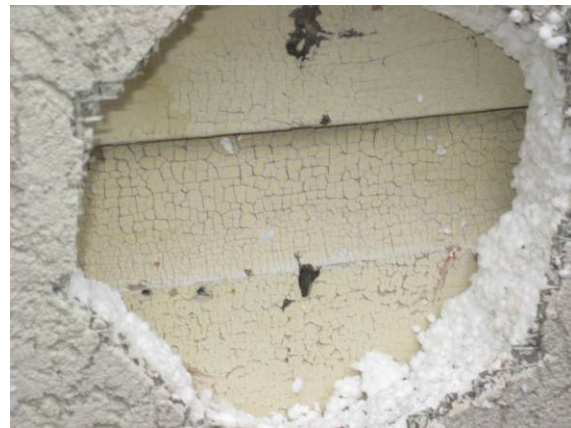
Figure 43. Cut out of recent EIFS stucco over Styrofoam, showing underlying wood drop channel shiplap siding. We believe the nail holes once secured the insulbrick siding.

We removed a patch of the recent EIFS stucco finish on the north side of the house, as seen in Figure 43. It is evident that the insulbrick was removed prior to the application of the stucco which was installed over the prior wood siding. We found wood siding under the stucco. The siding is milled to a drop channel pattern profile, which became popular around 1880, although it had originally appeared earlier. The rabbetted channel of the upper part of the board is unusually wide. The same siding profile is found on 10454 Islington across the street, and a similar profile, though with narrower channel, is found in the house immediately to the north at 10576 Islington Avenue. The front verandah on 10576 is similar to that on 10454.

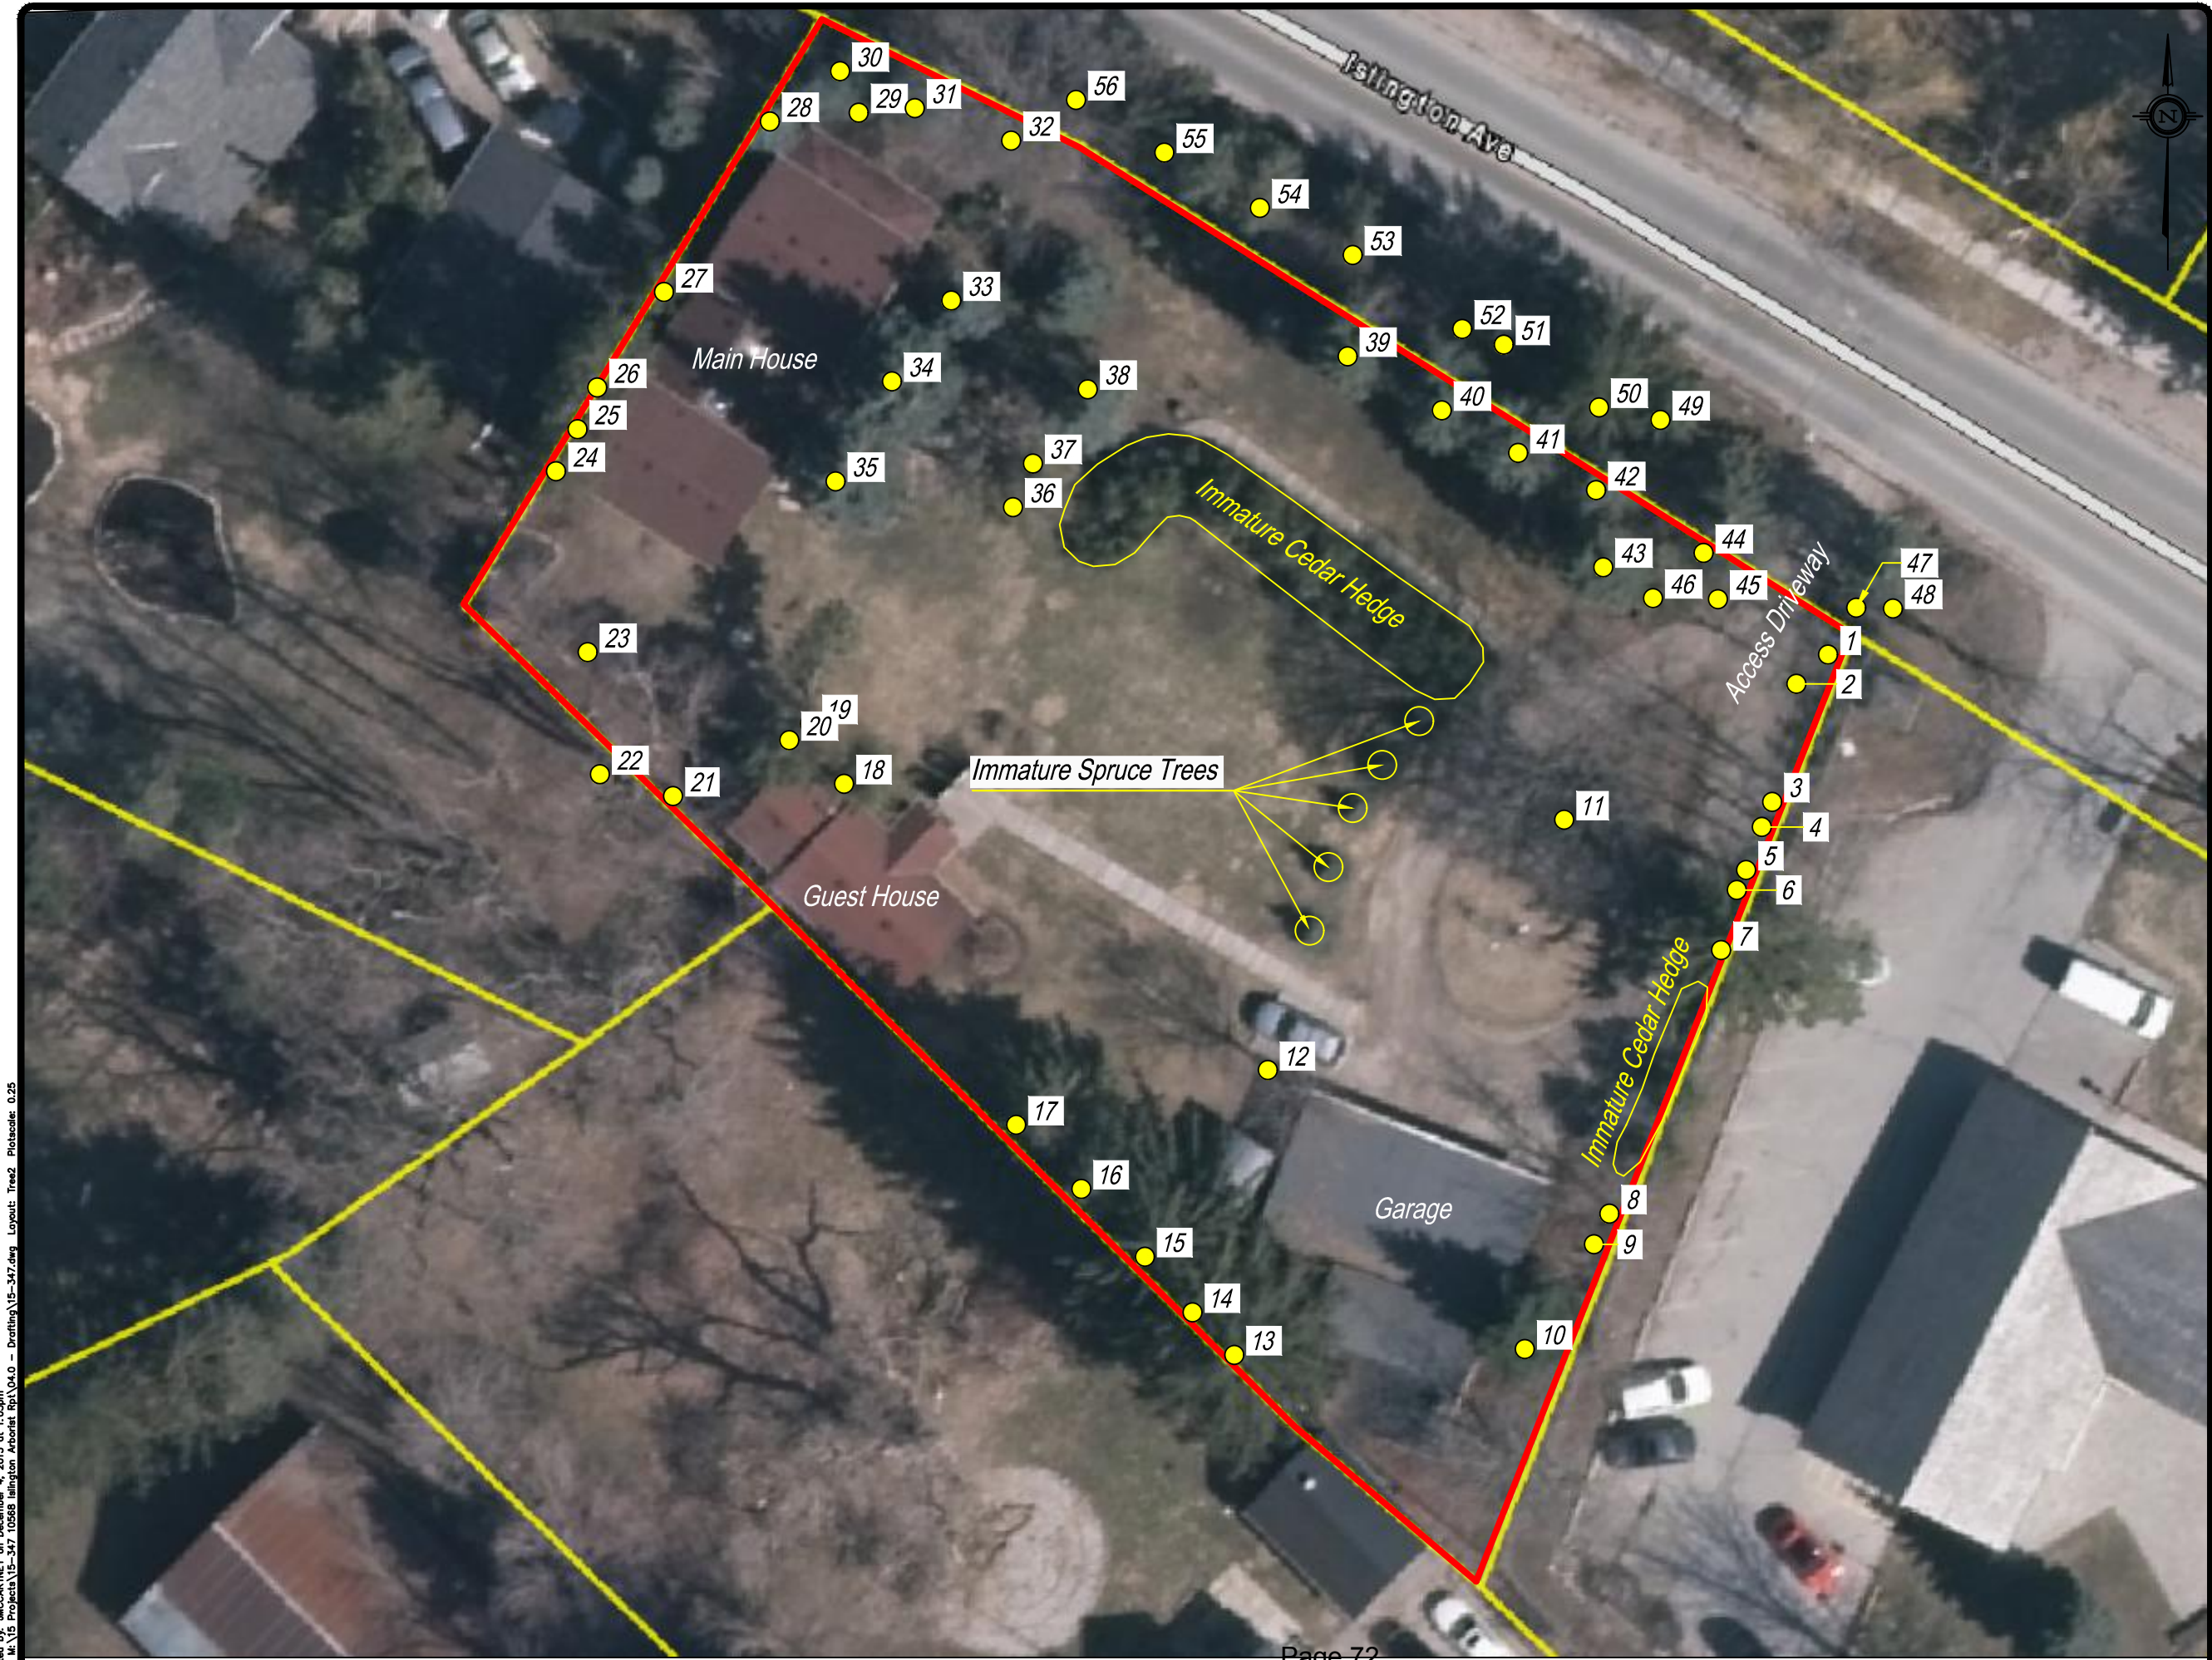
Tree Locations		
10568 Islington Ave., Kleinburg, ON		
DATE ISSUED:	December 2015	Figure No.  2
CREATED BY:	JLM	
PROJECT NO.:	15-347	
REFERENCE:	First Base Solutions

Of the 56 trees inventoried, 12 were either found to be located on adjacent land (within 5 metres of property boundary) or directly on the property boundary. Trees #22 (see Figure 2) is located on the neighbouring property to the south which should be preserved. Trees #47 - #56 are located on City property (Islington Avenue right-of-way). These trees will require permission from the City to be removed. Considering Tree #22 is close on

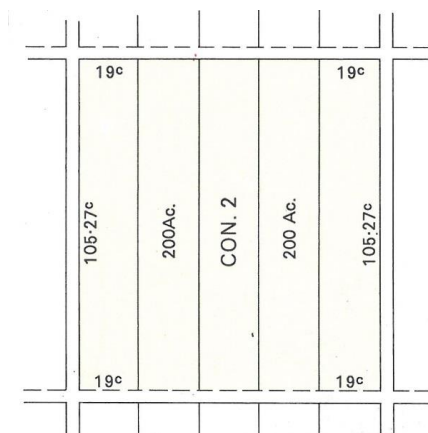
**Figure 2: The single front survey system, used from 1783 to 1818. As depicted, each lot is 200 acres created from surveying 19 chains by 105.27 chains (1 chain = 66 feet/20.12 metres; from Gentilcore & Head 1984:99)**

The property is located within the City of Vaughan, formerly Vaughan Township. Vaughan was named in 1792 for Benjamin Vaughan, a British commissioner who negotiated the 1793 Treaty of Paris between Great Britain and the United States (Rayburn 1997:335). Abraham Iredell surveyed the Township in 1795 according to the 'single front survey system', a method used from 1783 onward where only the concessions were surveyed and lots of 120 to 200 acres were delineated to be five times as long as they were wide (Schott 1981; see Figure 2). In Vaughan Township, the concession lines were oriented south to north, with the side roads crossing the township from east to west. Yonge Street, a military road surveyed in 1794, formed the baseline of the township, dividing it from Markham Township to the east (Miles & Co. 1878).

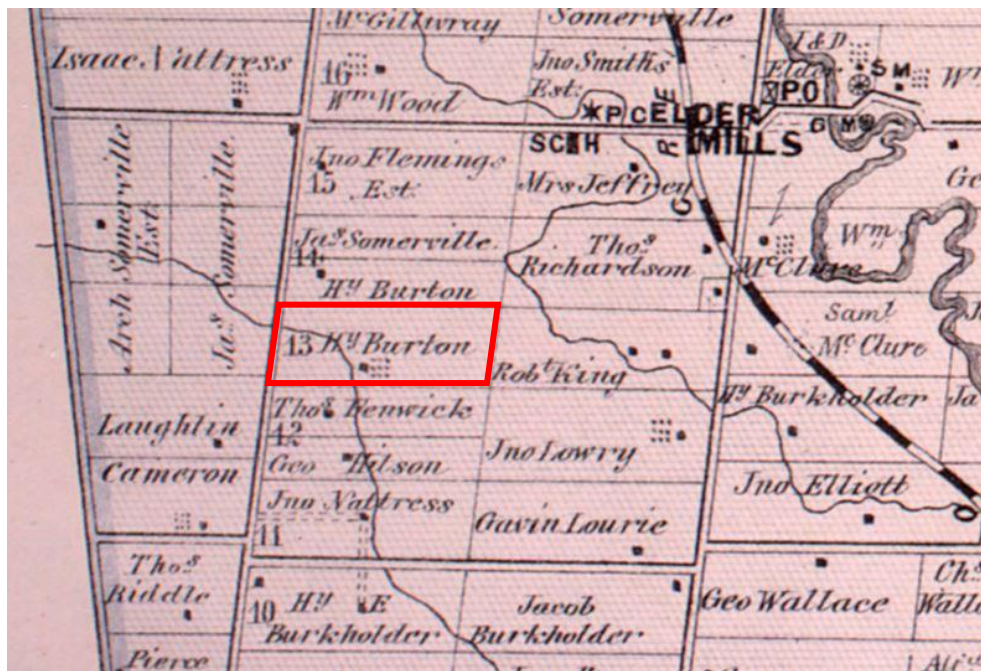
Figure 5: Portion of the 1878 map of the Region, with the west half of Lot 13, Concession 9 highlighted (Miles & Co. 1878).

The 1860 Tremaine Map of the Township shows H. Burton as owning the west half of the lot, and he is still listed on the 1878 map of the region (Miles & Co. 1878)(Figure 4 & Figure 5), with a small house and garden area indicated near the south-centre of the property. Henry Burton died in 1881, and the 100 acres were transferred to his son, Robert Burton, through his will, according to the abstract index to deed records.

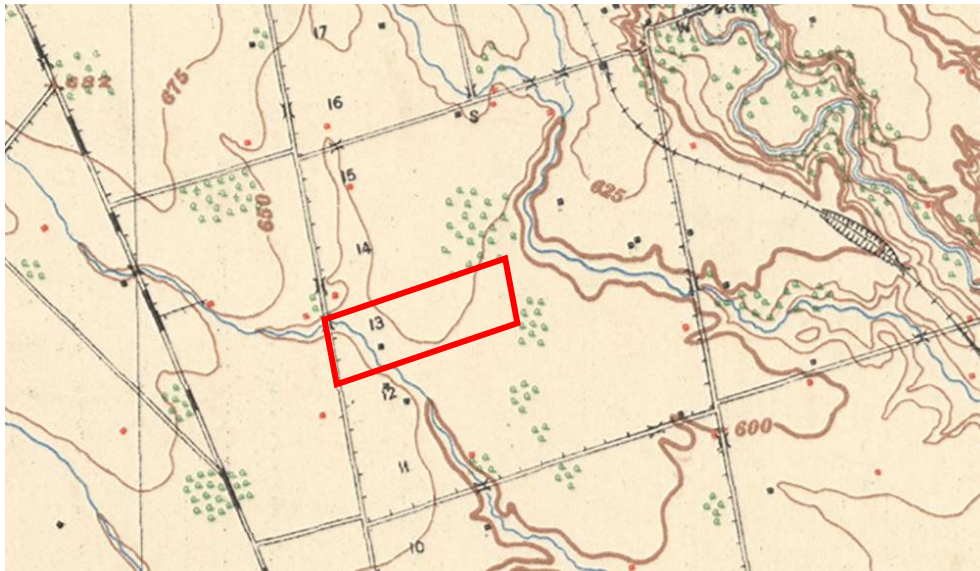
Figure 6: Portion of the 1914 topographic map of the region, with the west half of Lot 13, Concession 9 highlighted (Department of Militia and Defence 1914)

The property remained in the Burton family throughout the late 19<sup>th</sup> century and into the 20<sup>th</sup> century. A topographic map of the region from 1914 shows a wood structure on the property in the location of the current residence, but no outbuildings (Figure 6)(Department of Militia and Defence 1914). Between 1947 and 1956, portions of the property were undertaken by a by-law from the Township of Vaughan's subdivision control, but no amount of money was recorded as changing hands. An aerial photo obtained from the University of Toronto Archives from 1954 shows the farm property but is at too great of a scale to determine details about the structures, but does indicate a structure closer to the field boundary than the current barns, suggesting that the original barn was still standing at this point (Figure 7). In 1961, Robert E. Burton and his wife Mary granted the land to Catherine A. MacPherson for '\$1 etc.' for all 100 acres. The 1963 topographic map of the region shows the property as consisting of several small buildings including a barn, two outbuildings, and a residence in the location of the present house (Department of Energy, Mines and Resources 1963) (Figure 8). Through the 1960s,

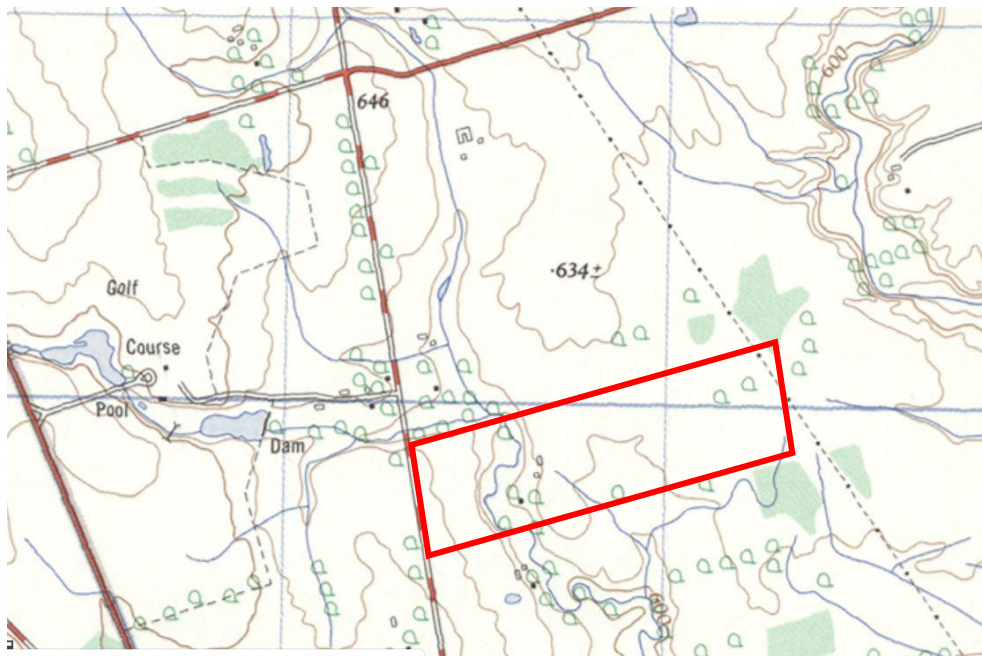
Figure 9: Portion of the 1972 topographic map of the region, with the west half of Lot 13, Concession 9 highlighted (Department of Energy, Mines and Resources 1972).

By 1972, the topographic map indicates the residence and only two outbuildings, including a barn and a smaller structure in the approximate location of the current structure between the residence and the barns (Department of Energy, Mines and Resources 1972) (Figure 9). According to aerial photos provided by the York Region interactive maps, the old barn's stone foundation was all that was left visible of the structure by 1978, with the existing north and south barns having already been constructed. MacPherson leased additional portions of the property to Ontario Hydro until 1981. Aerial images provided by Google Earth show that both additions were present by 2004.

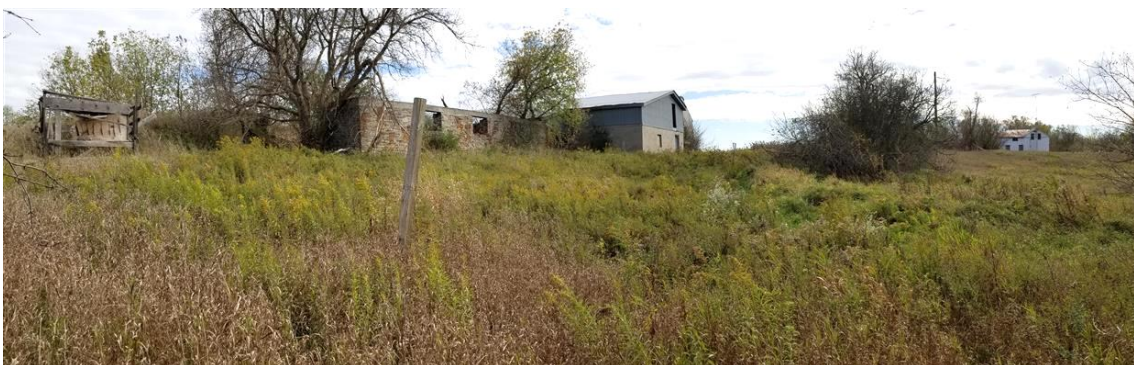
**Figure 14: View of stone barn foundation and barns, facing south. Residence is in the background.**

Bushes and low trees surround the residence, obscuring it from view from the right-of-way (ROW) to the west. A gravel road leads from Huntington Road, east to the occupation area of the property, and the property is surrounded by a low wire and post fence. To the north of the residence and outbuildings is the stone foundation of a barn (Figure 14). According to the previous report on the property (Scarlett Janusas Archaeology Inc. 2014) indicated that this barn burned down in the 1960s and was replaced by the current barns and outbuildings.

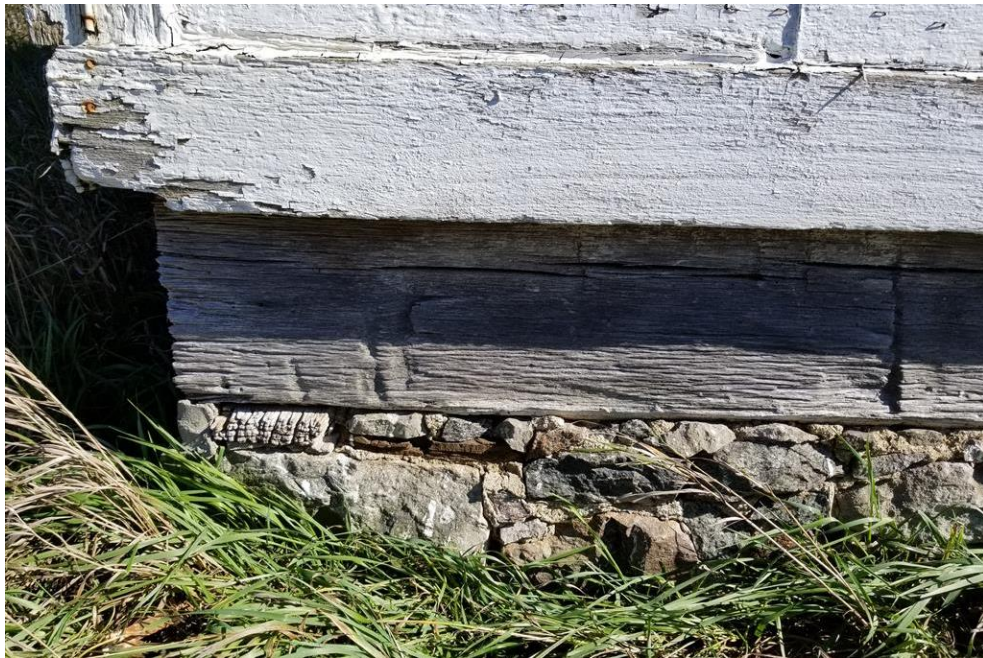
**Figure 21: Coursed rubble foundation of the Main Block.**

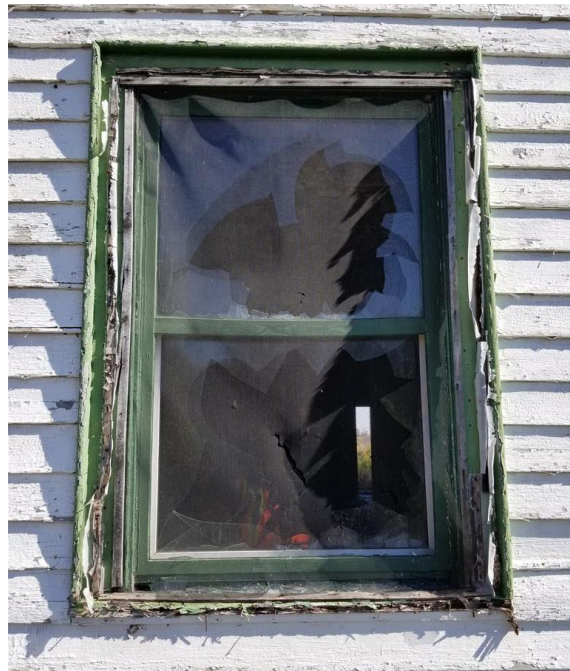
**Figure 22: Typical window on the ground floor, Main Block.**

Fenestration is symmetrical, with a central flat-head door with a moulded frame flanked by two tall, one-over-one flat head single-hung windows with a plain exterior wood frame and no sill, on the principal southwest façade with plain wood exterior frames (Figure 22). The door is undecorated with a plain exterior frame. Second storey windows on the main façade are wide single-pane with plain wood frames and no sills, which are symmetrical with ground-floor windows. Visible in the basement foundation are several additional wide two-pane, small wood-frame flat-head windows with no sills and plain exterior trim.

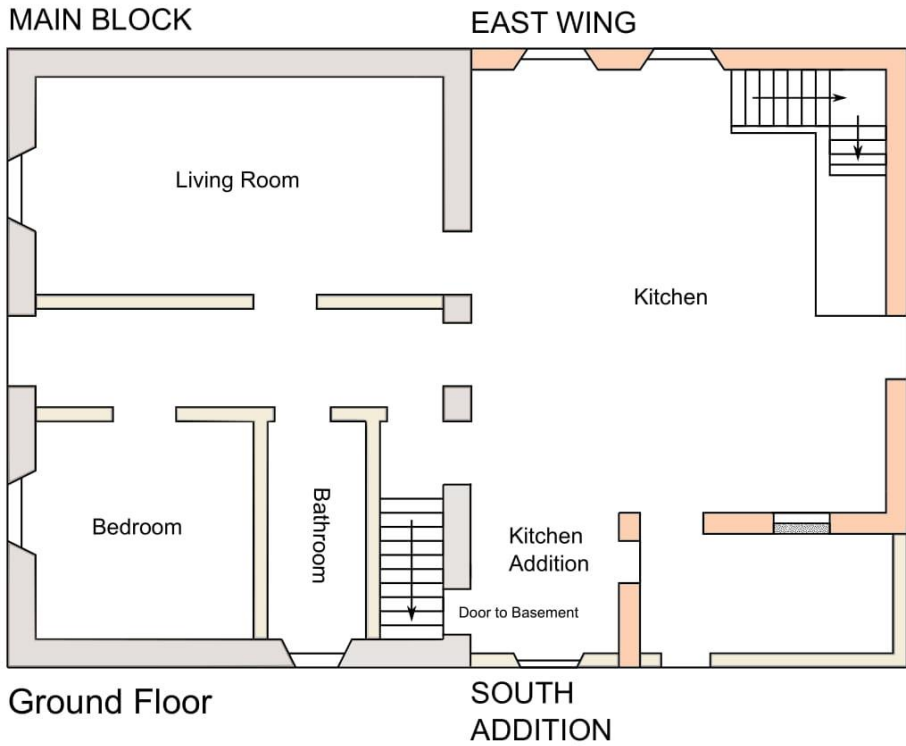
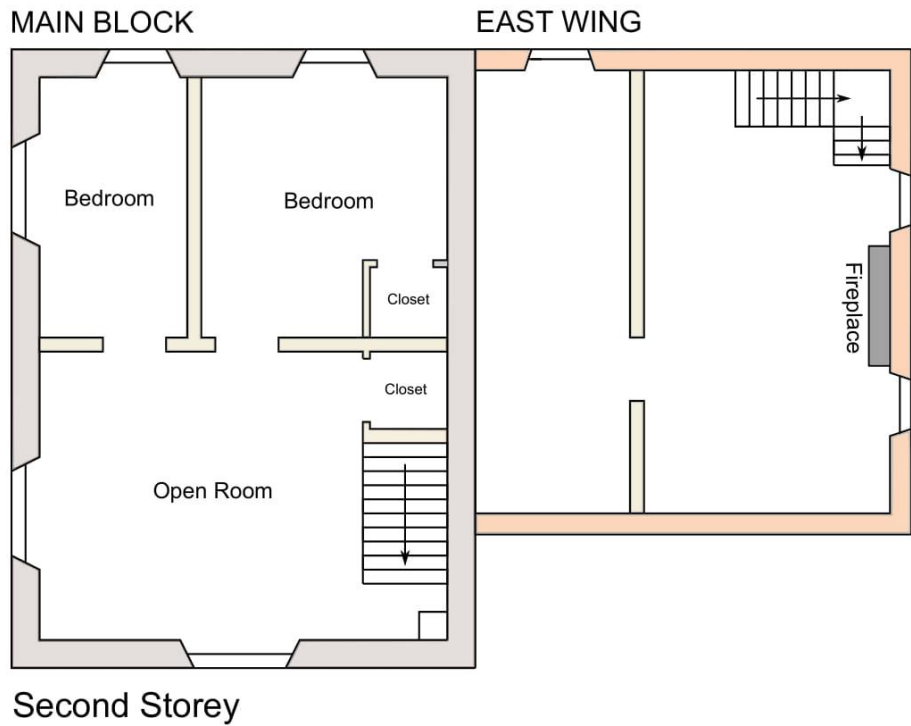
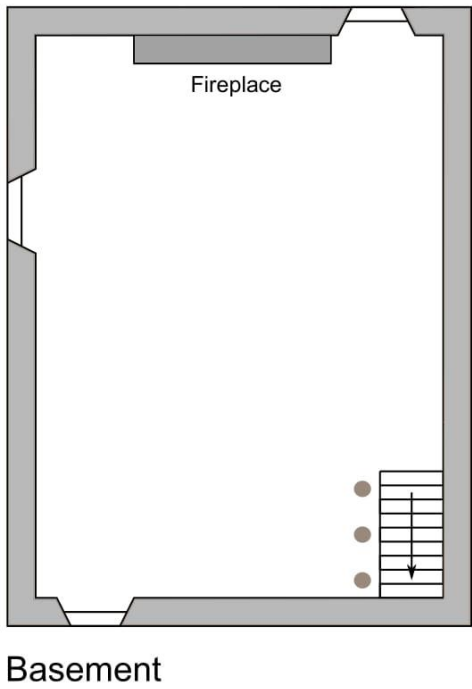
Figure 23: 8811 Huntington Road floorplan (not to scale)

On the ground floor, there are three major room divisions as well as one staircase. Two of room divisions appear to have been used as bedrooms, and one as a bathroom (Figure 23). Upon entering the central doorway, a hallway extends through the centre of the residence, with one doorway on the north side of the hallway, and three on the south side (Figure 24). Walls are likely lath and plaster and covered in cream wallpaper with a floral border at the top. The paint shows evidence of extended water damage. A tall baseboard runs the length of the hallway, and the wood floor has been covered by a low-pile carpet. The west door on the south side of the hallway, the first door encountered upon entering the house, has a wide flat-head, wood-frame transom above it (Figure 25). Only one window is present within the room, surrounded by a moulded wood frame but no other decoration. The floor is covered by a warped laminate which overlays older flooring below, as is evidenced by the lack of alignment with the baseboards. This room, as well as the hallway, has seen extensive damage from moisture and other pests, with paint and wallpaper peeling away from the walls and ceiling (Figure 26). Doorframes on the ground floor of the main block indicate that the walls are thin, and likely of wood-frame construction.

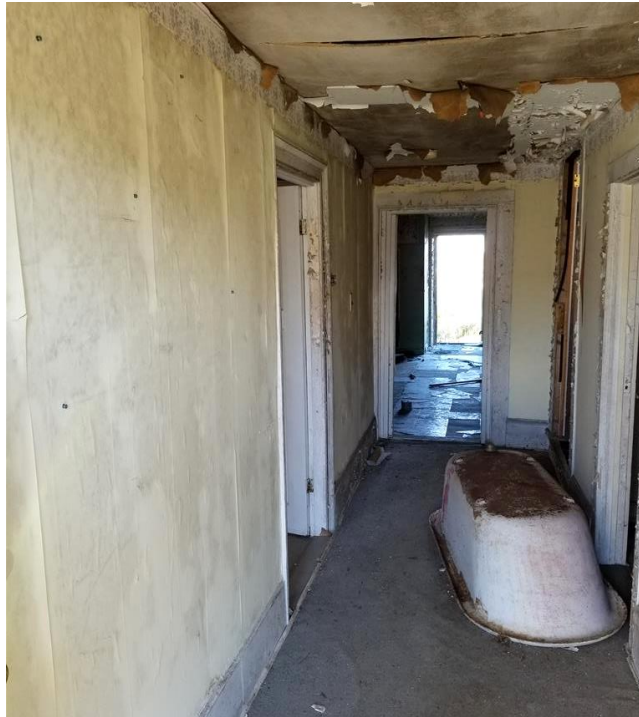
Figure 24: Central hallway in Main block, looking east from front door.
