**CITY OF VAUGHAN  
HERITAGE VAUGHAN COMMITTEE  
AGENDA**

**248 - 260 Woodbridge Avenue  
Woodbridge Heritage Conservation  
District (HCD)  
City of Vaughan**

Revised  
Heritage Evaluation of Existing Structures  
10568 Islington Avenue, Kleinburg, ON  
In the City of Vaughan

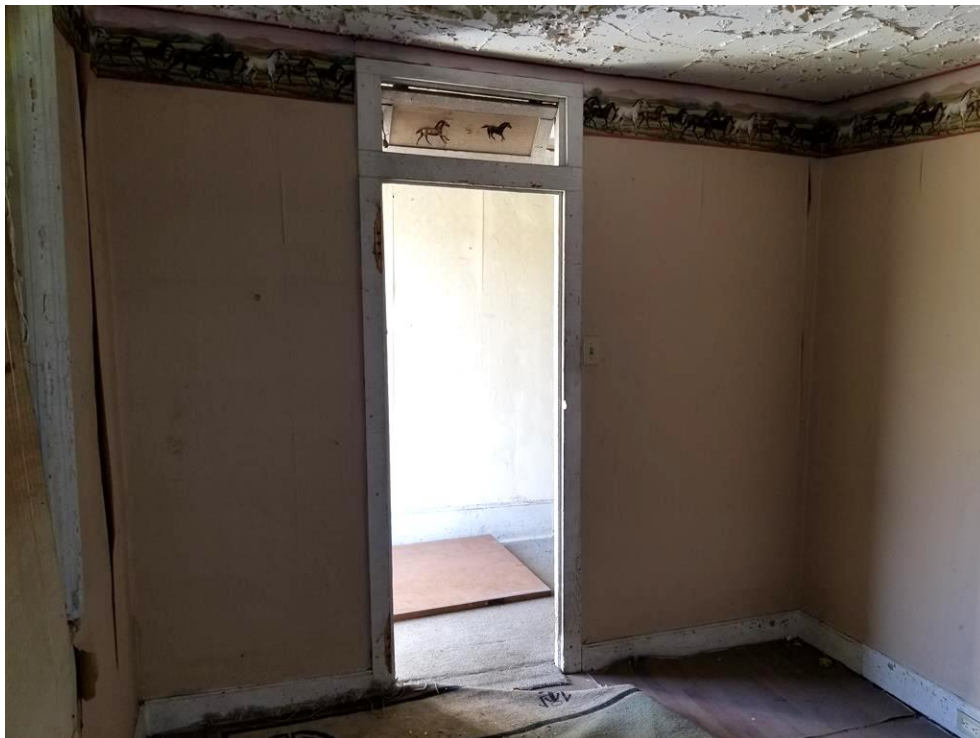
Figure 25: Interior transom above southwest room, ground floor.

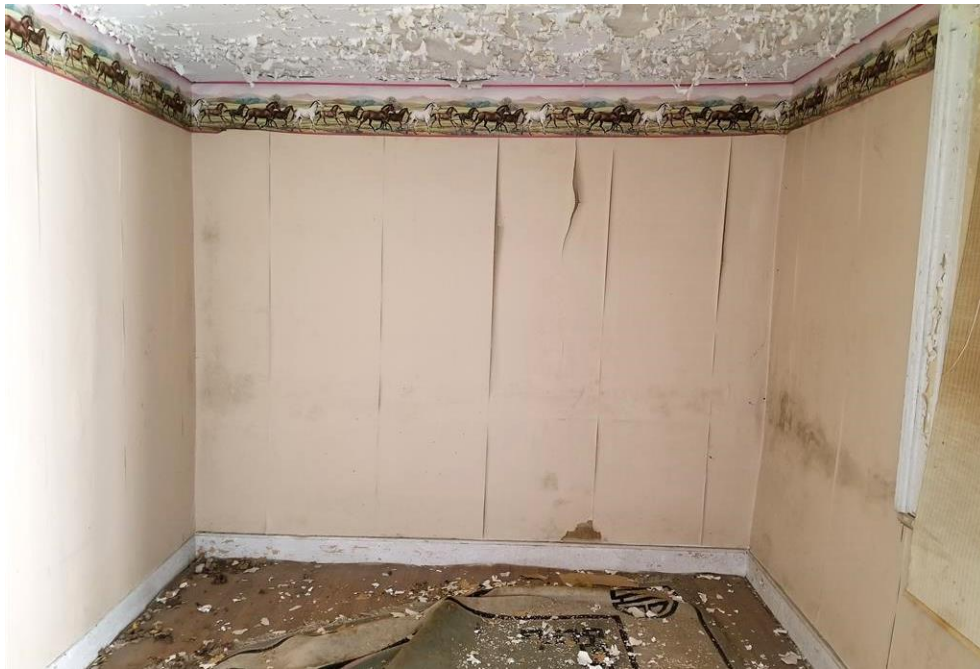
**Figure 26: Interior of southwest room, ground floor.**

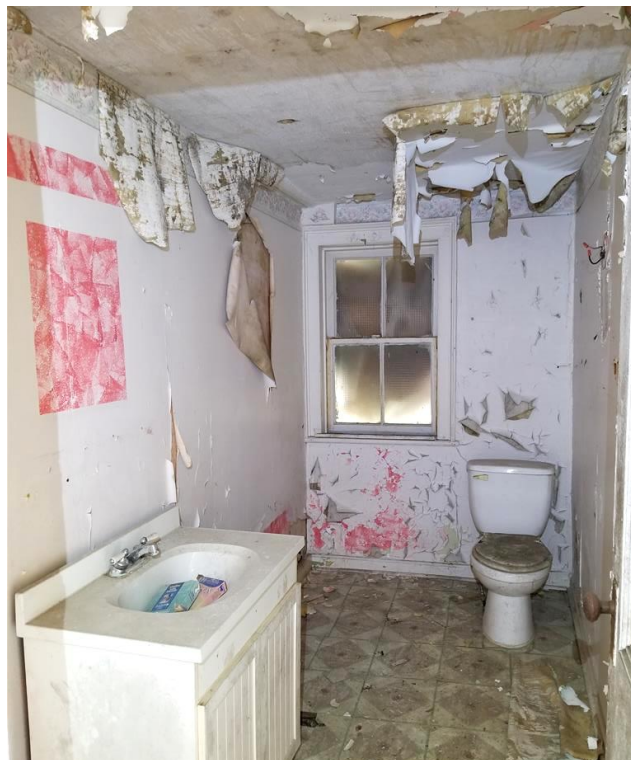
**Figure 27: Southeast bathroom, ground floor.**

Directly east of the first bedroom, a bathroom with a south-east facing window has undergone extensive renovations (Figure 27). It is sparsely furnished with a sink and cabinet, and a toilet in the south corner. The walls of this room are also covered by peeling wallpaper. The doorframe of the bathroom is of moderate width and undecorated, framing the four-panel wood door with a round metal door handle, with a keyhole in the escutcheon plate (Figure 28).

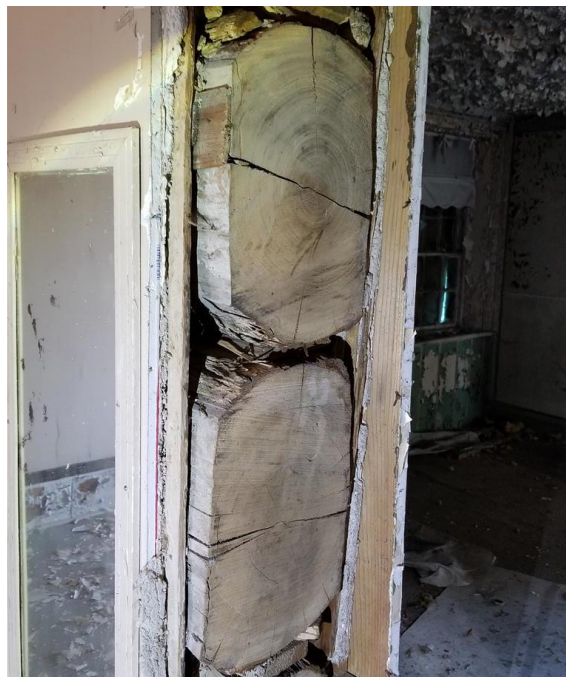
**Figure 31: Interior east log wall on the Main Block.**

The doorway that opens into the East Wing exposes the interior construction of the Main Block walls: partially shaped logs, indicating that a portion of the structure is a log house covered by siding (Figure 31). These logs were felled and cut using a crosscut hand saw, based on the non-parallel straight lines, which suggest hand sawing over a band saw, and are present on the exposed end surfaces of the wood, and did not have the bark removed from the upper and lower sides of the log before shaping and construction of the house (Figure 32). Plaster is visible on both sides of the logs, indicating plastered walls in both the Main Block and the East Wing. The large lintel over the doorway shows evidence of drill or wedge marks and split in order to create the flat beam. Vertical hand-split lath is present on the Main Block side of the doorframe (Figure 33).

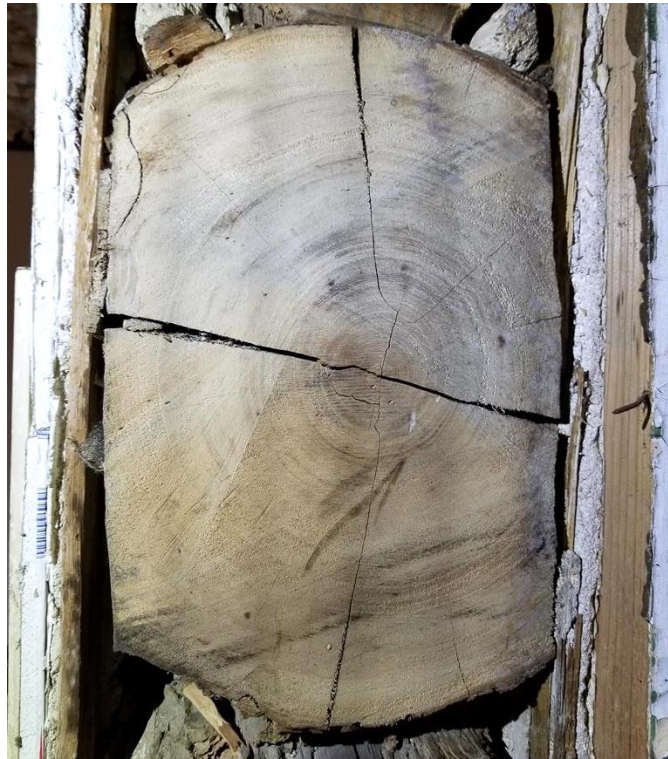
**Figure 32: Cross-cut saw marks.**

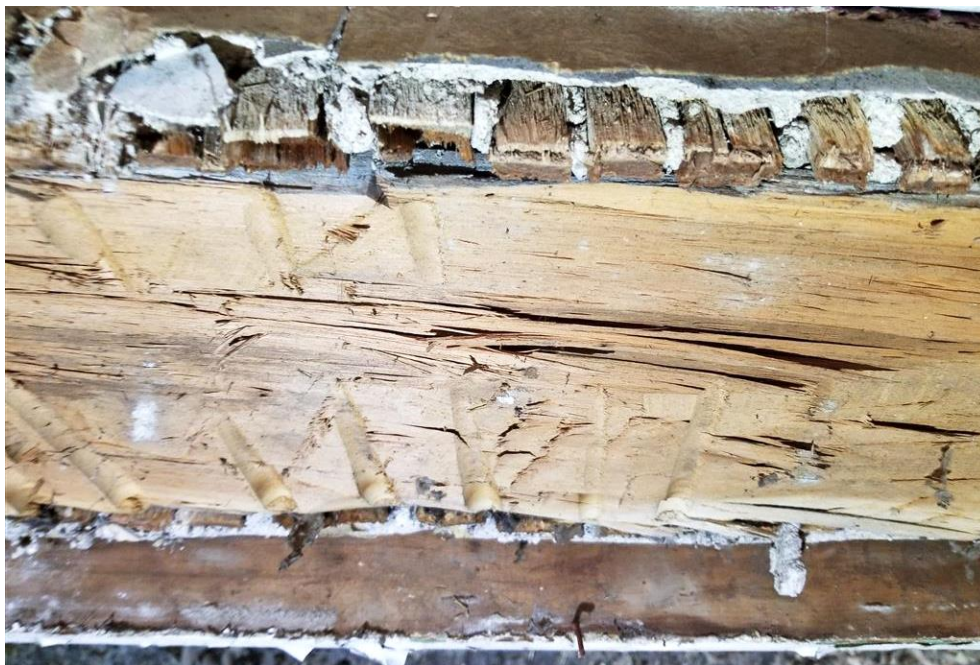
**Figure 33: Detail of top of the doorway, showing split log and vertical lath and plaster.**

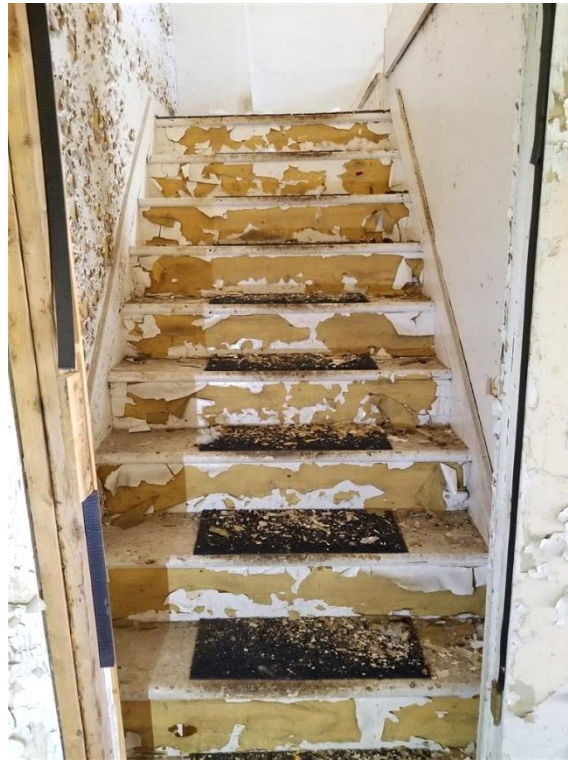
**Figure 34: Staircase in Main Block leading to second storey.**

The second storey of the Main Block is separated into three rooms. At the top of the staircase (Figure 34), bordered by a white-painted wood balustrade, is a room with two windows that comprise the south half of the upper level (Figure 35). In the corner of the staircase is a small rectangular protrusion from the wall, which corresponds to the exterior chimney in the east corner of the roof. A wall running through the middle of the space sections off two identically sized bedrooms, each with a window at the north wall. All three rooms are brightly coloured with moderately sized baseboards and narrow plain doorframes (Figure 36). Floorboards on the second storey are very wide hardwood planks that likely date to the original construction of the residence (Figure 37).

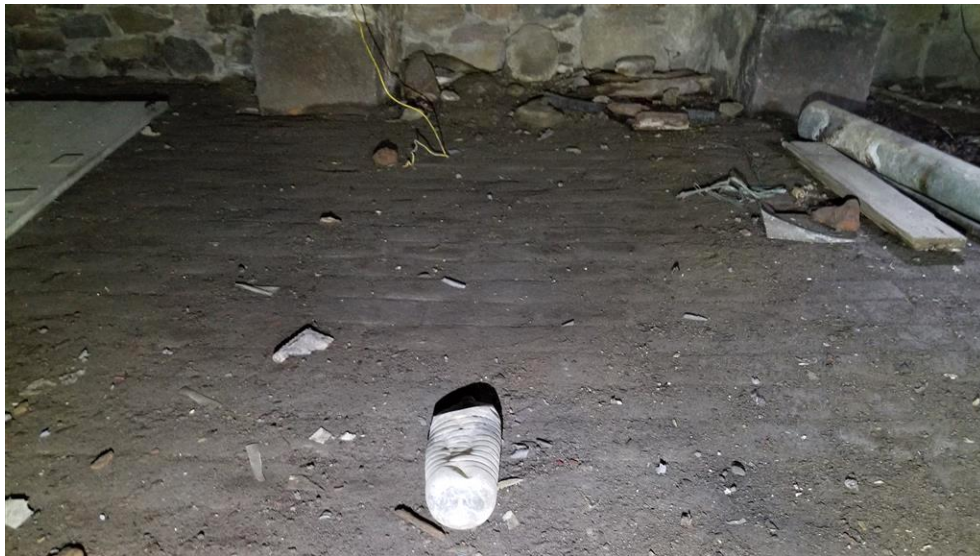
**Figure 39: Brick floor in the basement.**

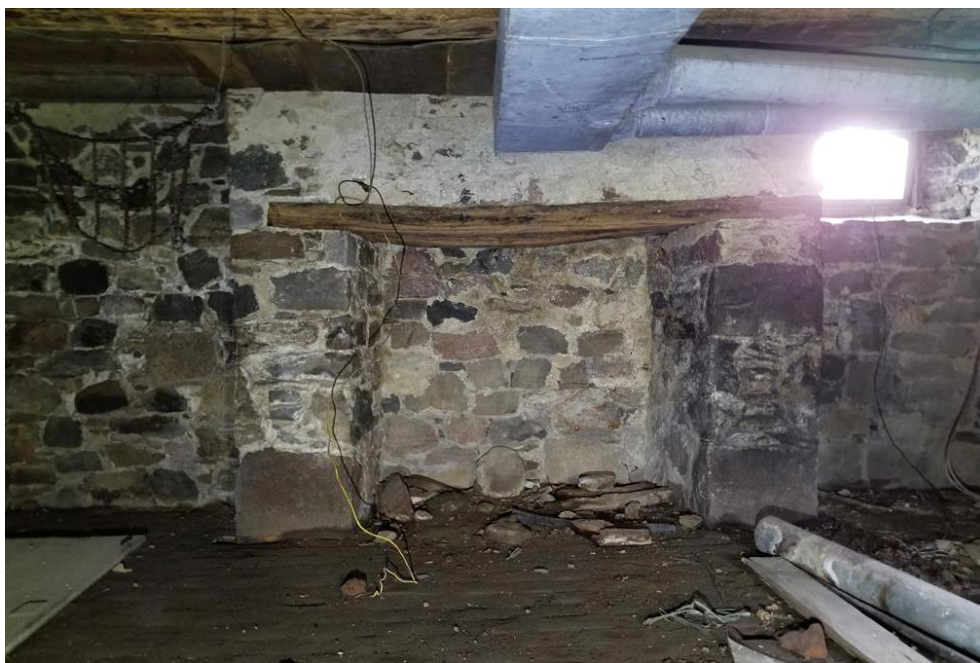
**Figure 40: Fireplace at north end of basement, with wood lintel.**

The basement is located beneath the Main Block of the residence and consists of a single full-height room with coursed stone rubble walls. A simple wood staircase leads downstairs from the exterior southeast corner, and three tree trunks are braced alongside the stairs, creating support for the floor above (Figure 38). An interesting feature of the basement is its brick floor, which spans the entire room (Figure 39). There are three wide single-pane, flat-head windows set into the stone walls, one on the north wall, one west, and one facing south, although the west window was filled in with stone rubble. At the north end of the basement, a large stone fireplace with a wood lintel is built into the foundation and would have extended into the ground and second storey at one point (Figure 40).

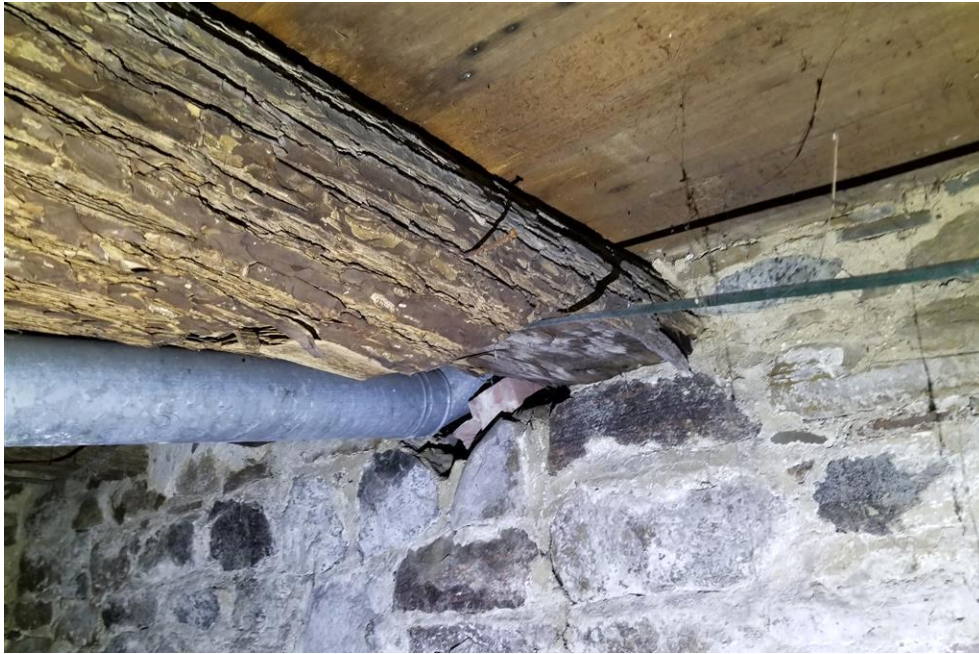
**Figure 41: Example of overhead sleeper.**

Resting on top of the stone foundation are a series of lateral beams running east-west, unsupported in the centre of the room save for the tree trunks. The beams are also made primarily from unshaped logs, known as sleepers, both with and without the bark removed, which have been cut to a square or flat-bottomed at either end to sit in the wall (Figure 41). At the east end of the room, a small crawl-space is visible extending east beneath the East Wing and South Addition (Figure 42). Adze marks are evident on a visible beam within the crawlspace in the East Wing, and machine lumber is present beneath the South Addition (Figure 43).

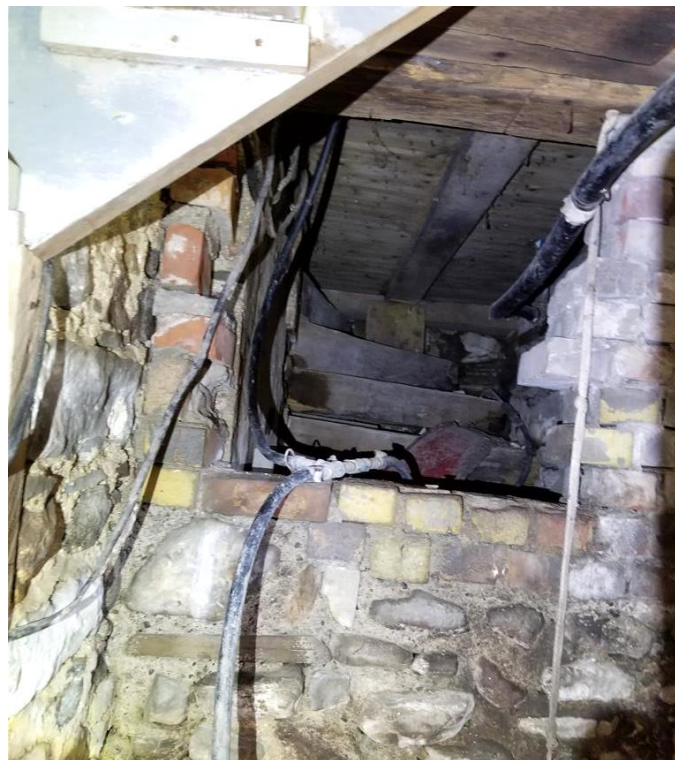
**Figure 42: Crawlspace in east wall of basement. Crawlspace is below the East Wing.**

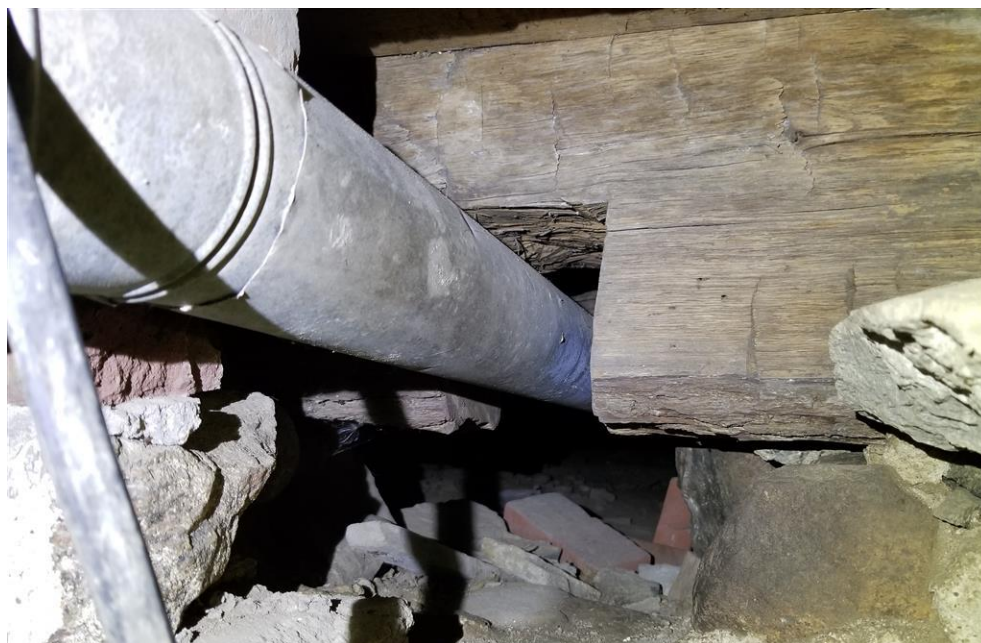
Figure 43: Space below East Wing and beam with adze marks.

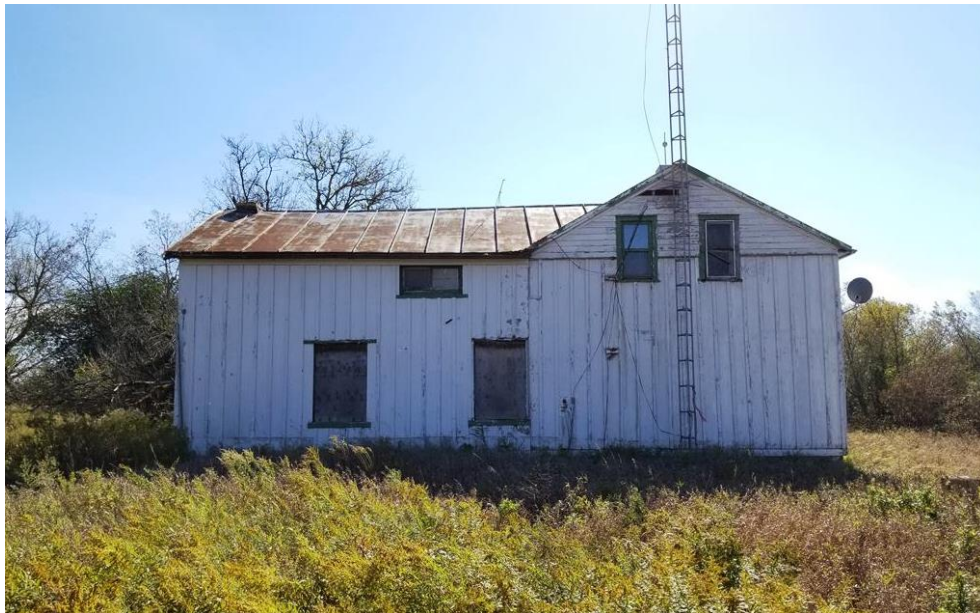
**Figure 44: North façade.**

The East Wing has a rectangular footprint and is oriented east-west (Figure 44 to Figure 46). It is a storey-and-one-half structure with a low gable roof, attached to the east façade of the Main Block. The walls are covered with a combination of board-and-batten siding and horizontal wood siding. The main façade, facing east, displays asymmetrical fenestration, with the exterior door on the northeast corner of the structure, and two tall, flat-head, wood frame windows with wood lug sills on the second storey, almost within the gable (Figure 47). One is single pane while the other is a two-over-two double hung window. The north-facing wall has two tall boarded windows on the ground floor, and one wide, two-pane, flat-head window on the second storey. Windows present in the East Wing have retained their wood frames, and windows on the north side of the second storey are horizontal sliding windows, like those in the historic photo of the house in Section 4.4. As with the Main Block, the metal roof has projecting eaves but not verges, and plain soffits and fascia. There is a small, disused chimney present at the east end of the roof, between the second storey windows.

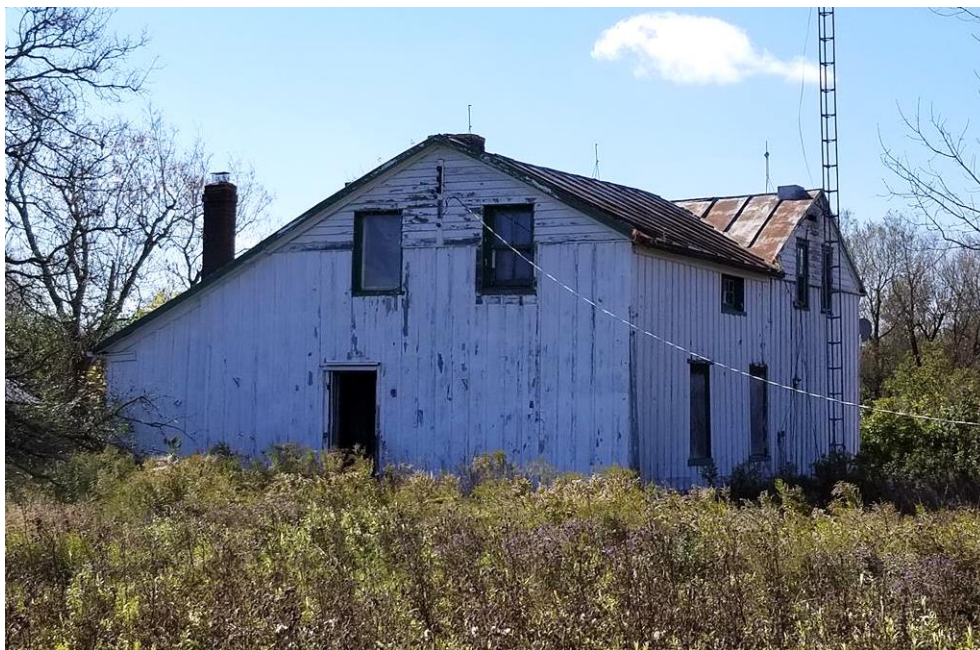
**Figure 45: North and east façades.**

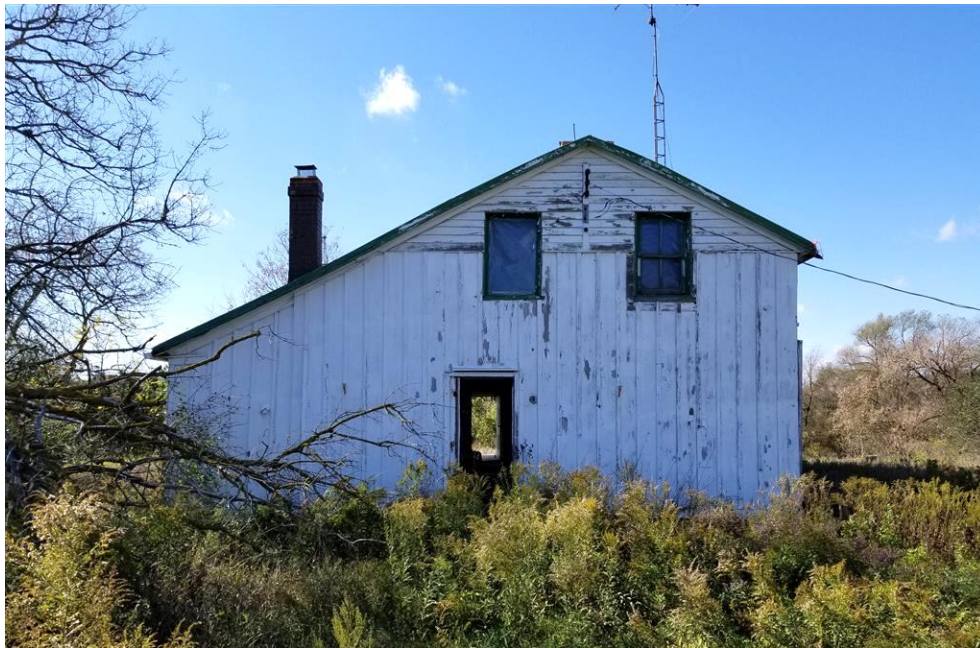
**Figure 46: East façade.**

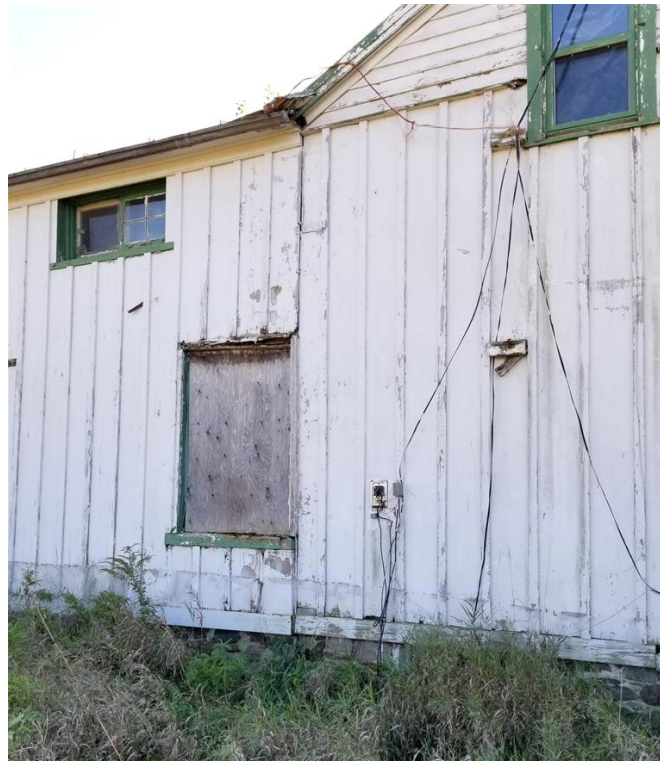
**Figure 48: Visible join between East Wing and Main Block. Note the small horizontal sliding window.**

Sitting on a coursed rubble foundation similar to that of the Main Block, there is a visible joint between the two structures (Figure 48 and Figure 49). Only the north and east walls of the structure are visible from the exterior, due to its connections to the Main Block to the west and the South Addition to the south.

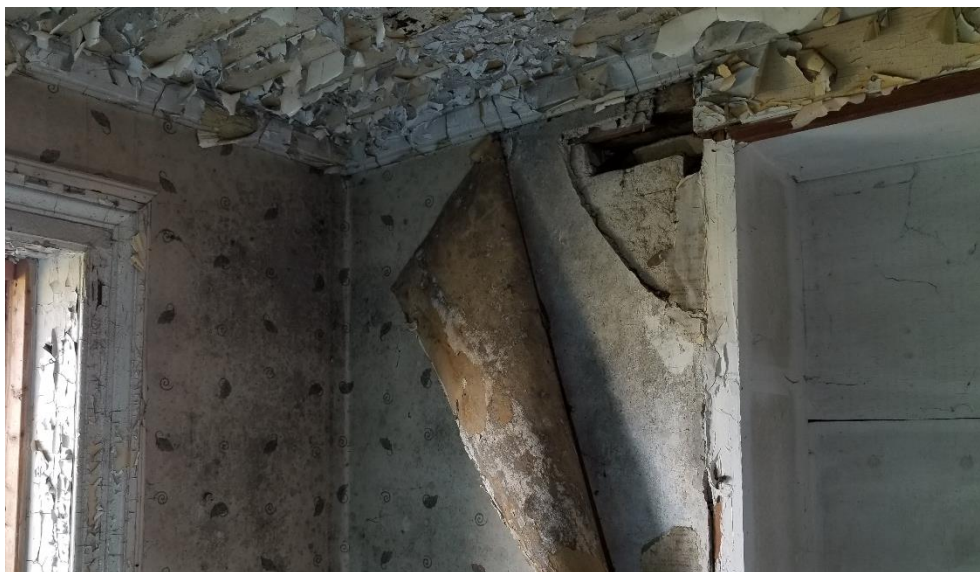
**Figure 52: Bricks visible behind wallpaper and plaster, southeast corner of the ground floor room.**

The East Wing can be entered from the exterior door on the east façade, or through the adjoined Main Block door on the west interior wall. The ground floor itself has only one, large room, and it was likely added as an extension for kitchen space to the structure (Figure 50 and Figure 51). While the exterior walls of the Wing are clad in wood, exposed brick around a blind window on the south interior wall suggest that the interior or exterior may have been previously clad in brick (Figure 52).

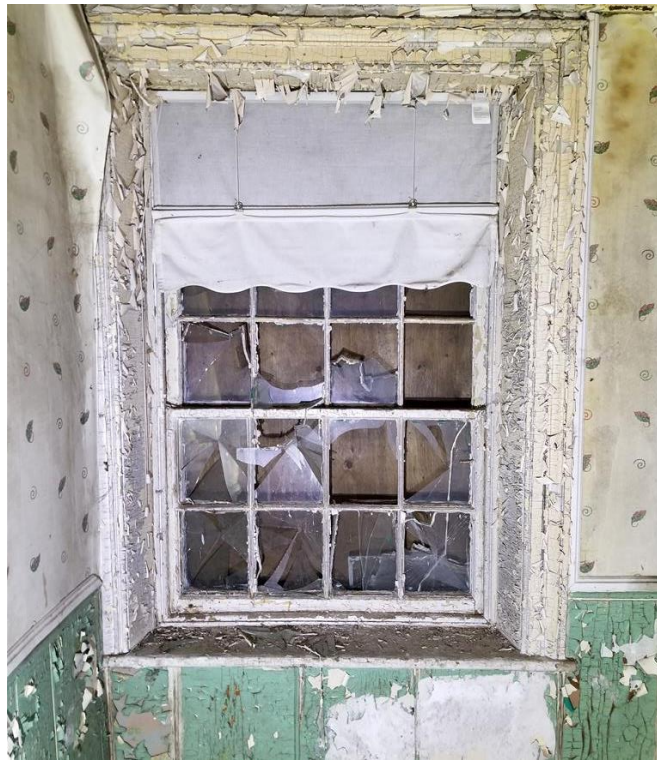
**Figure 53: Interior boarded-up window, 12-over-8, with wood panelling below chair rail.**

To the north of the exterior door is a set of built-in closets or cupboard space, with a door in the corner on the north wall leading to a set of stairs to the second storey of the structure. Two blind windows are on the north wall, and the entire room is covered in wood panelling, wallpaper, and paint. Interior window frames are moulded with a narrow wood sill and are twelve-over-eight flat-head, single-hung wood-frame (Figure 53). The flooring throughout has been obscured with carpet but is presumably wood below.

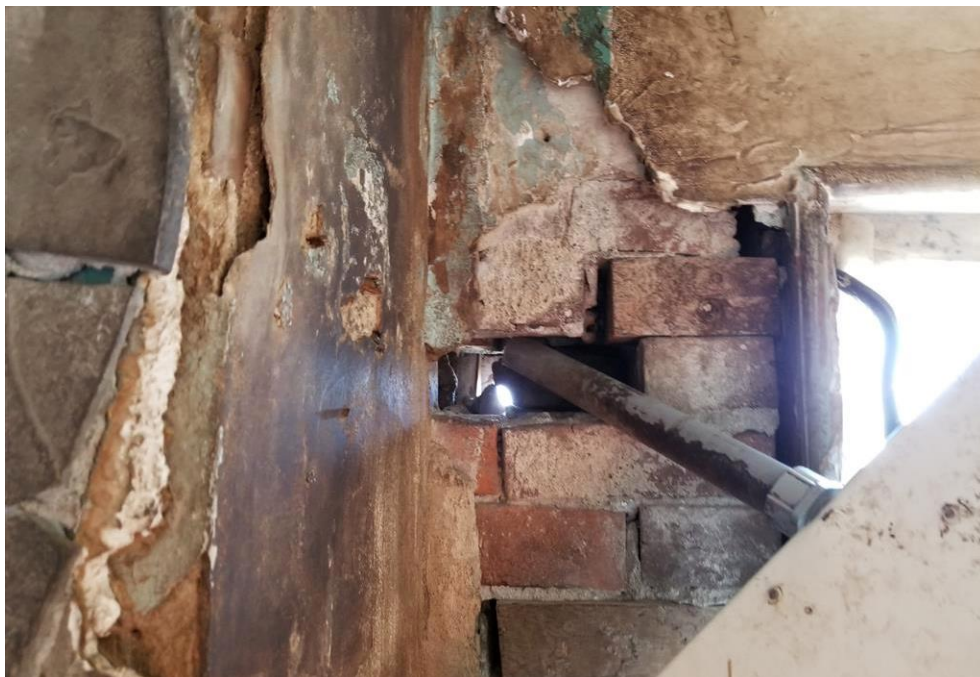
**Figure 56: Detail of brick wall on east side of the Wing.**

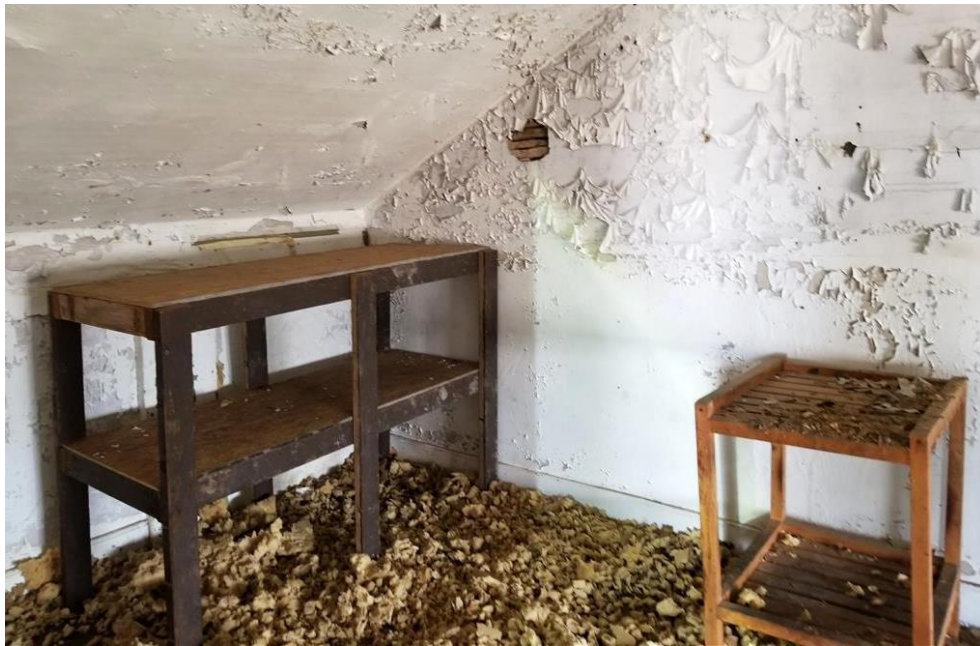
Figure 57: West room on second storey, with hand-split (riven) lath visible on the west wall.

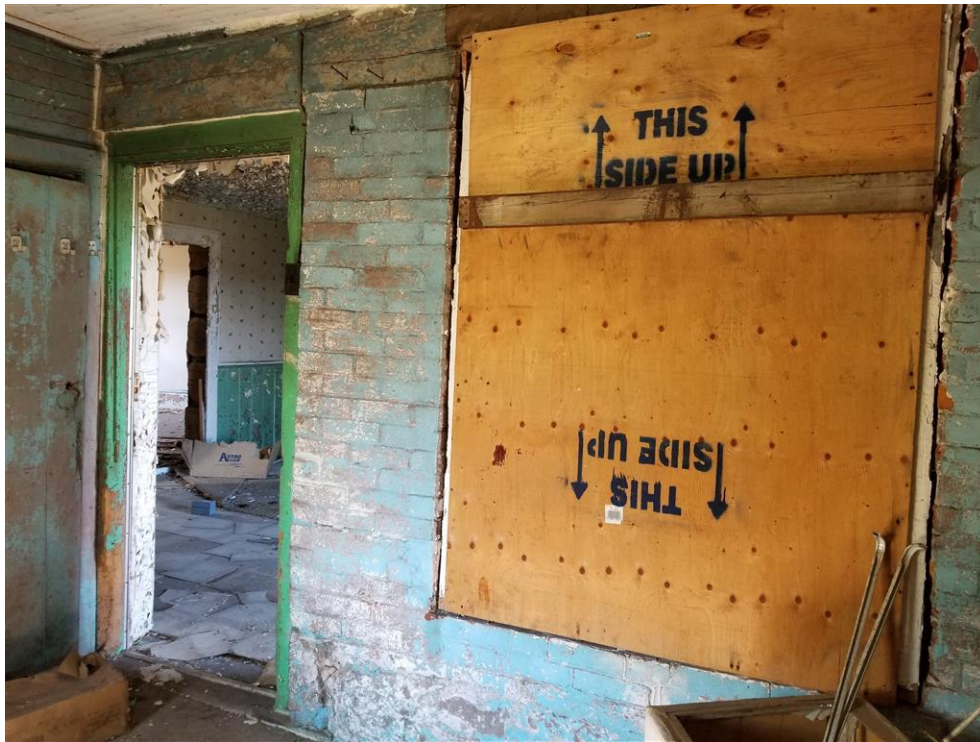
Figure 62: Brick wall on north side of South Addition.

The South Addition has an east and a west room. Within the east room, a blind window and exposed brick wall suggest that the Addition was constructed as an extension of the East Wing (Figure 62). The east wall is covered with plaster and paint, and a stove flashing with a brick flue extends upwards from the centre of the wall (Figure 63). Rotten wood-panels on the ceiling have fallen away at the east end of the room, exposing wood framing above. There are no baseboards along the walls. The south wall is covered by horizontal wood panelling, with a thin, single-panel wood door set into the south wall that leads outside, and a second door leading to a cupboard or the adjoining room (Figure 64). A large wood beam extends between the East Wing and the South Addition with adze marks (Figure 65). This beam is likely part of the frame of the East Wing. Stretcher bond makes up the visible brick wall, which used to be an exterior wall.

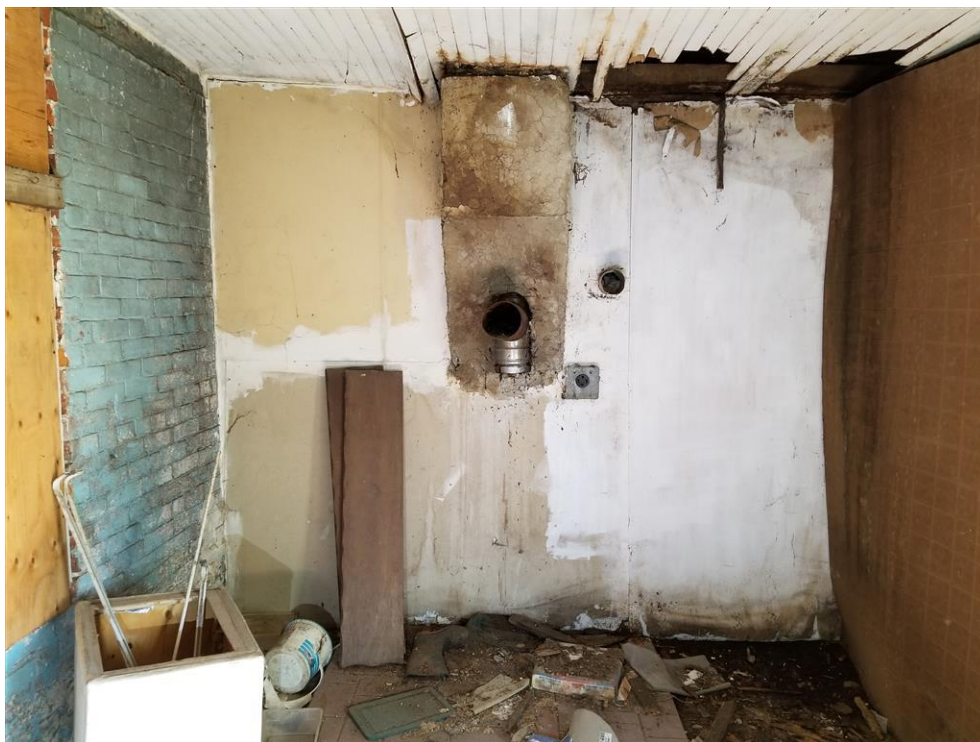
Figure 63: East wall of the South Addition, with stove flashing and wood panelled ceiling.

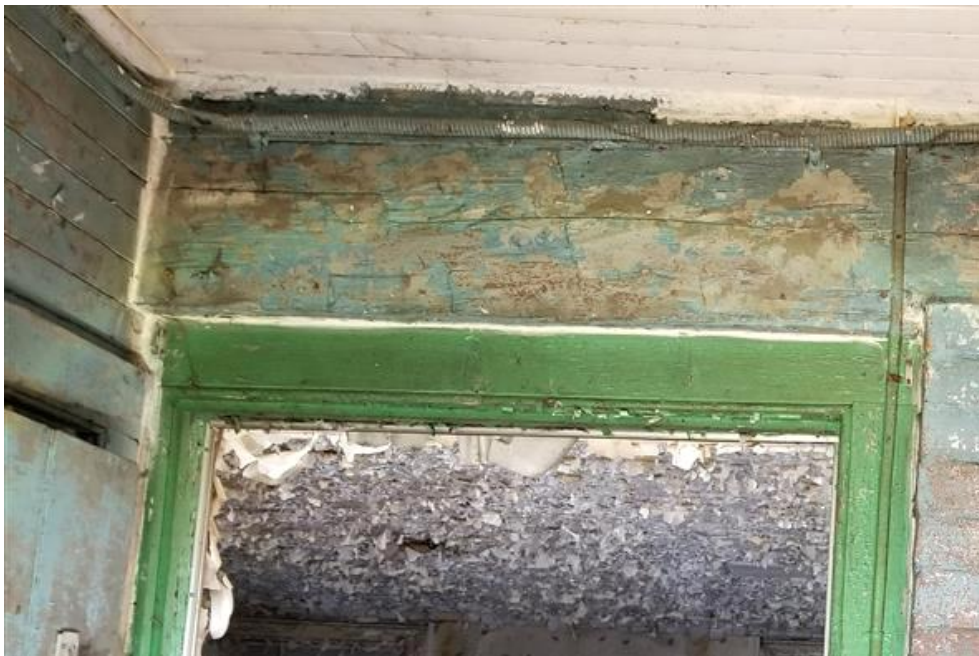
Figure 65: Adze marks on wood lintel above the door to the South Addition.

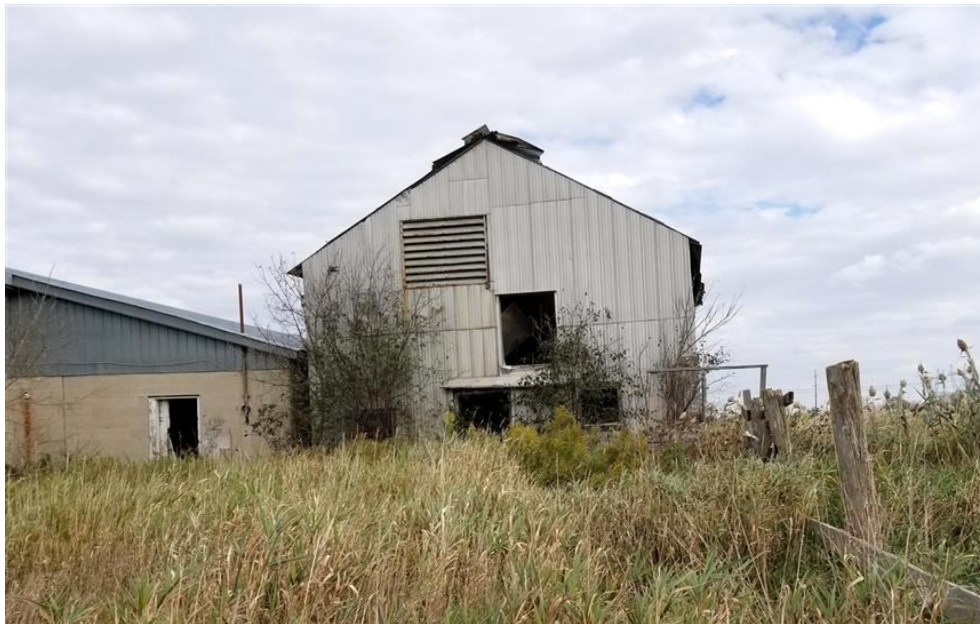
**Figure 70: West façade.**

Northeast of the residence are two barns. The south barn is a two-storey, medium gable roof, two-bay structure covered with aluminum siding (Figure 70 to Figure 72). The west façade has one doorway near centre of structure, with asymmetrical fenestration throughout the façade. Portions of the roof are detached and are visible from the ground.

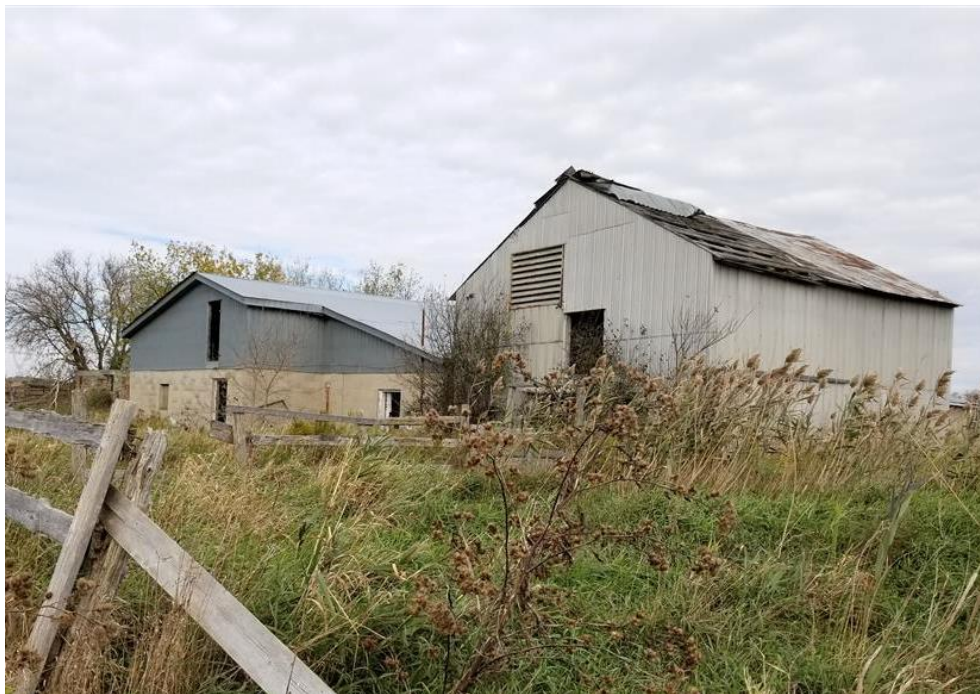
**Figure 71: South and west façades of the South Barn (in foreground).**

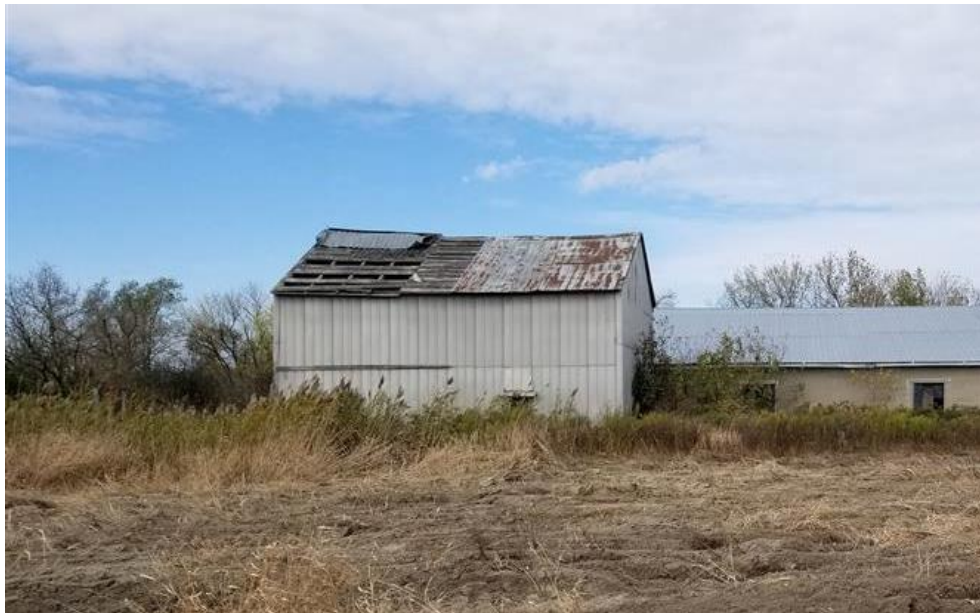
**Figure 72: South façade.**

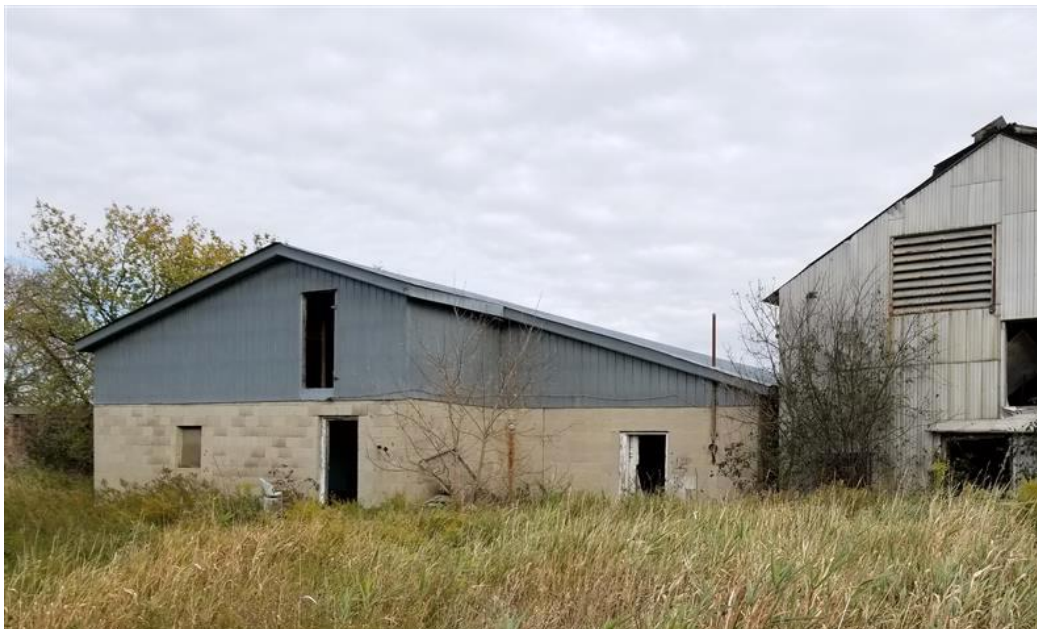
**Figure 73: West façade of the North Barn.**

Adjacent to the south barn is the two-storey, three-bay, low gable roof structure with a central portion and a north and south wing (Figure 73 and Figure 74). The ground floor walls are made from concrete masonry units (CMUs), with a door on the west façade of each portion of the structure. The second storey is only at full height in the central portion of the structure, and is covered by vertical board and batten siding, and is painted blue. The barn is directly south of the stone foundation of the old barn, which still stands (Figure 75).

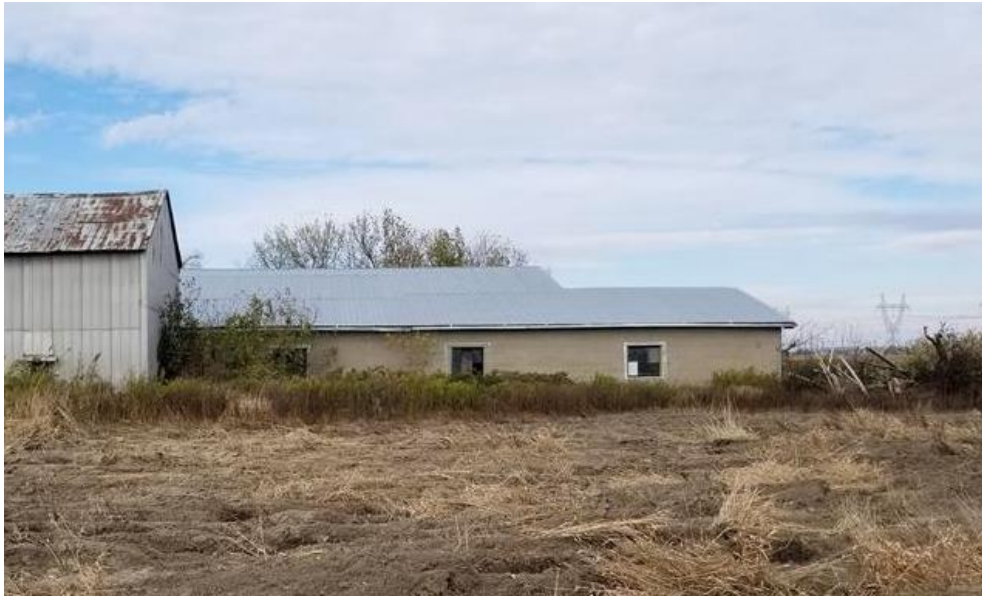
**Figure 74: South façade.**

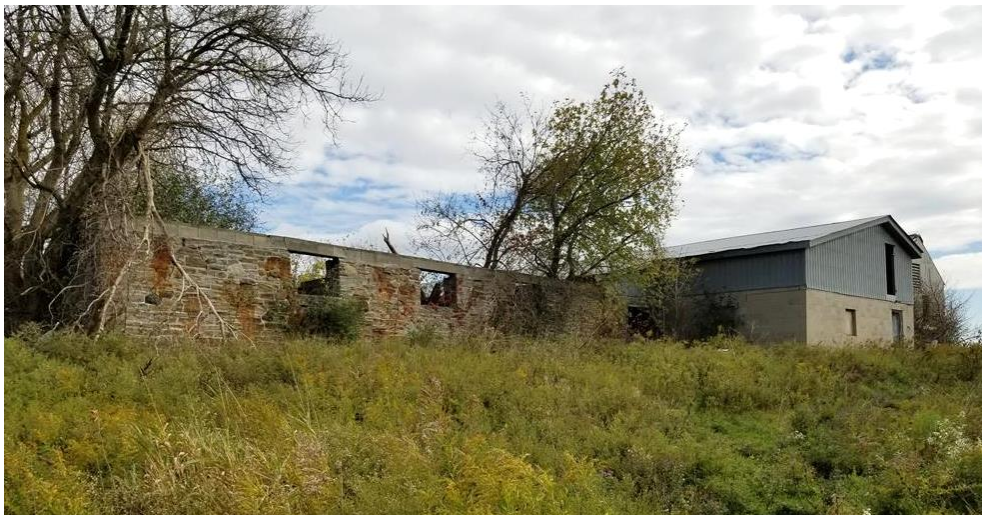
**Figure 75: West and north facades of the North Barn, and foundation of the old barn.**

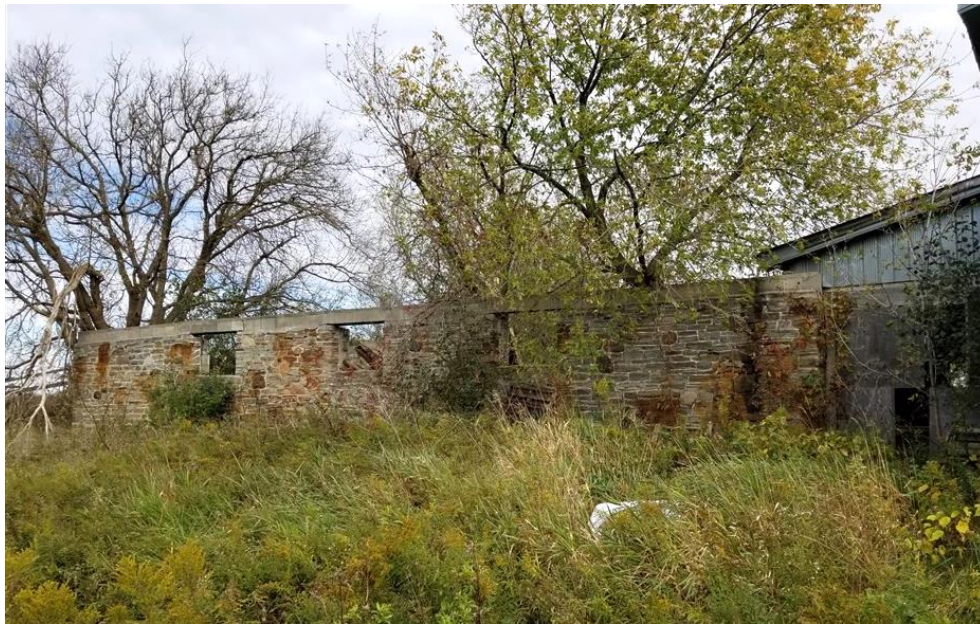
Figure 76: West façade.

North of the outbuildings is the foundation of the 'Old Barn', made from coursed rubble with a three-bay west façade (Figure 76). This structure is all that is left of the barn which was originally associated with Henry Burton House, prior to its collapse. Significant areas of iron staining are visible on the exterior walls, and no evidence of the upper frame construction remain intact.

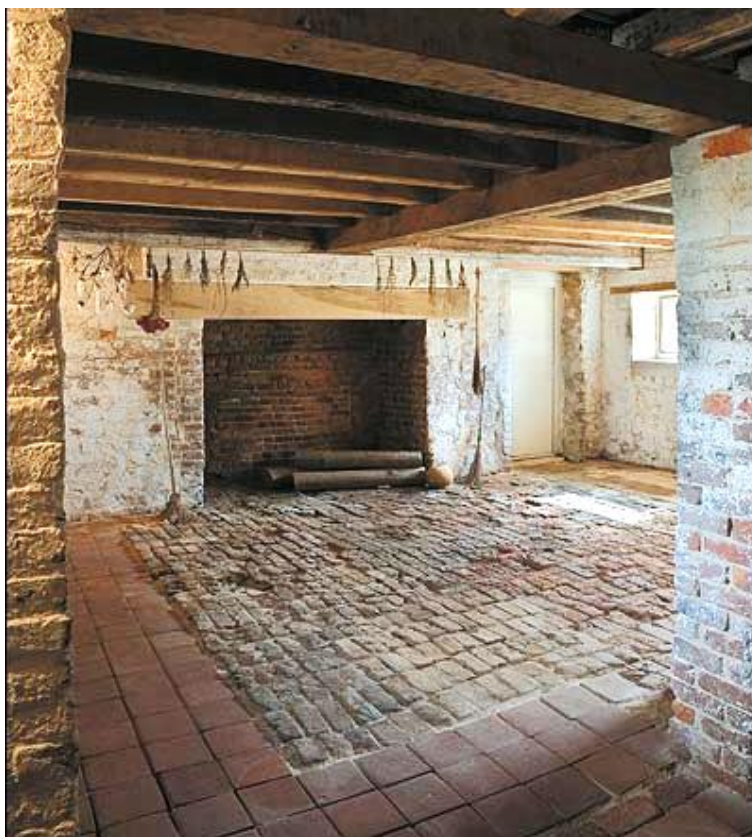
**Figure 77: Image from the basement of the 17<sup>th</sup>-century 'Bacon's Castle' in Surry County, Virginia (Colonial Williamsburg 2018).**

A further clue to the date of the structure lies in its basement, with a former winter kitchen fireplace on the north wall of the foundation. The great stone fireplace is built into the basement wall with a timber lintel and a brick hearth extending out across the basement floor. Brick is resistant to heat, therefore making the sensible choice for the flooring in a winter kitchen. Such a space would have been used to cook food during the winter months away from the wood construction of the upper levels of the structure, as well as help heat the entire house by means of the large fireplace. Examples can be seen in Virginia dating to the 17<sup>th</sup> century (Figure 77), and were employed for decades, but aren’t common in Ontario beyond the mid-1800s. Another example can be seen at the John Fleming House to the north of Henry Burton House at 9151 Huntington Road, which dates to the mid-1800s and also has a large stone fireplace in the basement of its Georgian house.

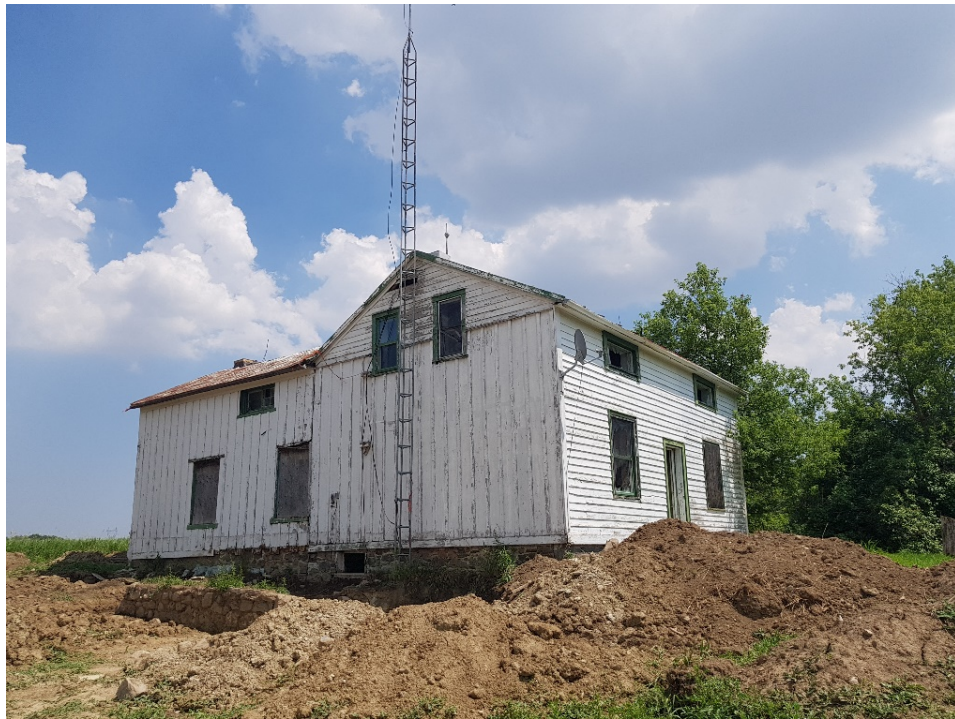
Figure 1: West and north façades.

Located on the west half of the property, the Main Block has a rectangular footprint. It is a single-detached, storey-and-a-half, three-bay residence with a rectangular plan oriented north-south. The structure stands on a coursed rubble foundation. Exterior walls are covered by board and batten on the north, south, and west sides, and thin horizontal wood clapboard siding on the main façade (Figure 1 to Figure 4).
