**CITY OF VAUGHAN  
HERITAGE VAUGHAN COMMITTEE  
AGENDA**

**248 - 260 Woodbridge Avenue  
Woodbridge Heritage Conservation  
District (HCD)  
City of Vaughan**

Revised  
Heritage Evaluation of Existing Structures  
10568 Islington Avenue, Kleinburg, ON  
In the City of Vaughan

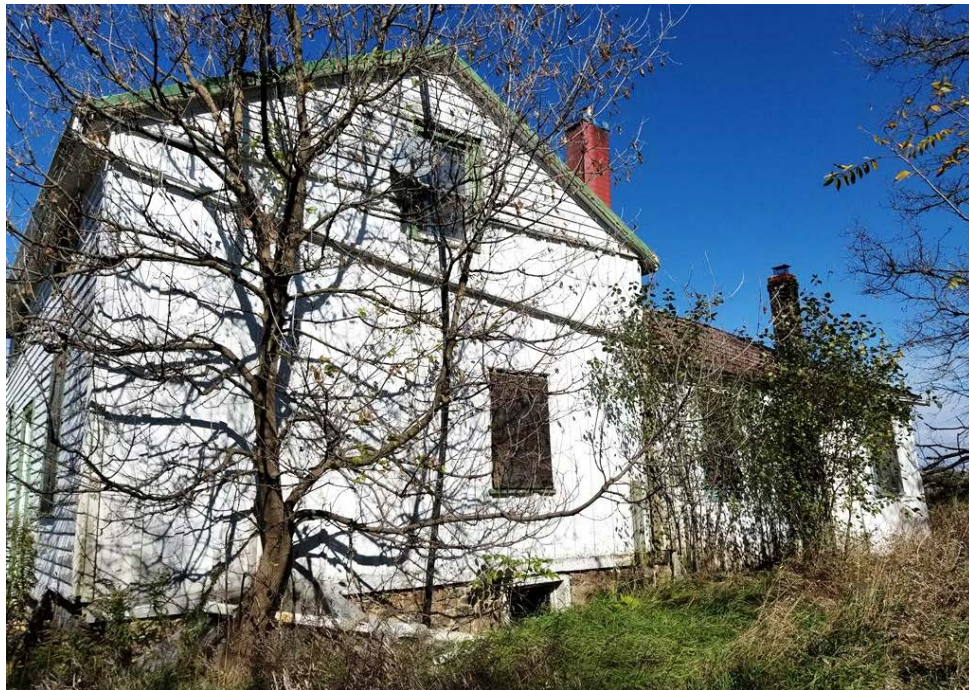
Figure 2: South façade.

Located on the west half of the property, the Main Block has a rectangular footprint. It is a single-detached, storey-and-a-half, three-bay residence with a rectangular plan oriented north-south. The structure stands on a coursed rubble foundation. Exterior walls are covered by board and batten on the north, south, and west sides, and thin horizontal wood clapboard siding on the main façade (Figure 1 to Figure 4).

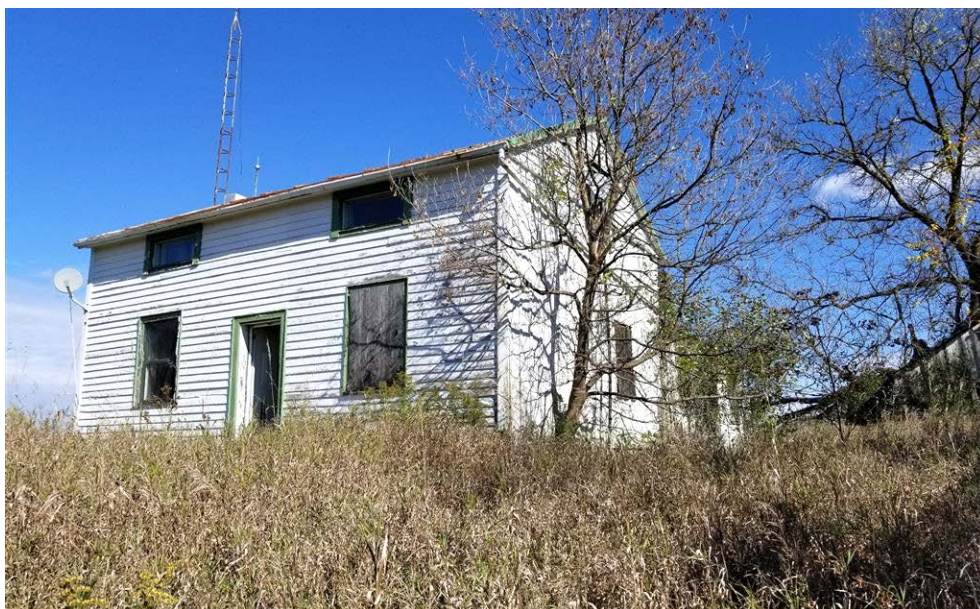
Figure 3: South and west façades.

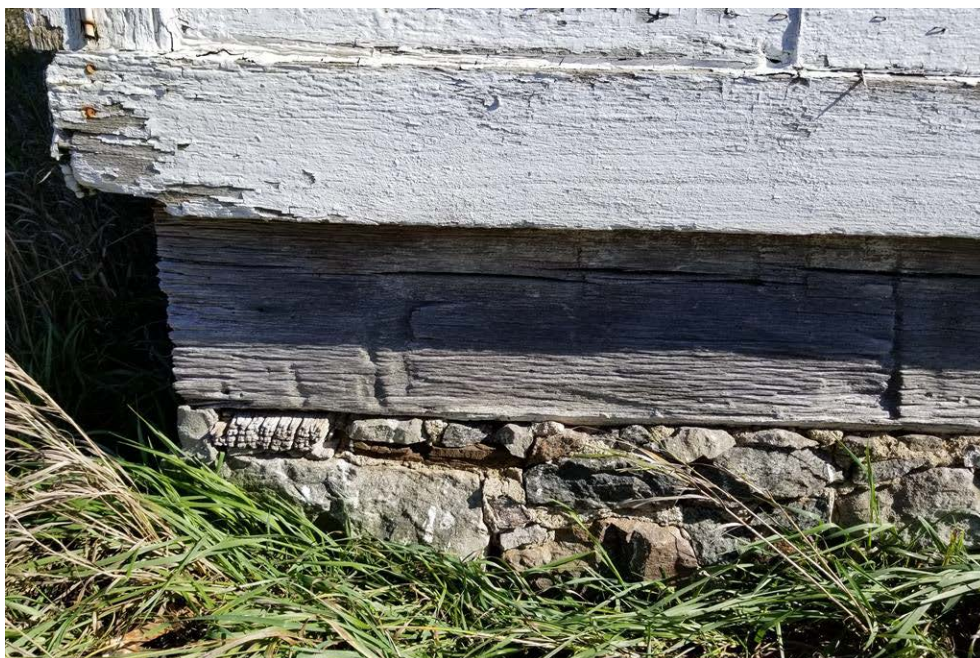
Figure 4: Coursed rubble foundation of the Main Block.

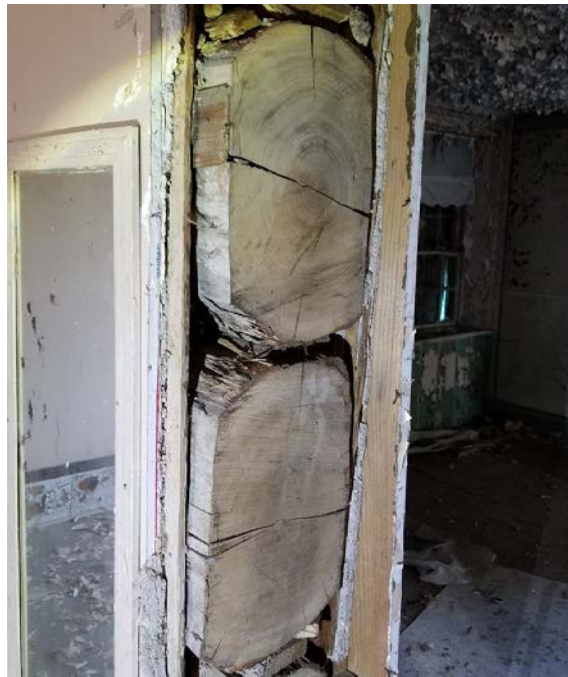
**Figure 6: Interior east log wall on the Main Block.**

The doorway that opens into the East Wing exposes the interior construction of the Main Block walls: partially shaped logs, indicating that a portion of the structure is a log house covered by siding (Figure 6). These logs were felled and cut using a crosscut hand saw, based on the non-parallel straight lines, which suggest hand sawing over a band saw, and are present on the exposed end surfaces of the wood, and did not have the bark removed from the upper and lower sides of the log before shaping and construction of the house (Figure 7). Plaster is visible on both sides of the logs, indicating plastered walls in both the Main Block and the East Wing. The large lintel over the doorway shows evidence of drill or wedge marks and split in order to create the flat beam. Vertical hand-split lath is present on the Main Block side of the doorframe (Figure 8).

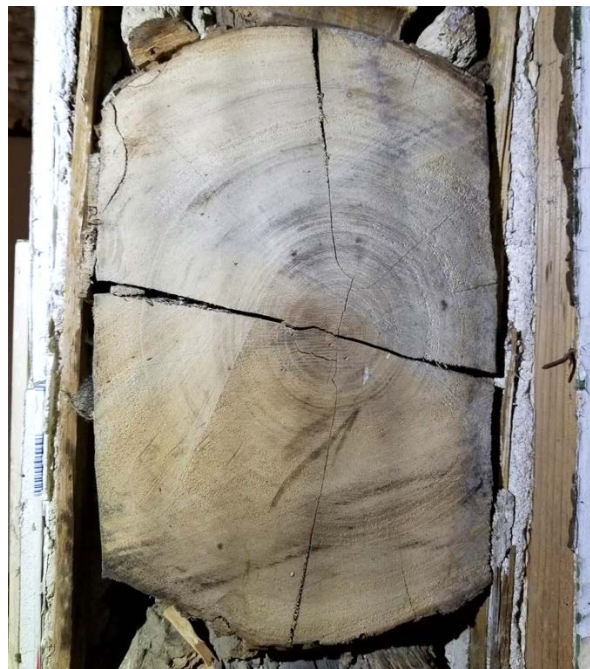
**Figure 7: Cross-cut saw marks.**

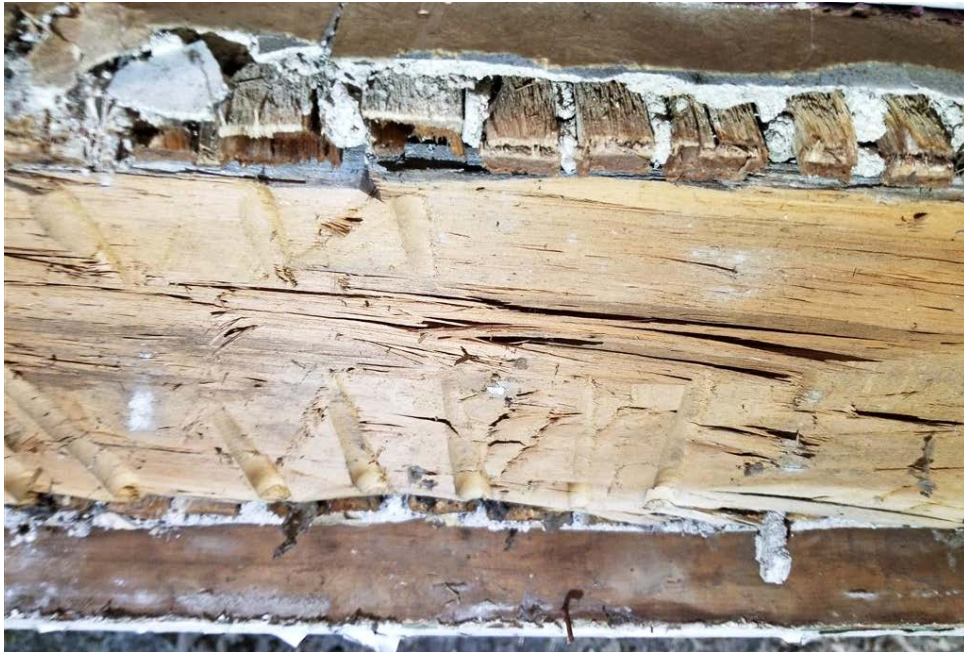
**Figure 8: Detail of top of the doorway, showing split log and vertical lath and plaster.**

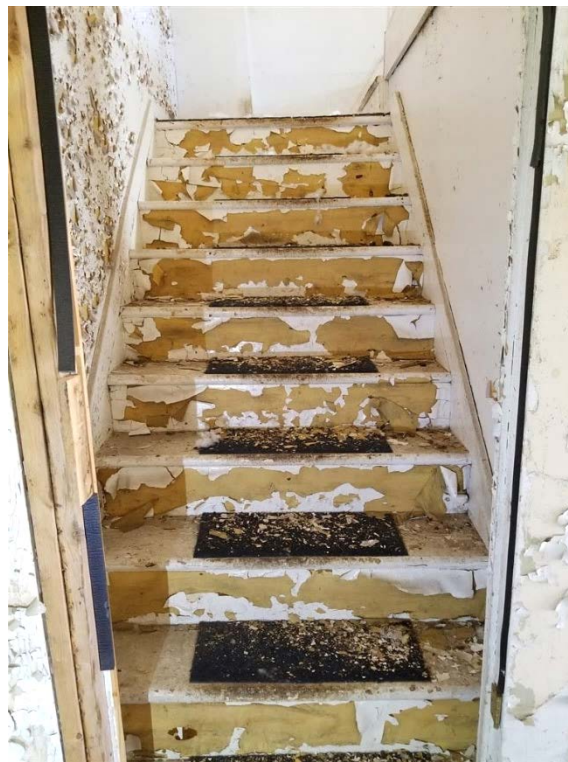
**Figure 9: Staircase in Main Block leading to second storey.**

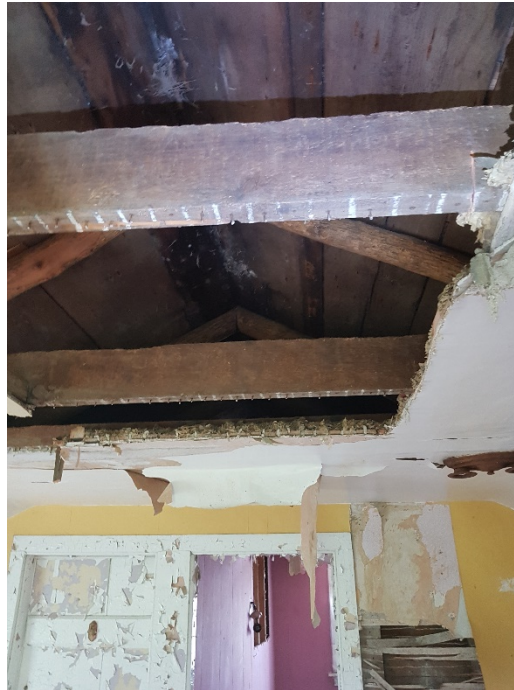
**Figure 10: Interior of second storey, with large south room and two north bedrooms.**

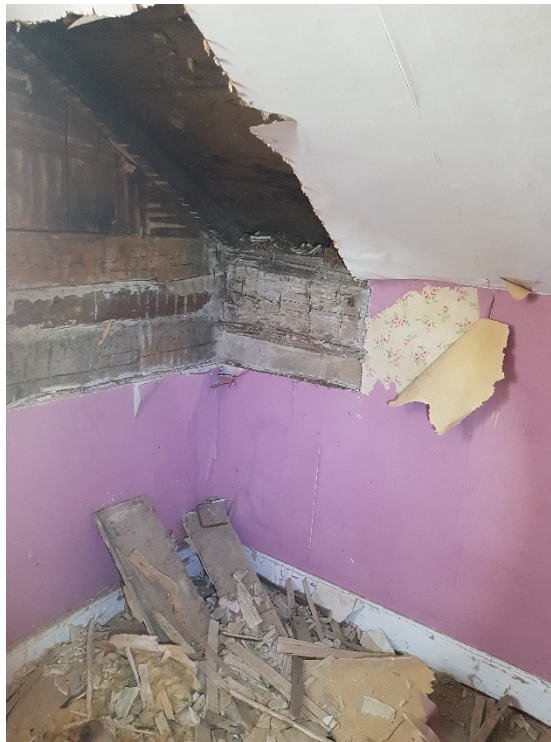
**Figure 12: Northeast bedroom, second storey. Note the wide baseboards.**

The second storey of the Main Block is separated into three rooms. A wall running through the middle of the space sections off two identically sized bedrooms, each with a window at the north wall. Floorboards on the second storey are very wide hardwood planks that likely date to the original construction of the residence (Figure 12).

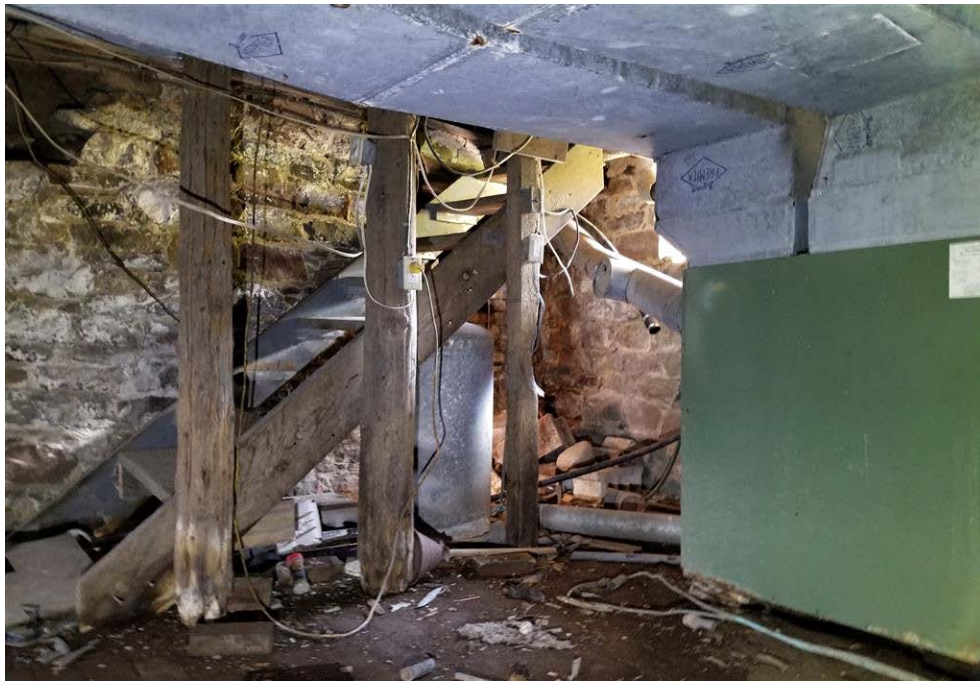
**Figure 13: Stairs in the southeast corner of the basement, with three support posts.**

The basement is located beneath the Main Block of the residence and consists of a single full-height room with coursed stone rubble walls. A simple wood staircase leads downstairs from the exterior southeast corner, and three tree trunks are braced alongside the stairs, creating support for the floor above (Figure 13). An interesting feature of the basement is its brick floor, which spans the entire room (Figure 14). At the north end of the basement, a large stone fireplace with a wood lintel is built into the foundation and would have extended into the ground and second storey at one point (Figure 15).

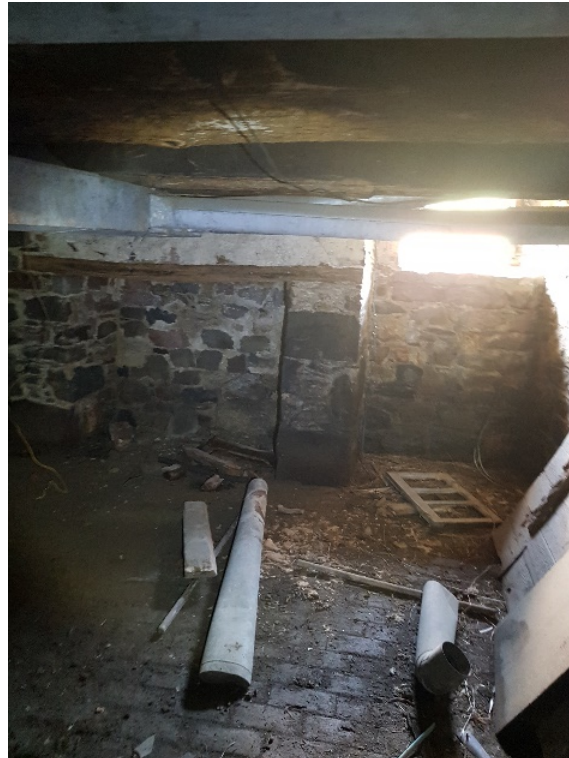
**Figure 14: Brick floor in the basement.**

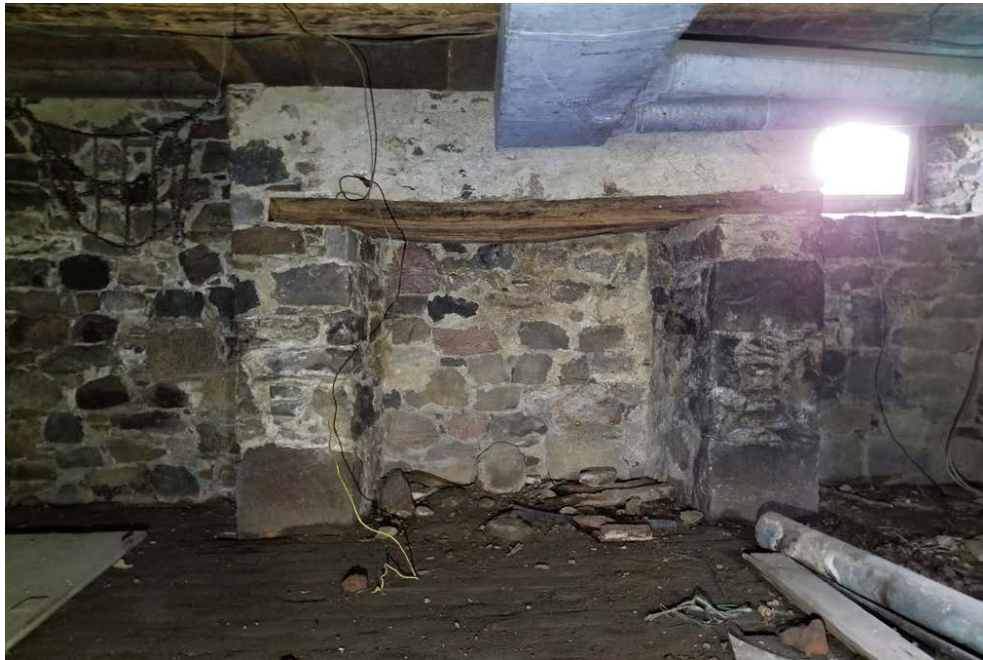
Figure 15: Fireplace at north end of basement, with wood lintel.

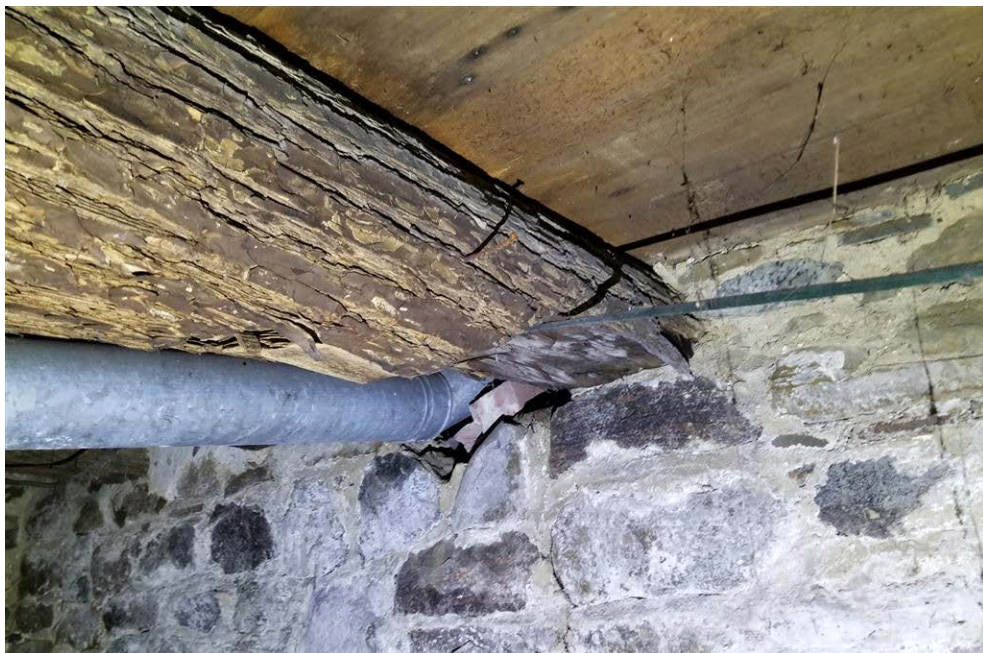
Figure 16: Example of overhead sleeper.

Resting on top of the stone foundation are a series of lateral beams running east-west, unsupported in the centre of the room. The beams are also made primarily from unshaped logs, known as sleepers, both with and without the bark removed, which have been cut to a square or flat-bottomed at either end to sit in the wall (Figure 16). At the east end of the room, a small crawl-space is visible extending east beneath the East Wing and South Addition (Figure 17).

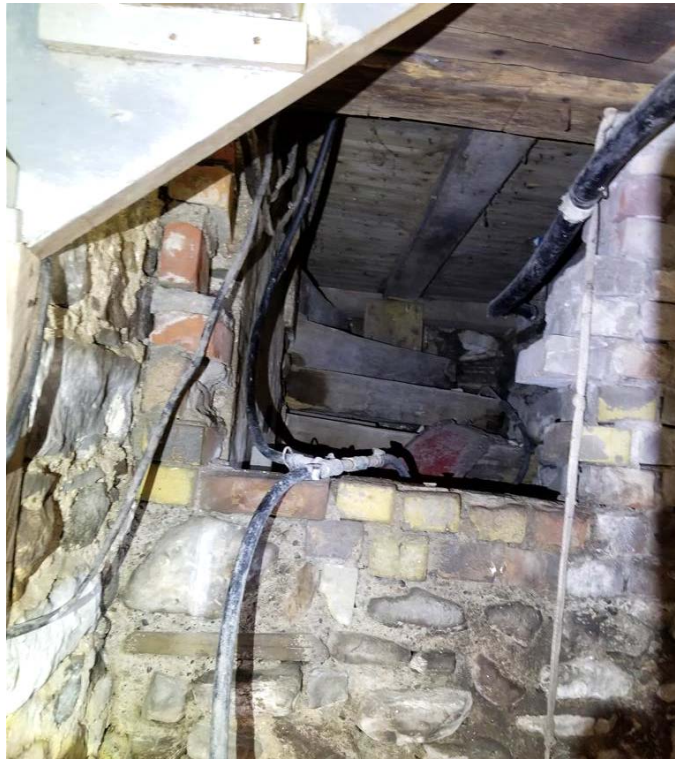
**Figure 17: Crawlspace in east wall of basement. Crawlspace is below the East Wing.**

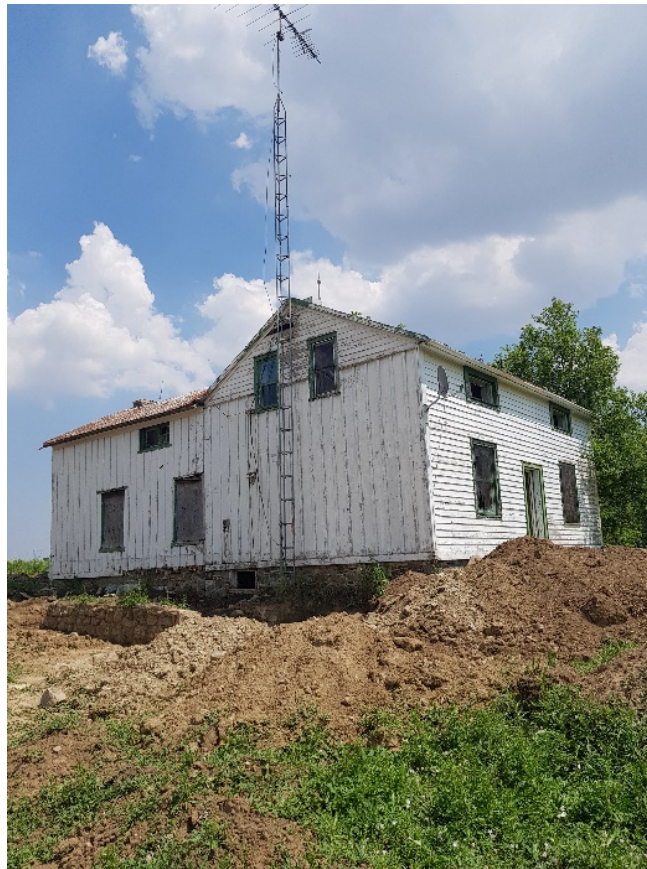
**Figure 18: North and West façades.**

The East Wing has a rectangular footprint and is oriented east-west (Figure 18 to Figure 18). It is a storey-and-one-half structure with a low gable roof, attached to the east façade of the Main Block. The walls are covered with a combination of board-and-batten siding and horizontal wood siding. As with the Main Block, the metal roof has projecting eaves but not verges, and plain soffits and fascia. There is a small, unused chimney present at the east end of the roof, between the second storey windows.

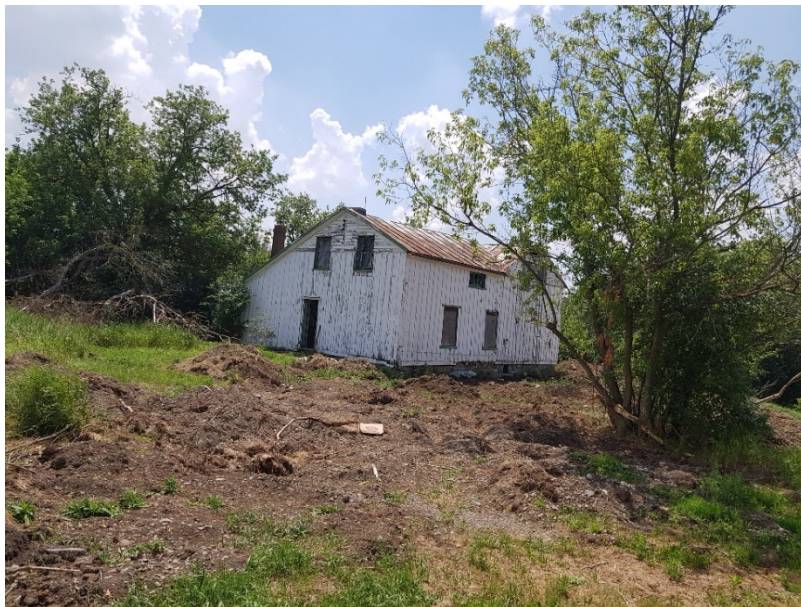
**Figure 19: North and east façades.**

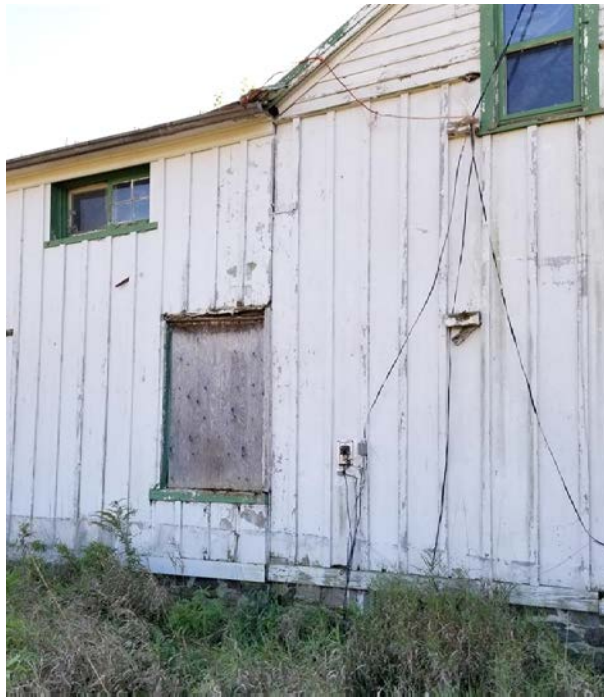
**Figure 20: Visible joint between East Wing and Main Block. Note the small horizontal sliding window.**

Sitting on a coursed rubble foundation similar to that of the Main Block, there is a visible joint between the two structures (Figure 20 and Figure 21). Only the north and east walls of the structure are visible from the exterior, due to its connections to the Main Block to the west and the South Addition to the south.

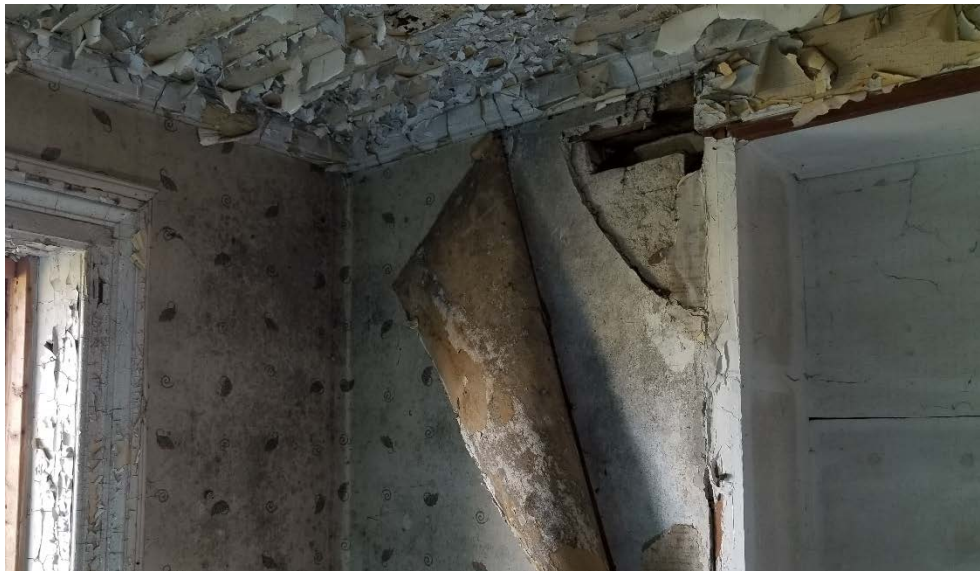
**Figure 22: Bricks visible behind wallpaper and plaster, southeast corner of the ground floor room.**

The East Wing can be entered from the exterior door on the east façade, or through the adjoined Main Block door on the west interior wall. The ground floor itself has only one, large room, and it was likely added as an extension for kitchen space to the structure. While the exterior walls of the Wing are covered by wood siding, brick is exposed around a blind window on the south interior wall, suggesting that the entire wing is likely constructed from brick (Figure 22).

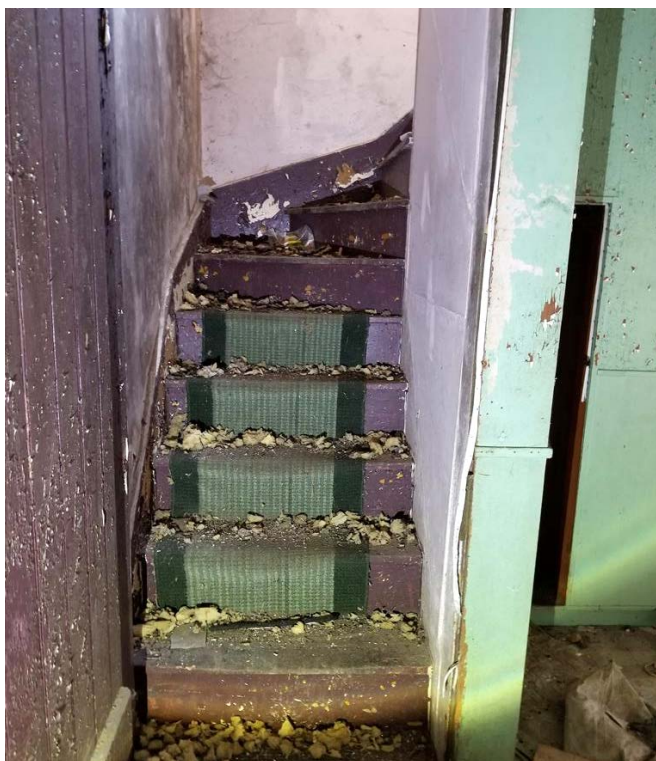
**Figure 23: Northeast staircase in East Wing.**

At the top of the north staircase (Figure 23), the East Wing's second storey does not connect to that of the Main Block. This level is divided into two rooms, an east and a west, that comprise the entire floor. Directly adjacent to the staircase on the east wall is a large brick chimney with a stove flashing near the roof, which has been covered over in stones and cement, but has since been decommissioned (Figure 24). Brick is visible beneath the plaster on the exterior walls as well, confirming the brick construction of the Wing (Figure 25).

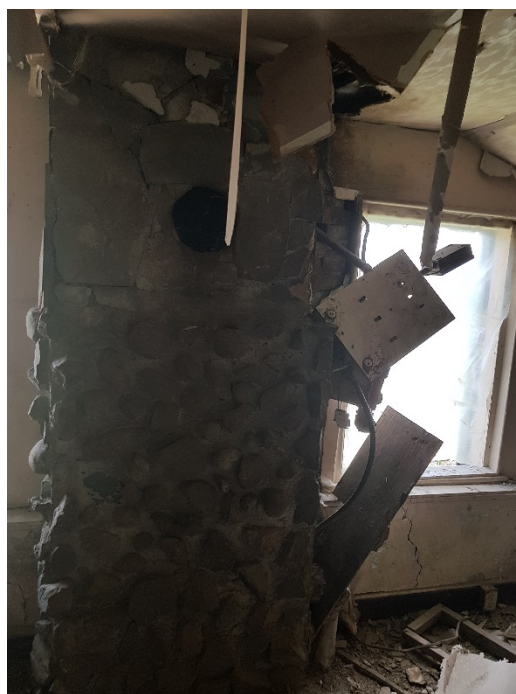
**Figure 24: Northeast corner, second storey of East Wing.**

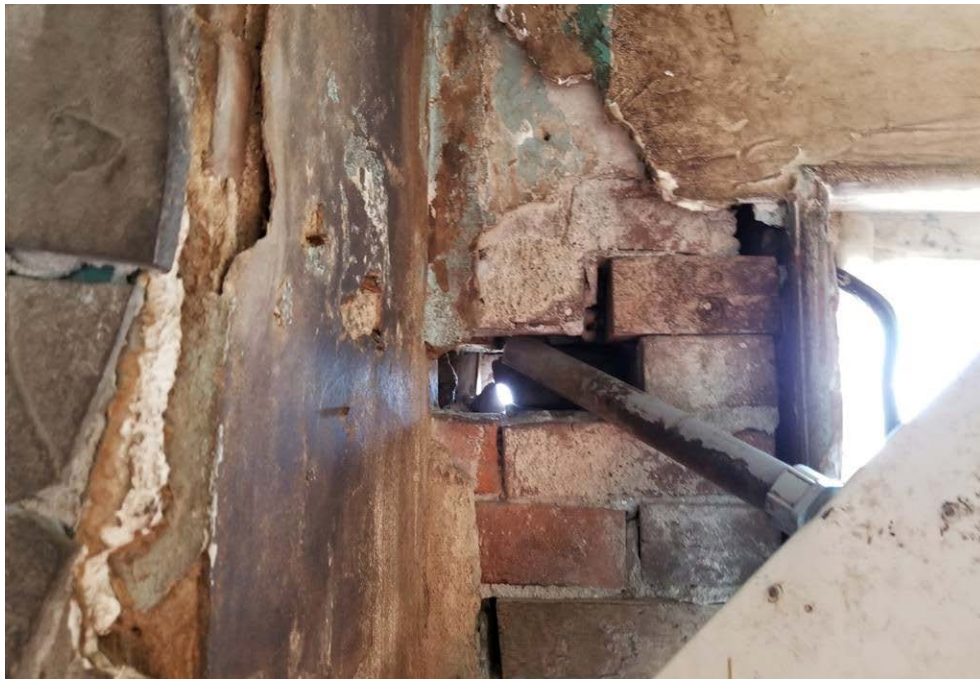
Figure 25: Detail of brick wall on east side of the Wing.

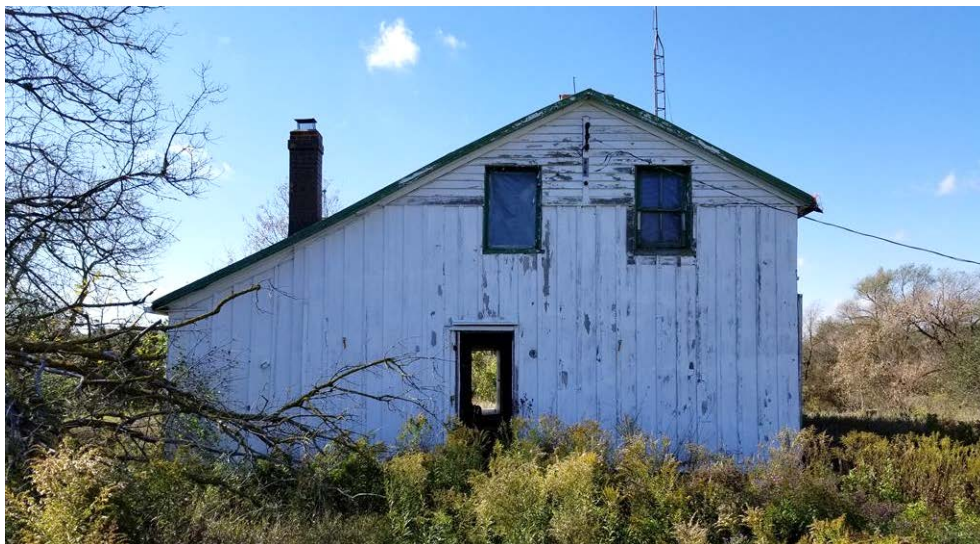
Figure 26: East façade, with South Addition on the south façade of the East Wing.

The South Addition covers a rectangular floor plan and is oriented east-west, aligned with the East Wing of the structure. It has one exterior doorway, and only one window, now boarded over, on the south façade (Figure 26 and Figure 27). The metal shed roof extends from the South Wing. A brick chimney is present on the east side of the Addition.

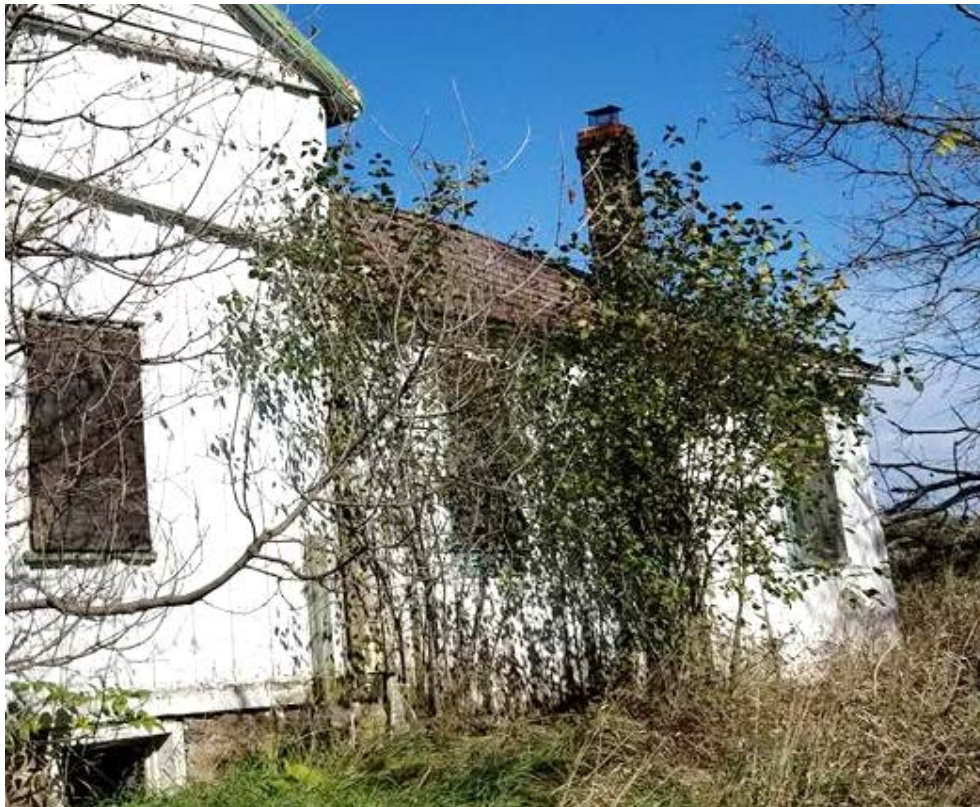
**Figure 27: South façade of South Addition, obscured by bushes.**

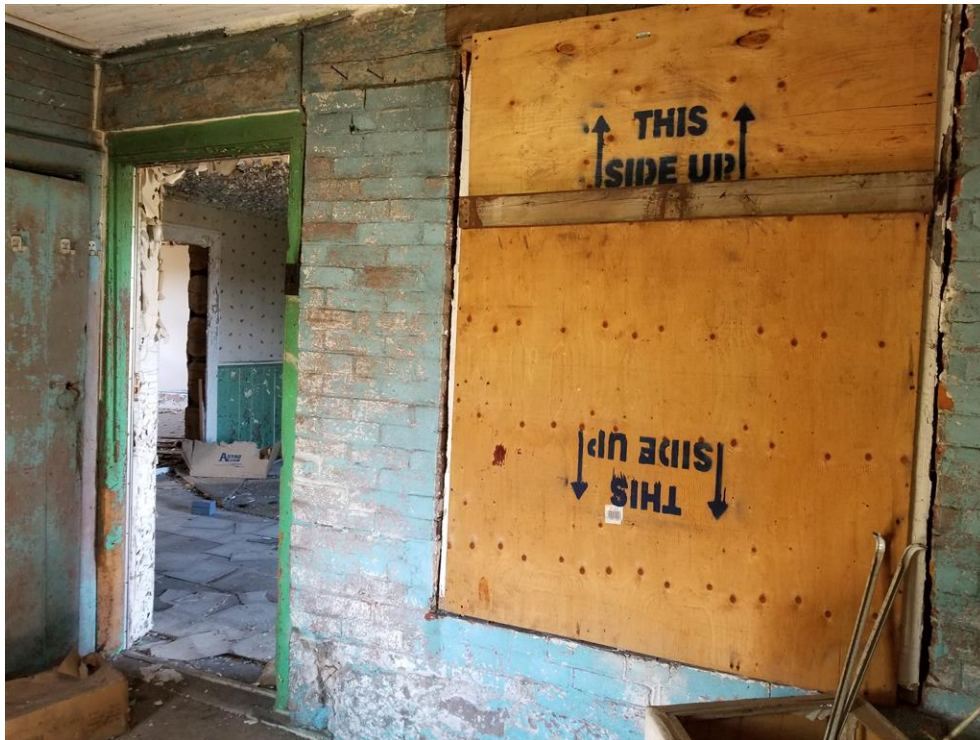
Figure 28: Brick wall on north side of South Addition.

The South Addition has an east and a west room. Within the east room, a blind window and exposed brick wall suggest that the Addition was constructed as an extension of the East Wing (Figure 28). The east wall is covered with plaster and paint, and a stove flashing with a brick flue extends upwards from the centre of the wall (Figure 29). Rotten wood-panels on the ceiling have fallen away at the east end of the room, exposing wood framing above. A large wood beam extends between the East Wing and the South Addition with adze marks (Figure 30). This beam is likely part of the frame of the East Wing. Stretcher bond makes up the visible brick wall, which used to be an exterior wall.

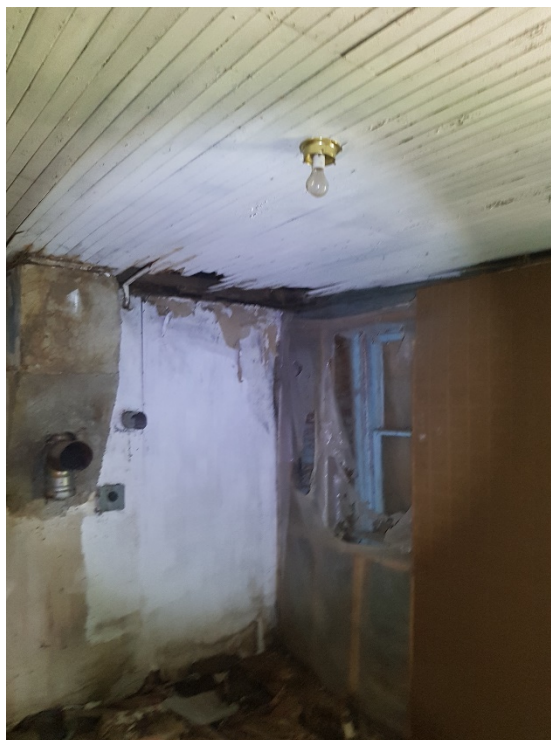
Figure 29: East wall of the South Addition, with stove flashing and wood panelled ceiling.

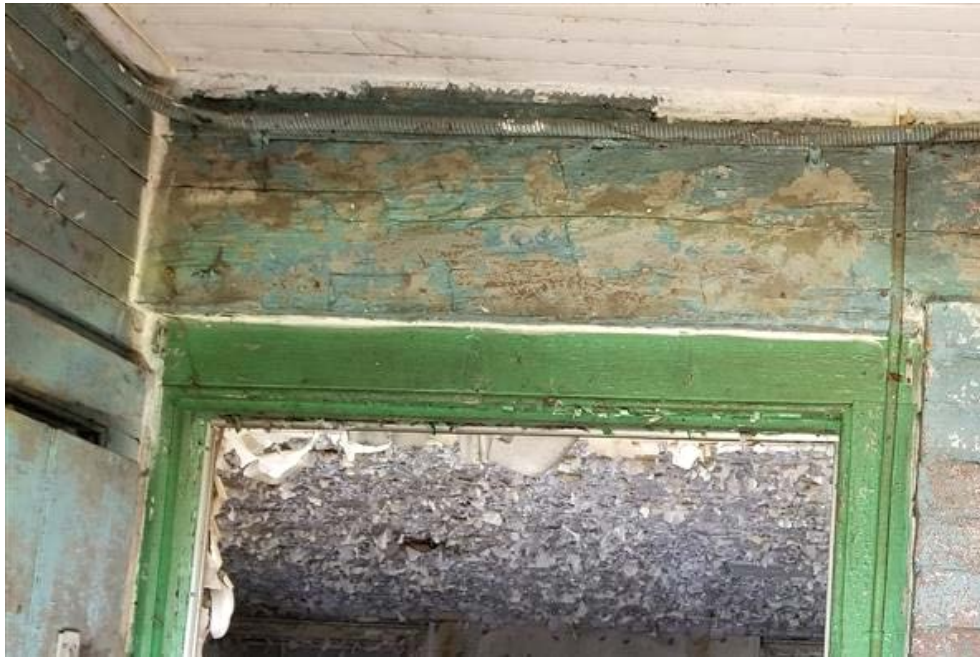
**Figure 30: Adze marks on wood lintel above the door to the South Addition.**

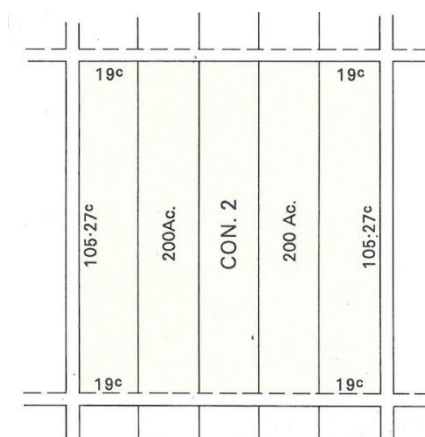
**Figure 2: The single front survey system, used from 1783 to 1818. As depicted, each lot is 200 acres created from surveying 19 chains by 105.27 chains (1 chain = 66 feet/20.12 metres; from Gentilcore & Head 1984:99)**

The property is located within the City of Vaughan, formerly Vaughan Township. Vaughan was named in 1792 for Benjamin Vaughan, a British commissioner who negotiated the 1793 Treaty of Paris between Great Britain and the United States (Rayburn 1997:335). Abraham Iredell surveyed the Township in 1795 according to the 'single front survey system', a method used from 1783 onward where only the concessions were surveyed and lots of 120 to 200 acres were delineated to be five times as long as they were wide (Schott 1981; see Figure 2).

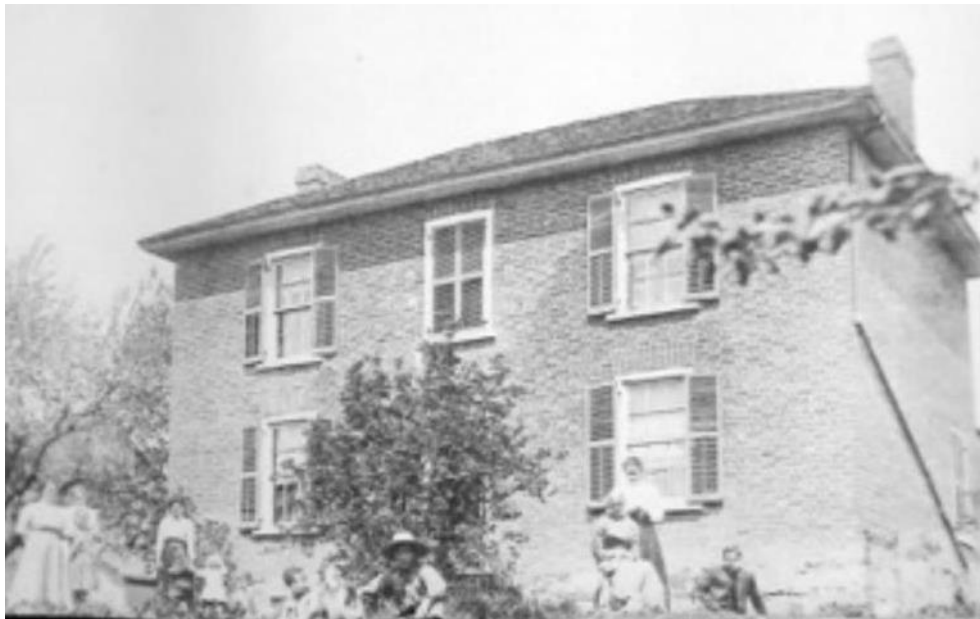
Figure 5: The farmhouse in 1909, as inhabited by the Wood family (image from City of Vaughan Archives).

The Fleming family continued to own the property until April of 1909 when abstract index to deed records show that William Fleming sold the 100 acres to James H. and George T. Wood (Figure 5). At this point, the Fleming Family had owned the property for a significant 65 years and aided in the development of the community. The 1914 topographic map of the region shows a brick house present on the west half of the property with no outbuildings (Department of Militia and Defence 1914) (Figure 6). By the 1940s, members of the Elder family obtained portions of the property, which has since been subdivided into lots. Members of the Elder family owned portions of the lot through the 1950s, as is evident throughout the abstract index to deed records.

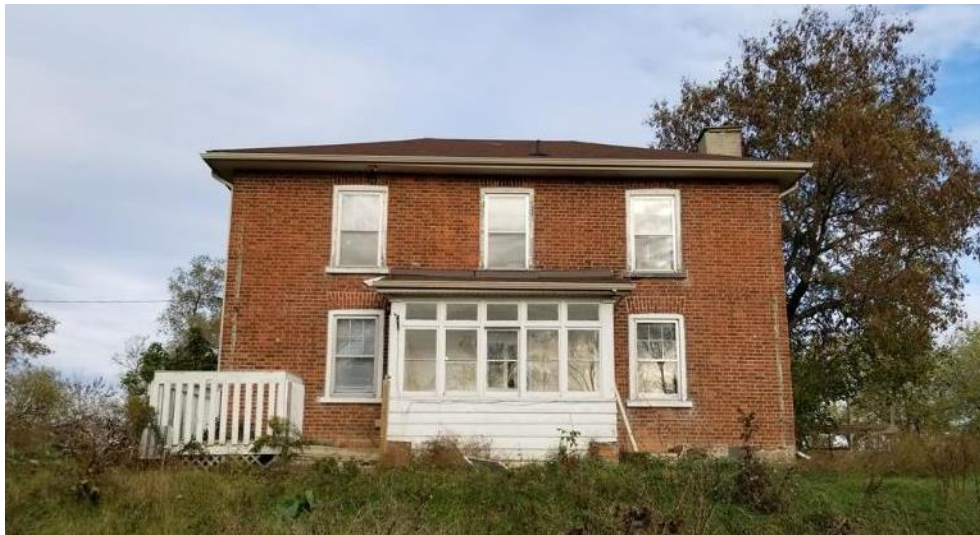
**Figure 16: West façade of John Fleming House.**

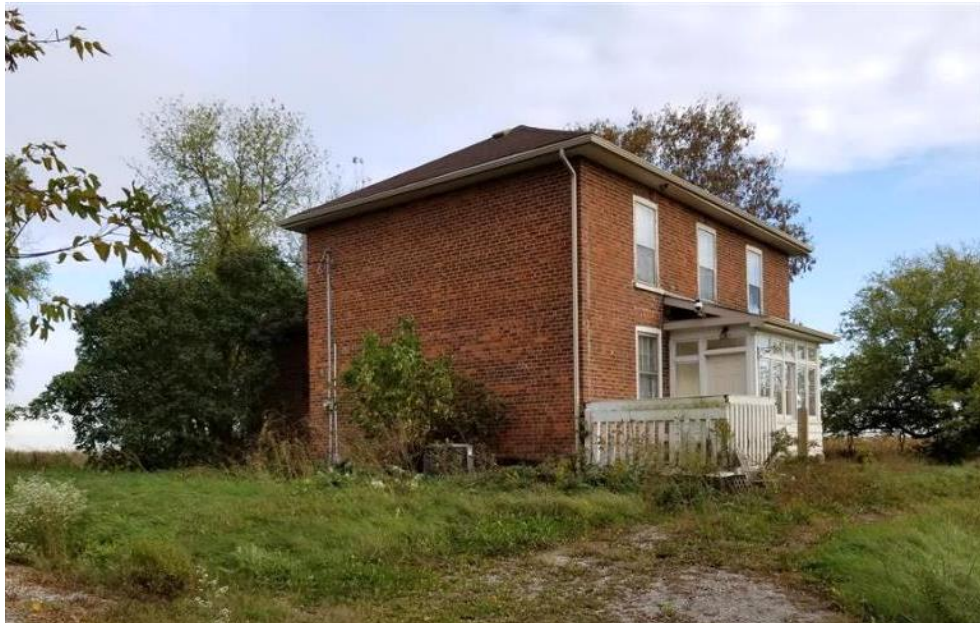
**Figure 17: West and north façades.**

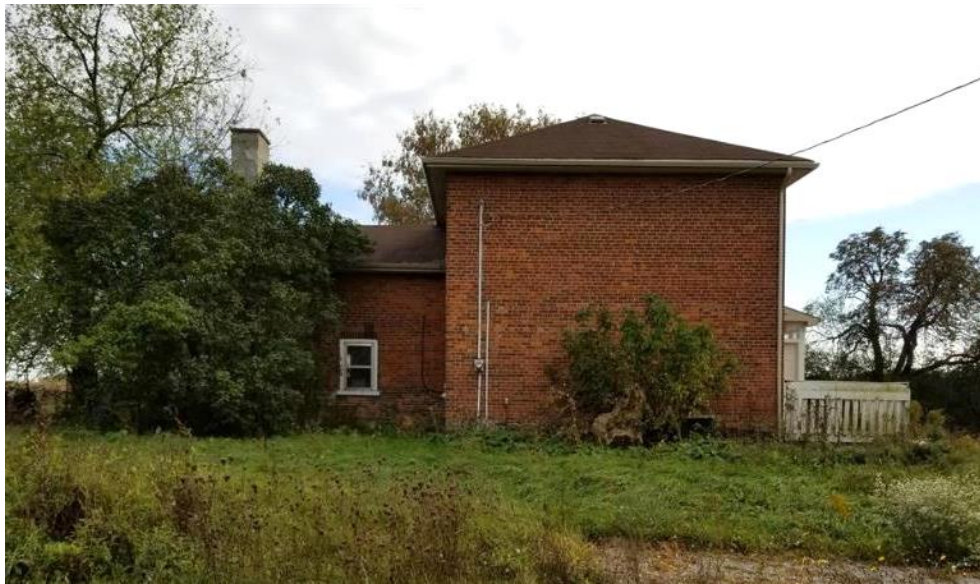
**Figure 18: North façade of the Main Block and East Wing.**

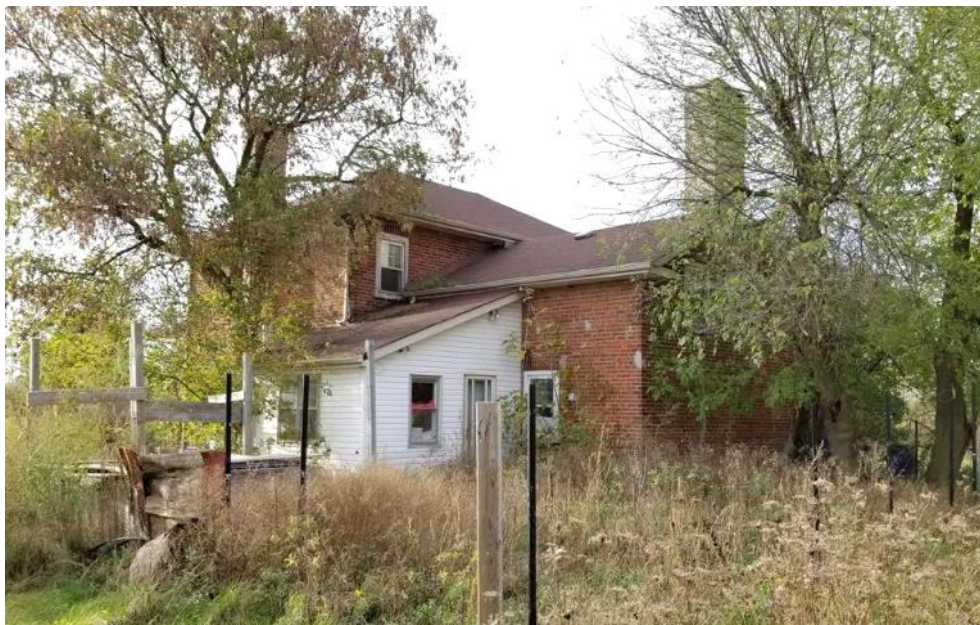
**Figure 19: South and east façades.**

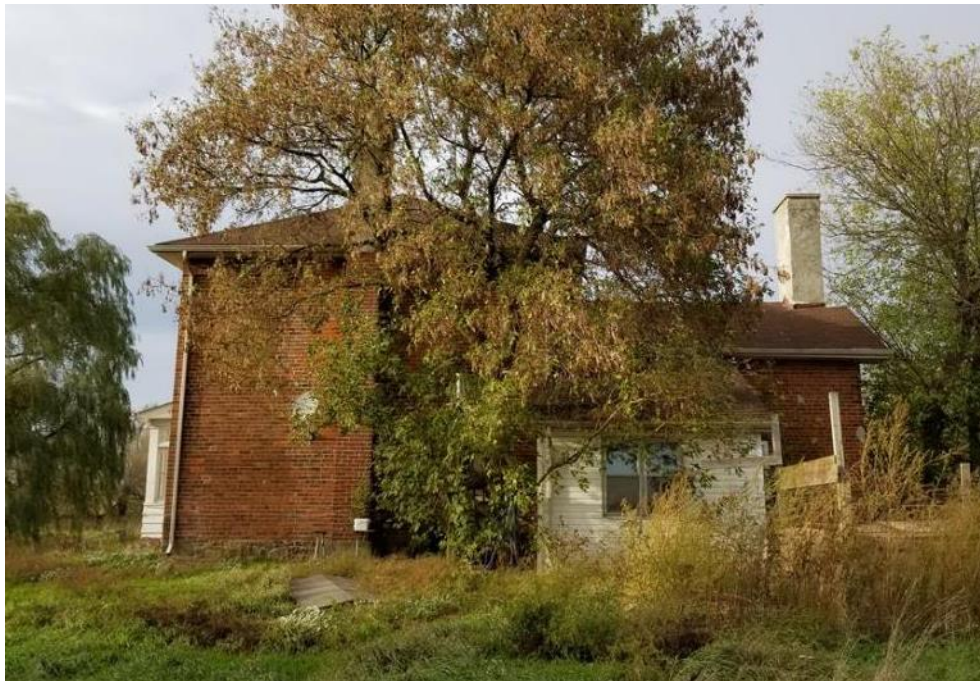
**Figure 20: South façade.**

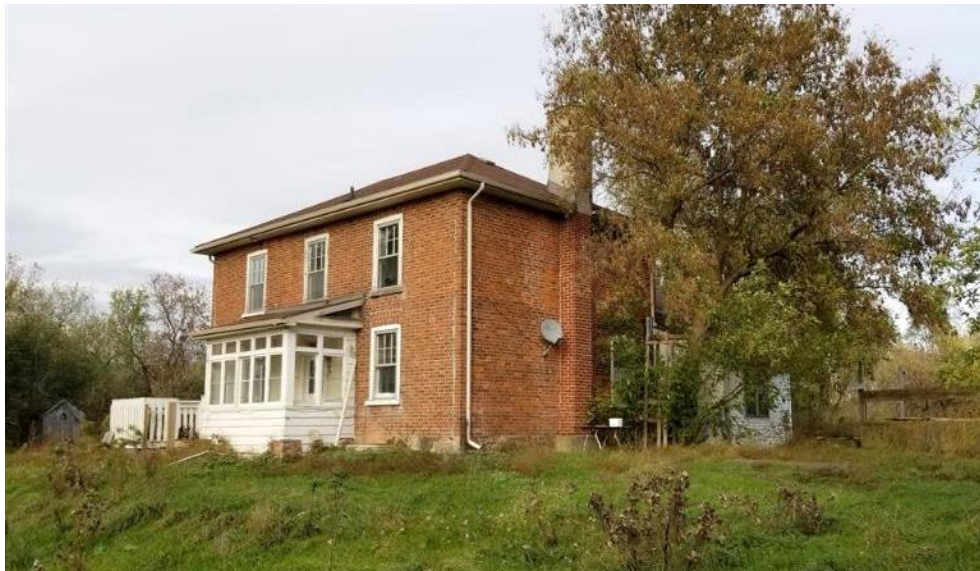
**Figure 21: South and west façade.**

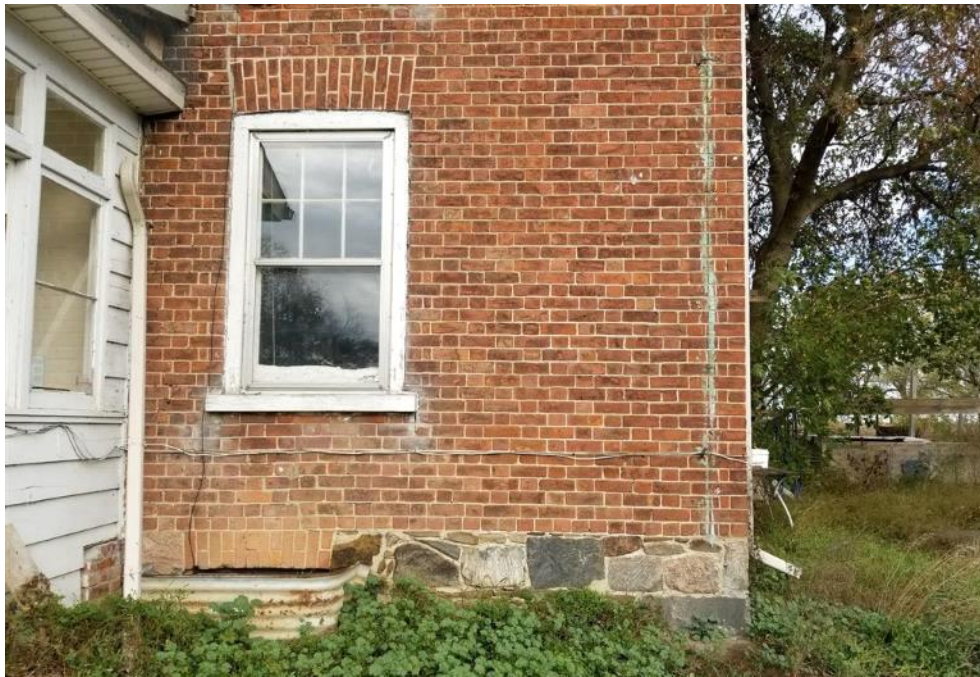
**Figure 22: Detail of Flemish Bond and coursed rubble foundation on the west façade of the Main Block.**

The Main Block is rectangular, measuring 11.3 m north-south and 7.3 m east-west. It is a single-detached, two-storey, three-bay brick farmhouse with a rectangular plan. It sits above a fieldstone foundation and full basement. Constructed from red brick, the main façade is built with Flemish Bond (Figure 22), while the other three sides of the building are 1:5 Common Bond (Figure 23).

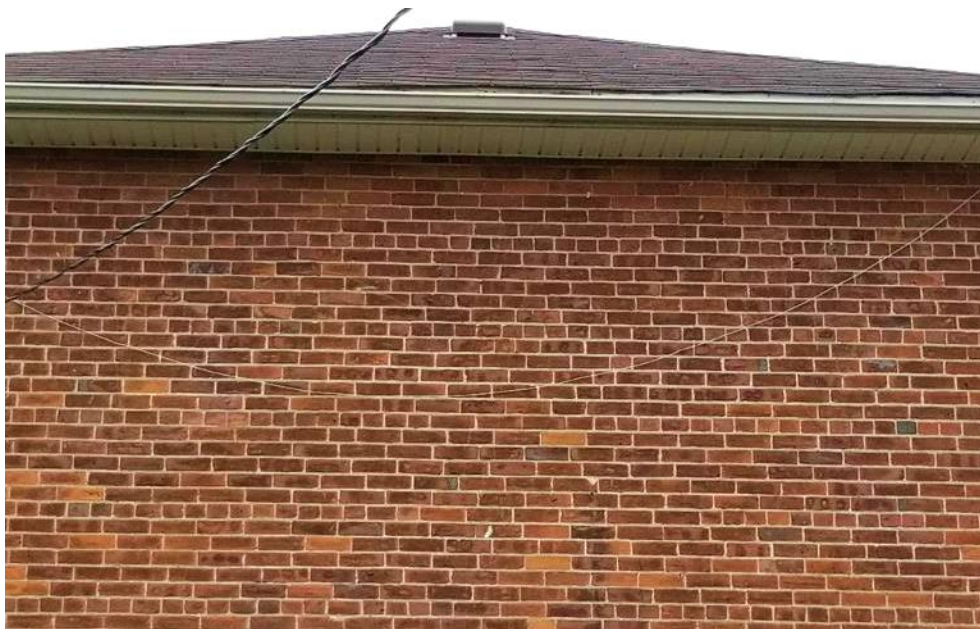
**Figure 23: Detail of Common Bond on the north façade.**

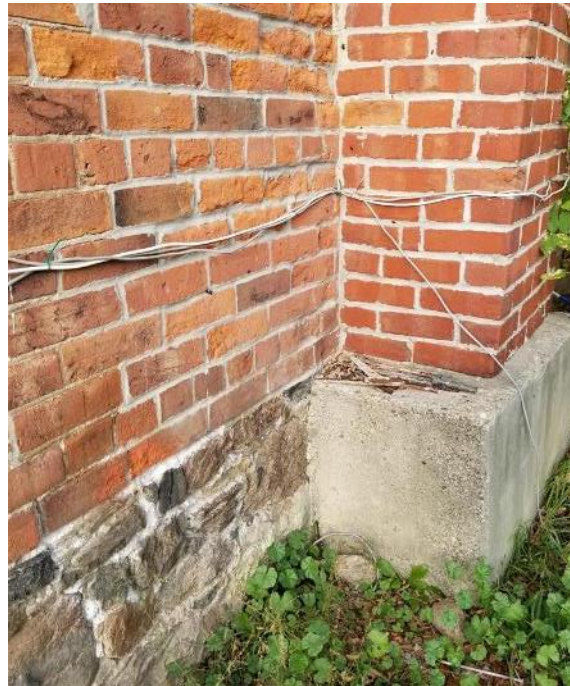
**Figure 24: Chimney on the south façade of the Main Block.**
