**CITY OF VAUGHAN  
HERITAGE VAUGHAN COMMITTEE  
AGENDA**

**248 - 260 Woodbridge Avenue  
Woodbridge Heritage Conservation  
District (HCD)  
City of Vaughan**

Revised  
Heritage Evaluation of Existing Structures  
10568 Islington Avenue, Kleinburg, ON  
In the City of Vaughan

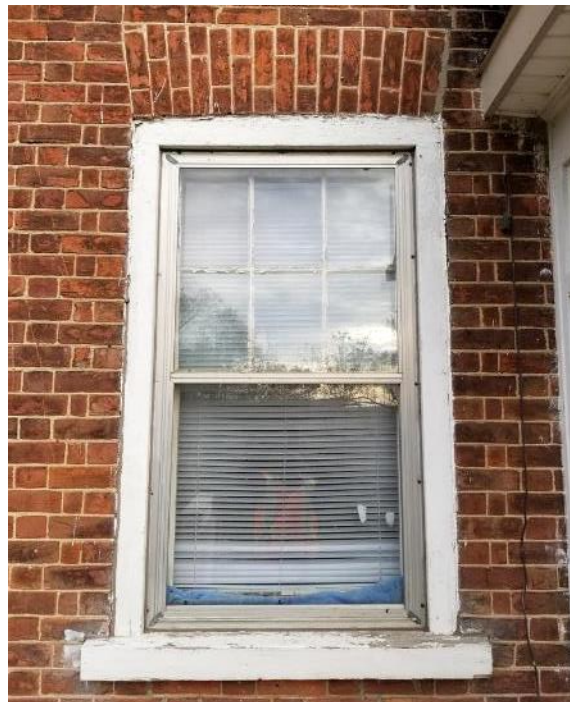
**Figure 25: Typical window on the Main Block, with Flemish bond brickwork.**

Fenestration is symmetrical on the main façade of the structure, with a central door. Typical windows on the ground floor are characterized as 6-over-2 windows with a segmental arch with a wood frame and plain wood lug sill, covered on the exterior by aluminum frame storm windows (Figure 25). The windows have plain exterior frames and wood lug sills. Each window has red-brick voussoirs above the frame. A blind window is visible in the basement at the southwest corner of the foundation. The front door to the Main Block is a rectangular wood door with a plain moulded wood frame, and two window panels on the top half of the door, and a flat single light transom above the door (Figure 26). The main entrance is in the centre of an enclosed wood-frame porch with a shed roof, which opens north onto an unenclosed wood porch with a wooden balustrade (Figure 27).

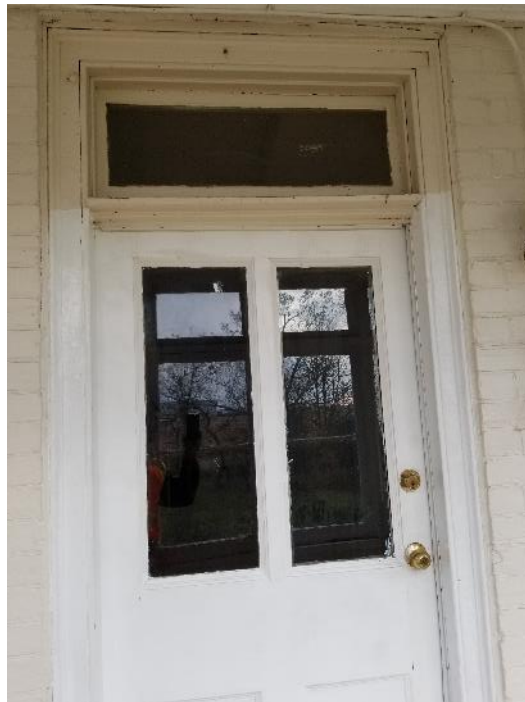
**Figure 26: Front door on the west façade of the Main Block.**

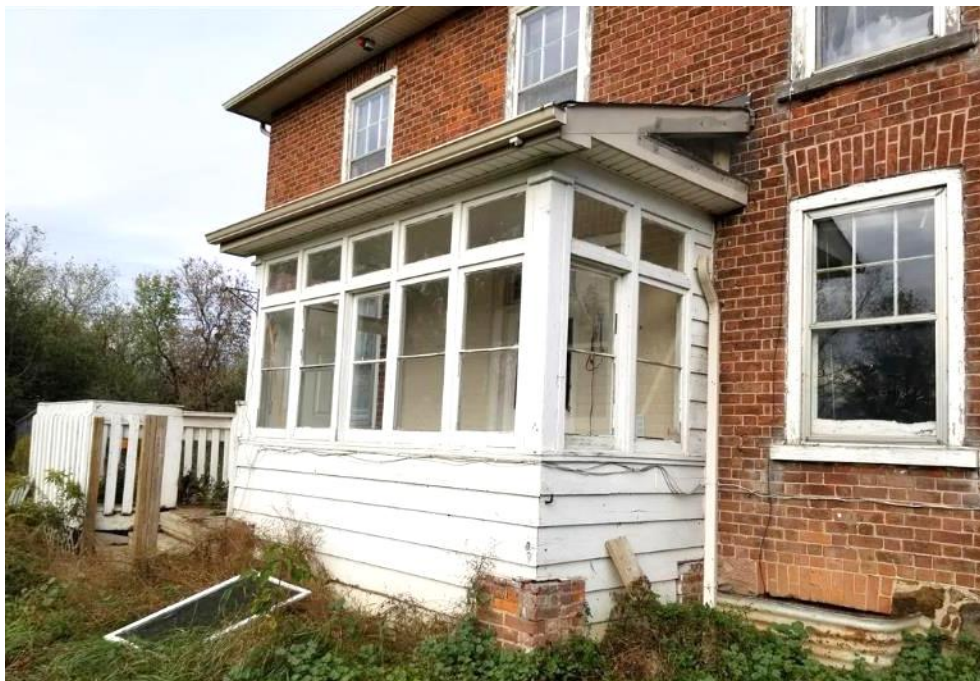
**Figure 27: Enclosed porch.**

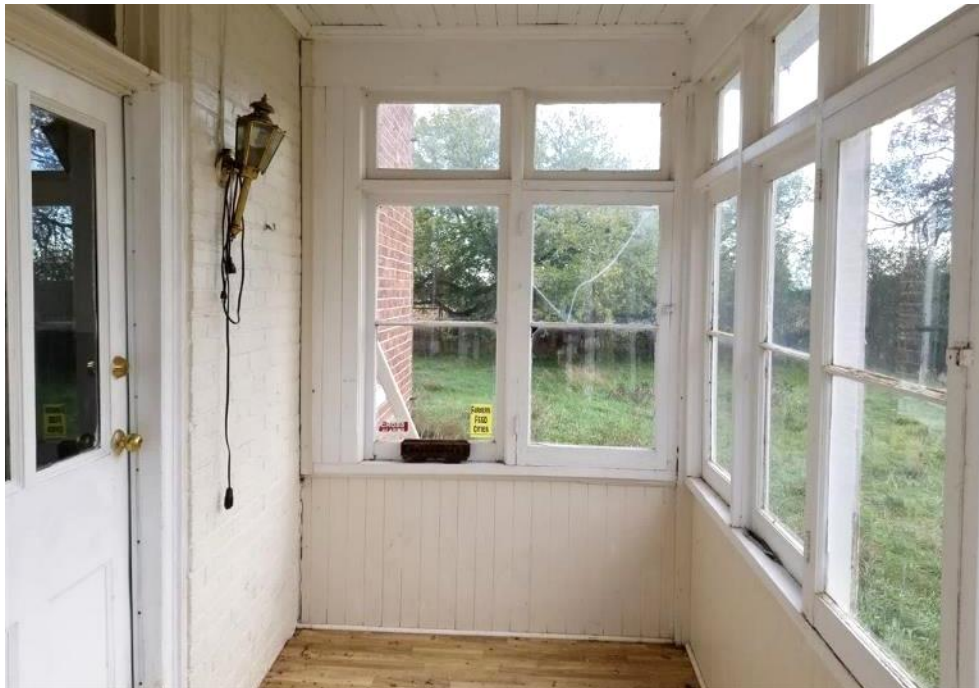
**Figure 28: Interior of the covered front porch, west façade of Main block.**

The enclosed wood-frame porch on the west façade consists of two one-over-one rectangular wood-frame windows, which open using hinges on one side of the frame. Each window has a flat single light transom above it, and there are two windows on the north and south side of the porch, and five on the west side. The interior of the porch is sided with vertical wood strips and the exterior with horizontal overlapping clapboard (Figure 28).

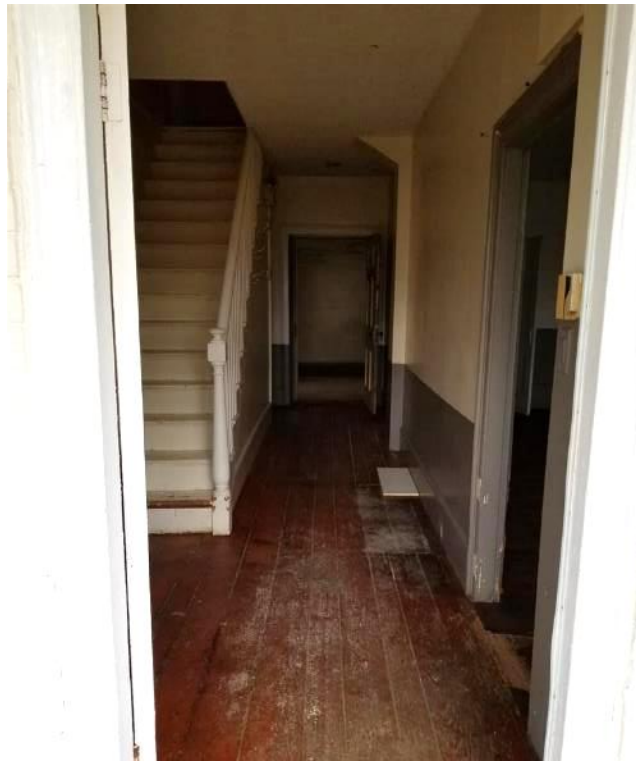
**Figure 30: Central hall of Main Block.**

The front door opens directly into the central hall that extends the width of the Main Block and into the East Wing (Figure 29). On the north of the central hall are the straight stairs to the second story (Figure 30). All door and window trims, baseboards, stair banister and newel appear to be consistent with the mid-nineteenth century date of construction (Figure 31). The floors are generally finished pine planks, probably 5/4, and appear to be butted (Figure 31). Walls appear to be painted plaster. All doors within the house had flat head openings.

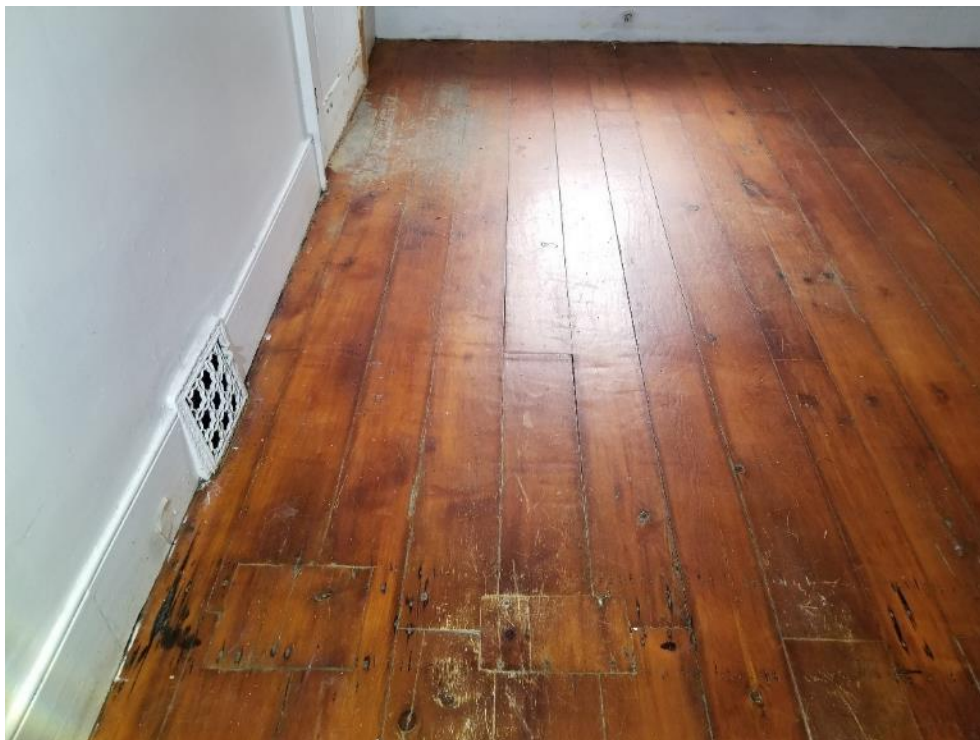
**Figure 31: Detail of floorboards and baseboards on first level of Main Block.**

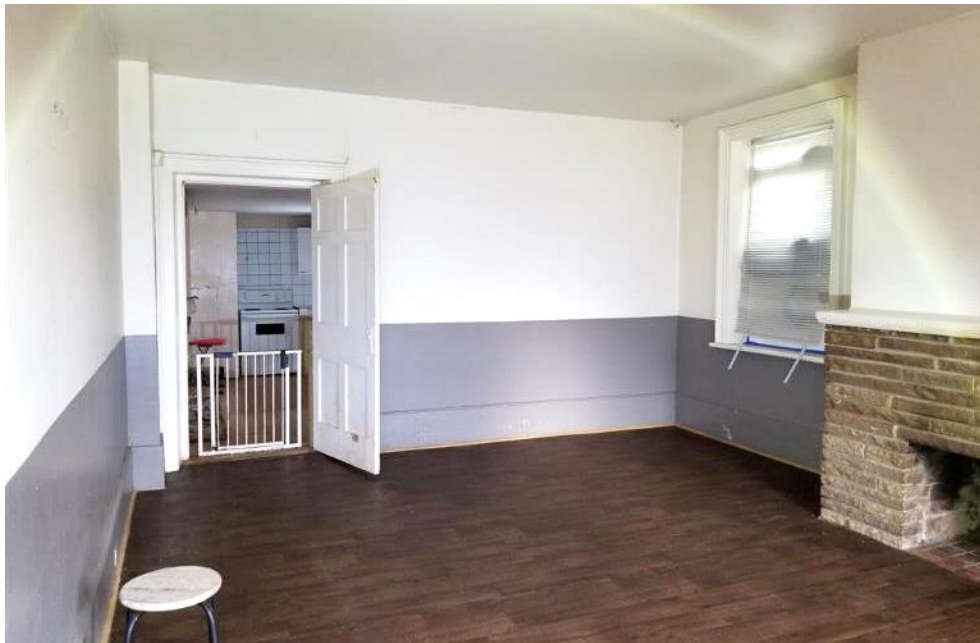
**Figure 32: Facing south in the south room on the ground floor, Main Block.**

On the south half of the first level, is a single room with a large fieldstone fireplace centred on the south wall (Figure 32). The fireplace veneer consists of machine cut stone, covering the original fieldstone. There is a window on the south and west walls, with wide moulded wood frames and thin wood sills (Figure 32). A door at the east end of the room leads into the East Wing. The wood frame around the door is similar to the moulded wood frame as the windows in the room (Figure 33).

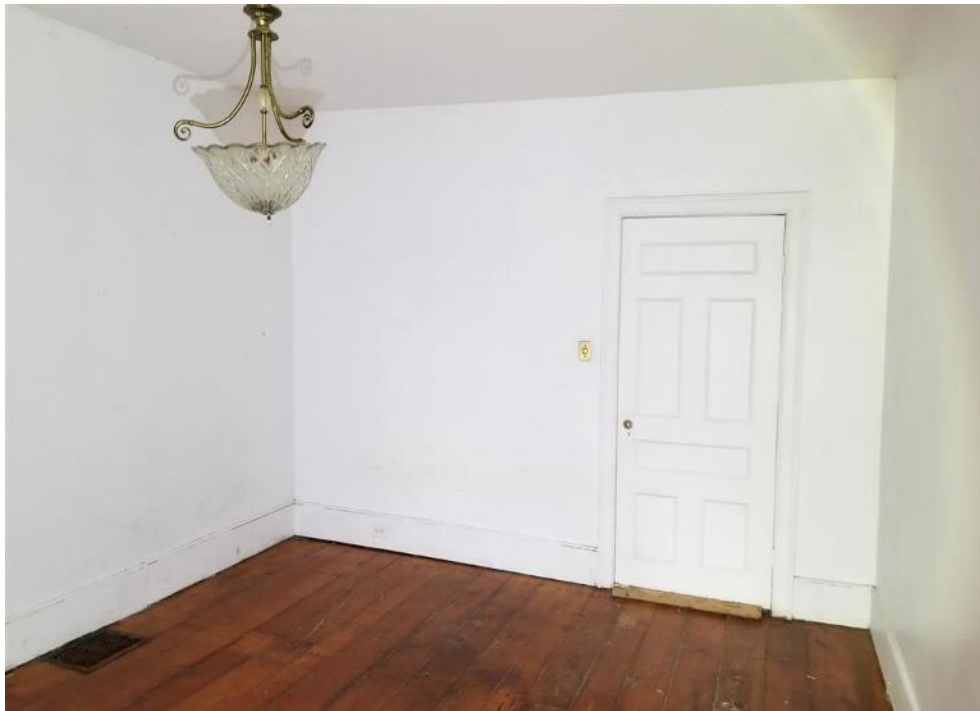
**Figure 33: Detail in the south room of the wood panelled door.**

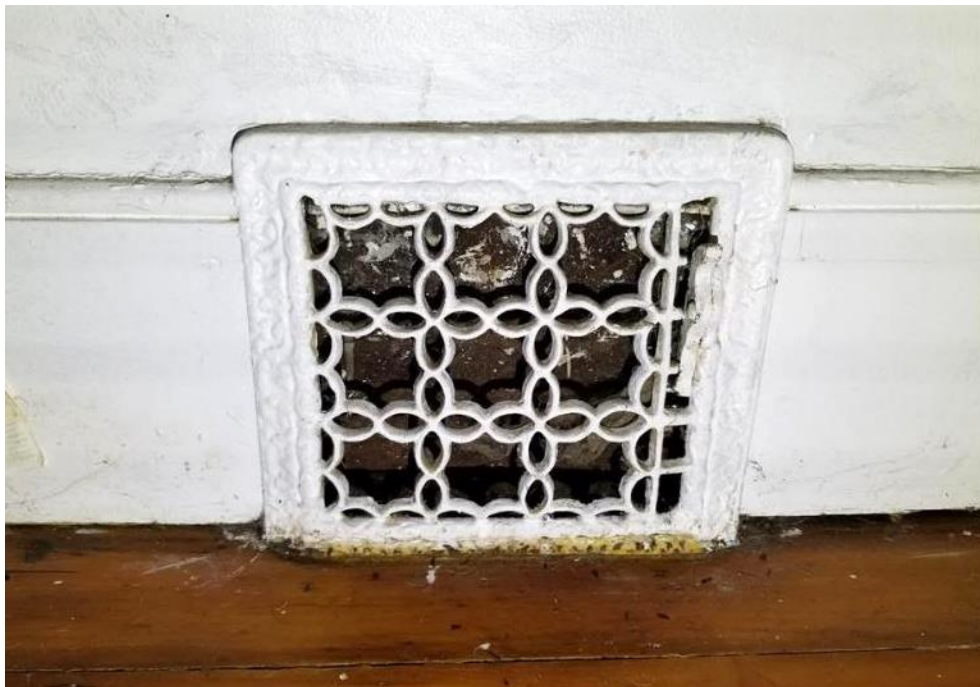
**Figure 34: The northwest room on the ground floor.**

On the north half of the first level, is room and bathroom (Figure 34). The bathroom encompasses the western 1/3 of the north half, with the room encompassing the remainder of the north half. There is a window on the west wall of the room, and a small metal decorative grate is present in the baseboard of the south wall of the room (Figure 35). A doorway on the east wall connects to the adjoining bathroom, which can also be entered from the central hallway. The bathroom is narrow and undecorated, with a rectangular window on the east wall (Figure 36).

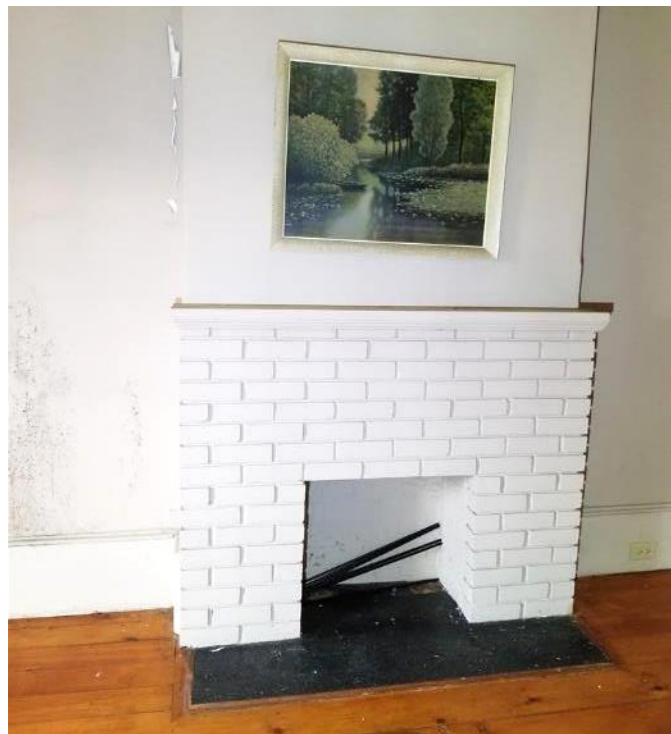
**Figure 37: North room on the second storey. A closet was added when the function of the room changed.**

The stairs to the second storey lead to an upper hall directly above the first level hall, with doors to four rooms, as well as an opening to the East Wing on the east wall. On the north of the landing is a large bedroom with a large fireplace centred on the north wall (Figure 37). The fireplace is finished with a brick veneer (Figure 38). There is window on the east and west wall, as well as large closet centred of the south wall.

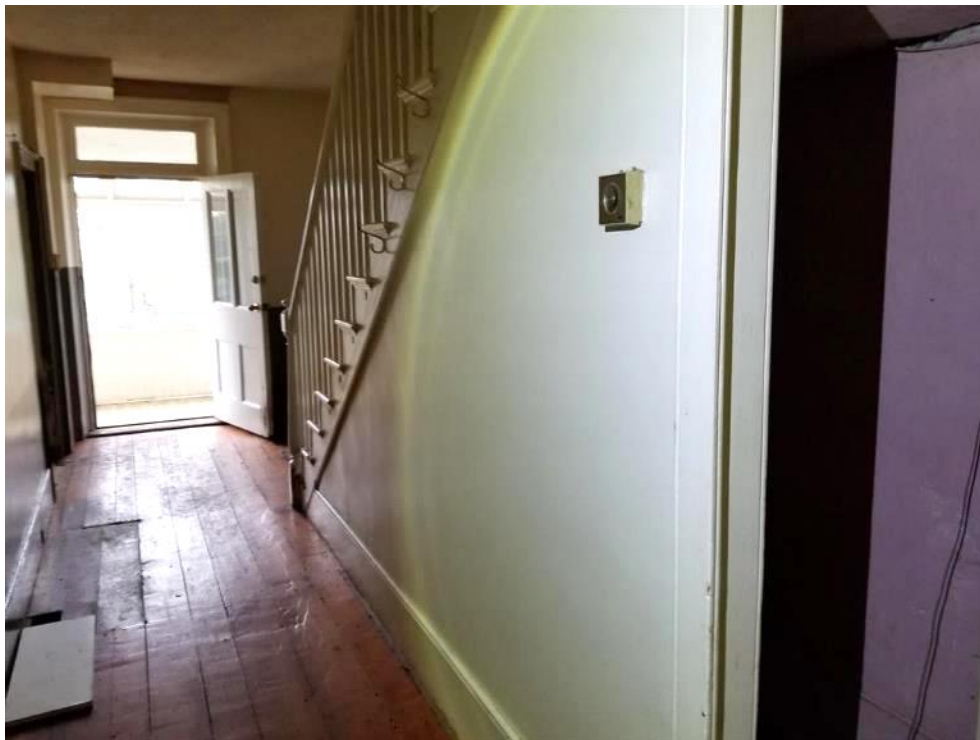
Figure 44: Opening to the basement stairs, below the main stairs in the Main Block.

The Main Block has a full basement that is accessible from the first level hall (Figure 44). The basement is comprised of a single rectangular room with coursed rubble walls and a cement floor. A large central fieldstone fireplace is on the south wall with a wood mantel beam to function as part of the winter kitchen (Figure 45).

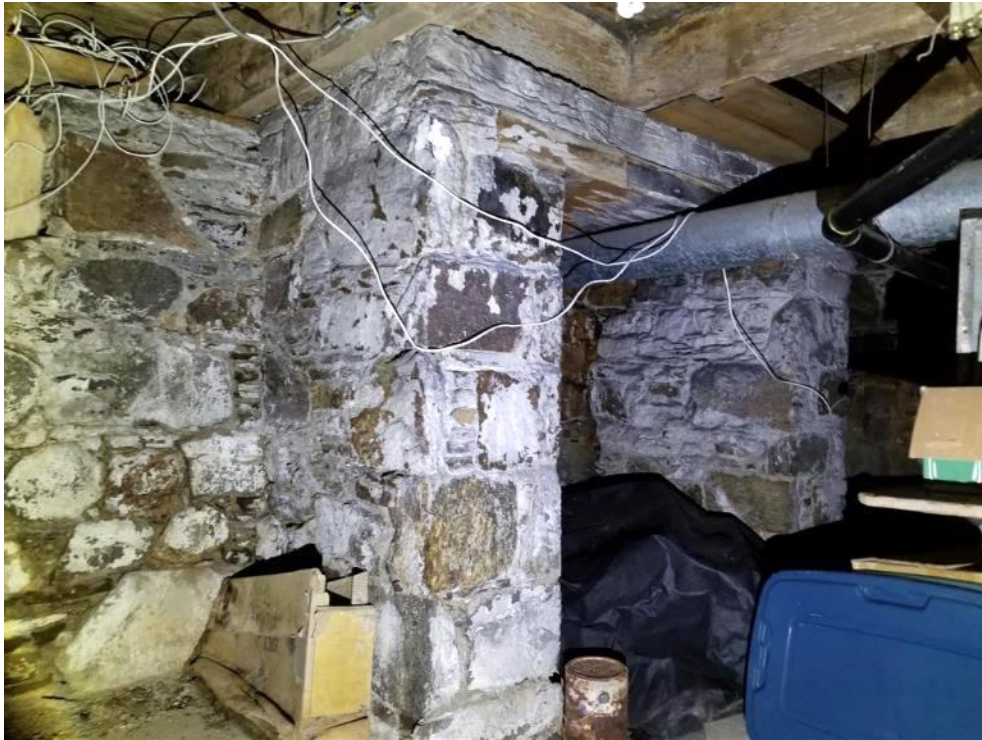
**Figure 45: Stone fireplace in the basement below the Main Block, on the south wall of the foundation.**

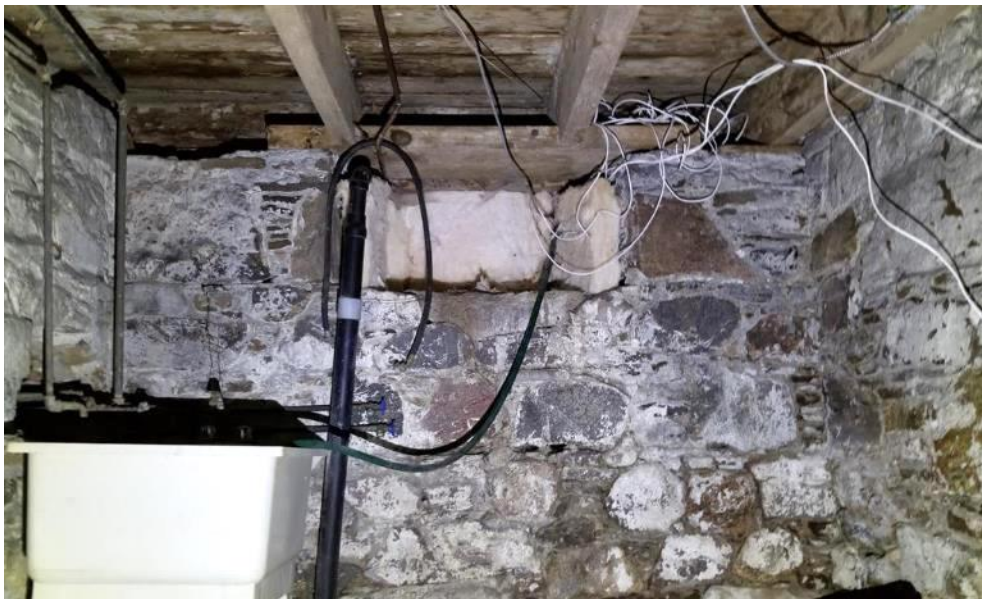
**Figure 46: Basement window on south wall.**

There are two windows on the west wall and one window on the east and south walls (Figure 46). All the basement windows were small and rectangular, likely one or two panes, although no frames have survived. Running east-west through the centre of the basement's ceiling is a large summer beam, as a central support for the floor above (Figure 47).

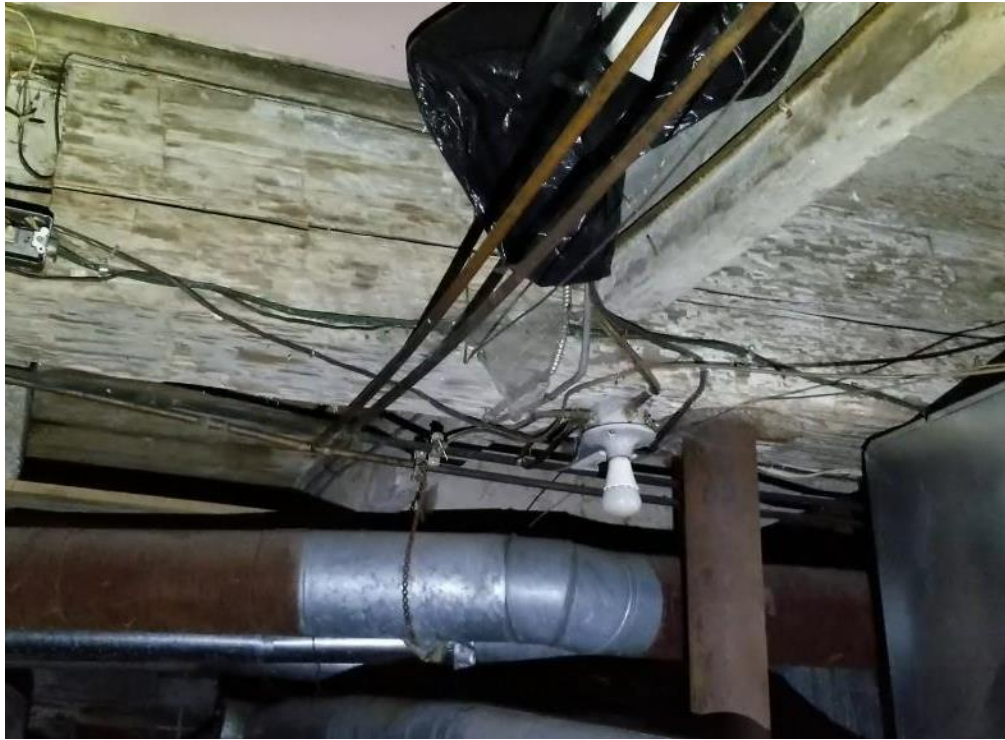
**Figure 47: Close up of the summer beam running east-west across the basement ceiling.**

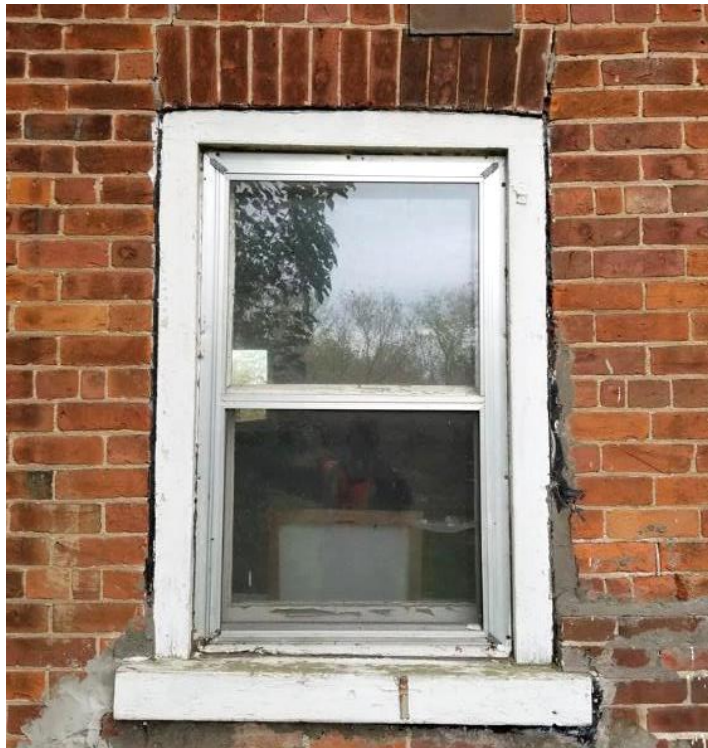
Figure 48: Typical window on the East Wing, north façade.

The walls are constructed from red brick laid in 1:5 Common Bond. There is a window on the north and south walls. Windows are 1-over-1 segmental head with a wood frame and wood lug sill, with aluminum external storm windows, and each window has a straight brick voussoir above the frame (Figure 48). The gable roof has projecting eaves and verges, with plain metal soffits and fascia, and a metal rainwater catchment system on the eaves. The gable end of the roof has metal return eaves, and a large chimney extending from the east wall of the East Wing (Figure 49). The size of the chimney is indicative of its early age and would have originally been fed by a large cooking hearth rather than a stove (Goldsmith Borgal & Company Ltd. Architects 2017)

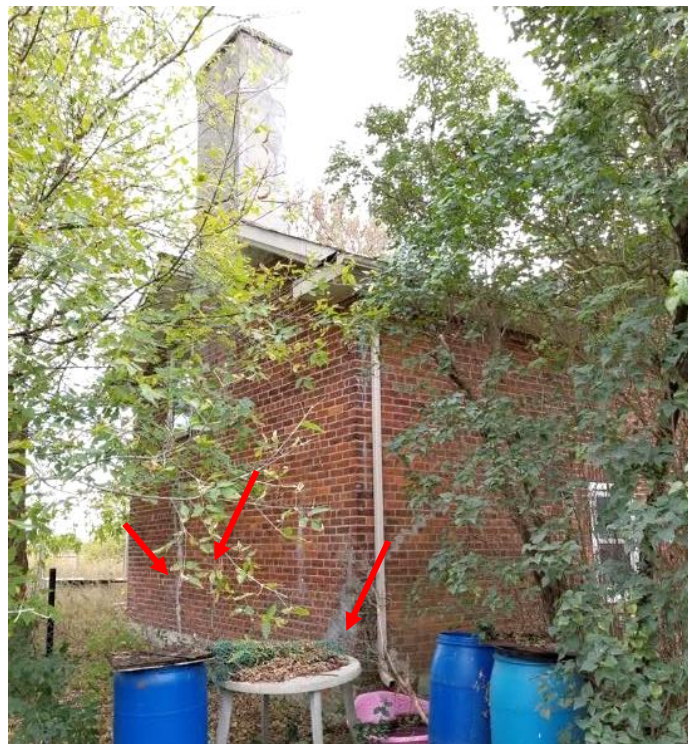
Figure 49: North and east façades of the East Wing. Note, extensive damage and repair to the east wall (red)

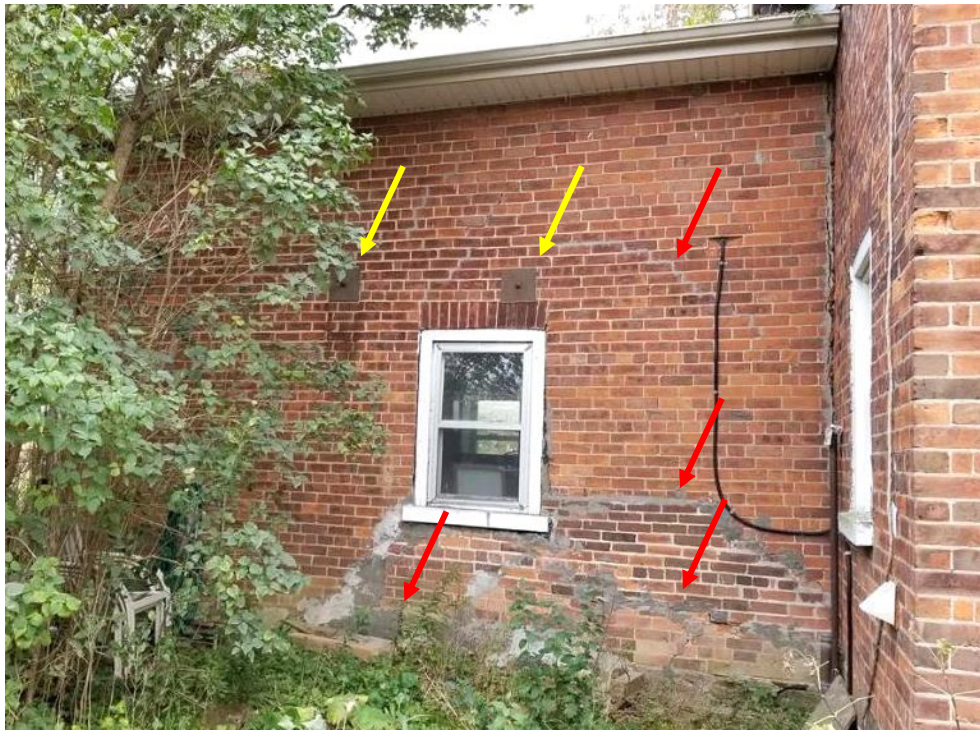
**Figure 50: Extensive damage and repair to the north wall (red). Note the metal rods to secure the wall (yellow).**

The north, east and west walls of the East Wing have experienced significant structural damage, as evidenced by the presence of tie rods, repaired cracking and patchy color of large brick areas (Figure 50). Thus, relocation of the East Wing may be difficult.

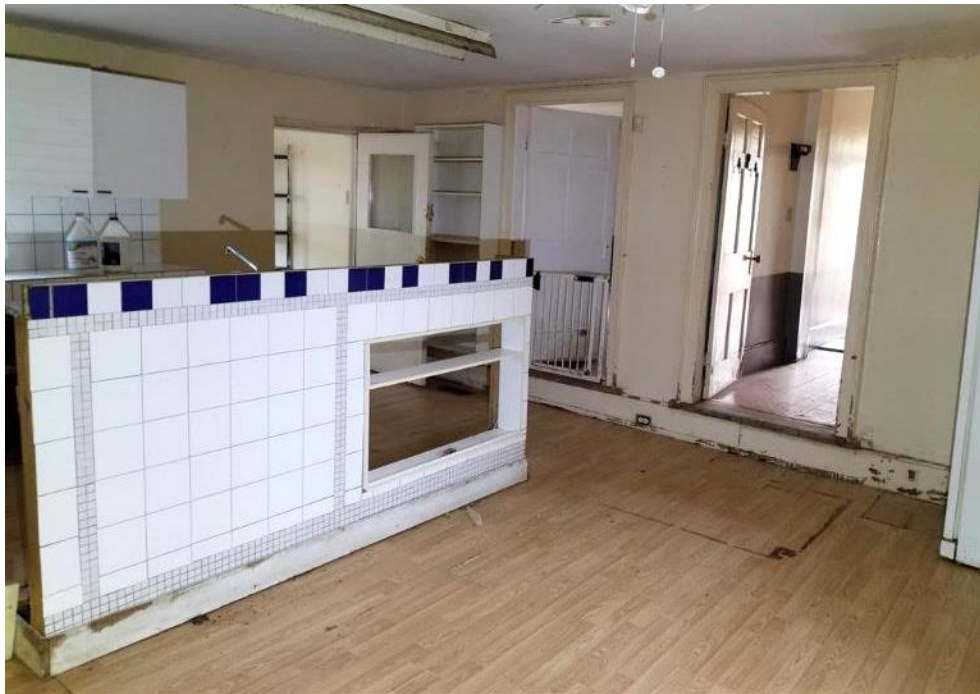
**Figure 51: Interior of the East Wing facing west. Doorways to the Main Block to the west and South Addition to the south.**

The interior of the east wing consists of a single room on the first floor, which was used as a kitchen (Figure 51). The first level of the East Wing is accessible through the central hallway of the Main Block, the south room of the Main Block, and through the South Addition. The first level of the East Wing is slightly lower than the first level of the Main Block, as is evidenced by the step between the East Wing and the Main Block. There is a large hearth centred on the east wall that has been covered by drywall.

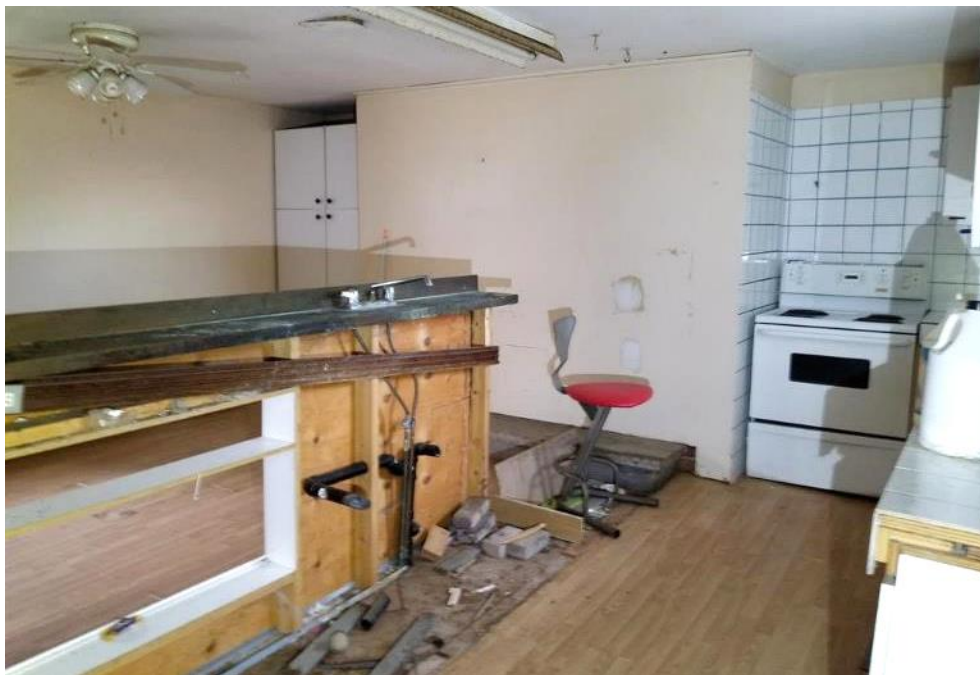
**Figure 52: Interior of the East wing facing the east wall. Covered hearth in the centre of the wall.**

Both door frames on the west wall have moulded trim, and the door frame on the south wall has plain trim. There is a window on the north and south walls. The room has some of its cabinetry, however, none of the surviving elements appear to be contemporaneous to the original construction (Figure 52). Laminate flooring covers the room, and the baseboards are shorter than those found in the Main Block. A portion of the kitchen walls is faced with white and blue tiles. A doorway on the south wall opens into the South Addition.

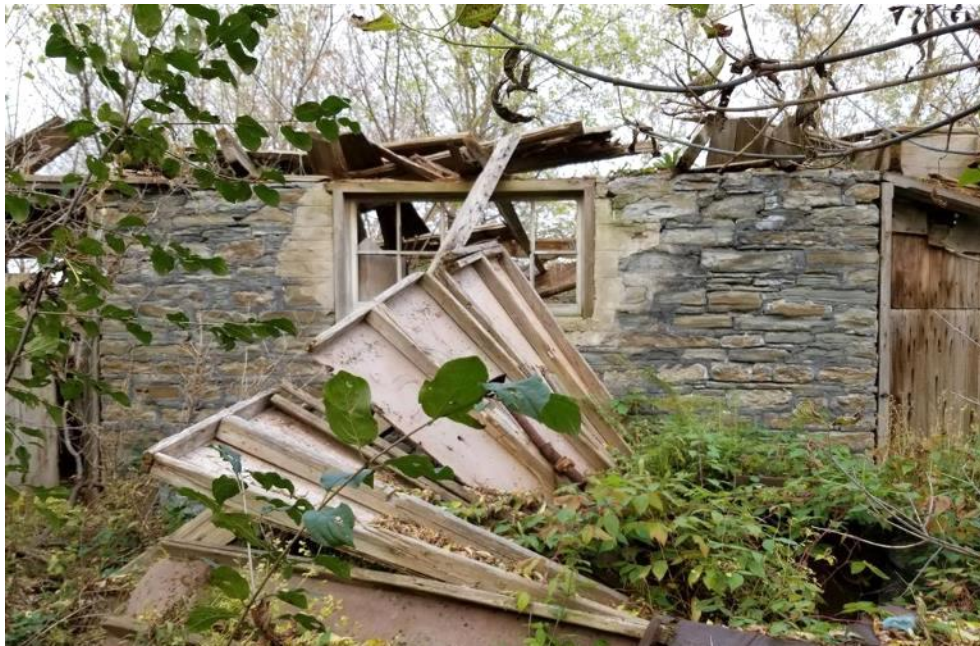
**Figure 60: West façade of the stone barn foundation.**

All that remains of the barn is a portion of the stone foundation. The coursed stone foundation presents asymmetrical fenestration with 10-pane fixed wood windows with flat head openings and no exterior decoration (Figure 60 and Figure 61). Exterior doors on the surviving west wall are plain wood. Interior beams which would have supported the floor above have decayed and cracked, and there is not much left inside the barn (Figure 62 to Figure 64).

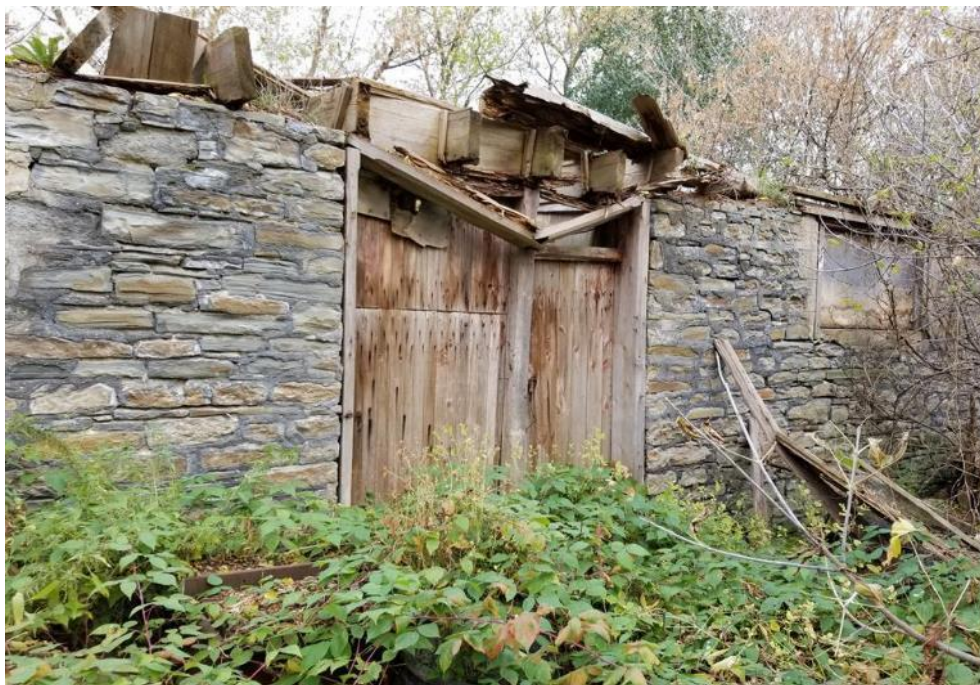
**Figure 61: West façade and doors of the stone barn foundation.**

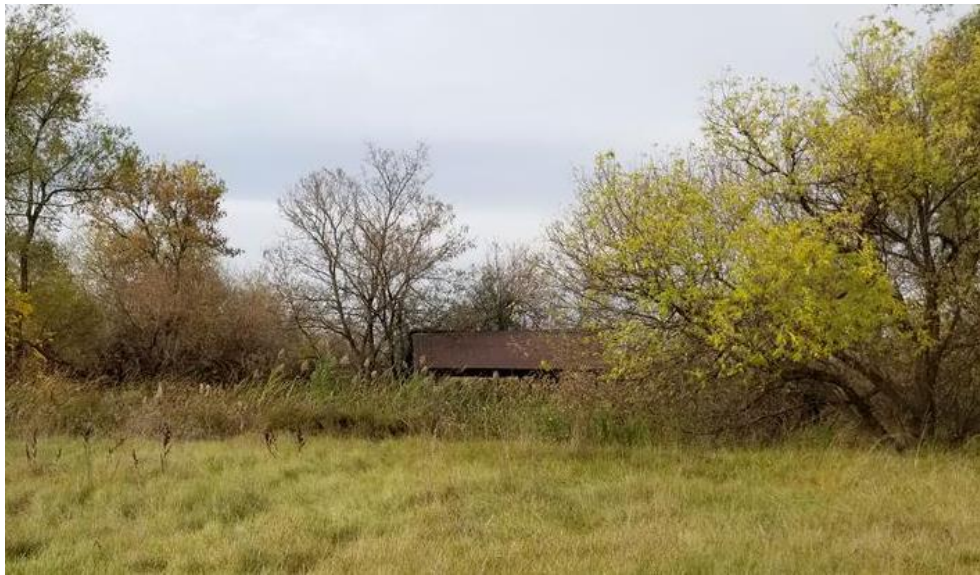
**Figure 65: Northeast outbuilding, looking north.**

This 20<sup>th</sup>-century structure has a medium gable roof with a wood frame, currently in a state of collapse. Much of the wall material has rotted away, leaving the support posts in place (Figure 65). It was sided with vertical wood planks and is currently leaning to the east (Figure 66).

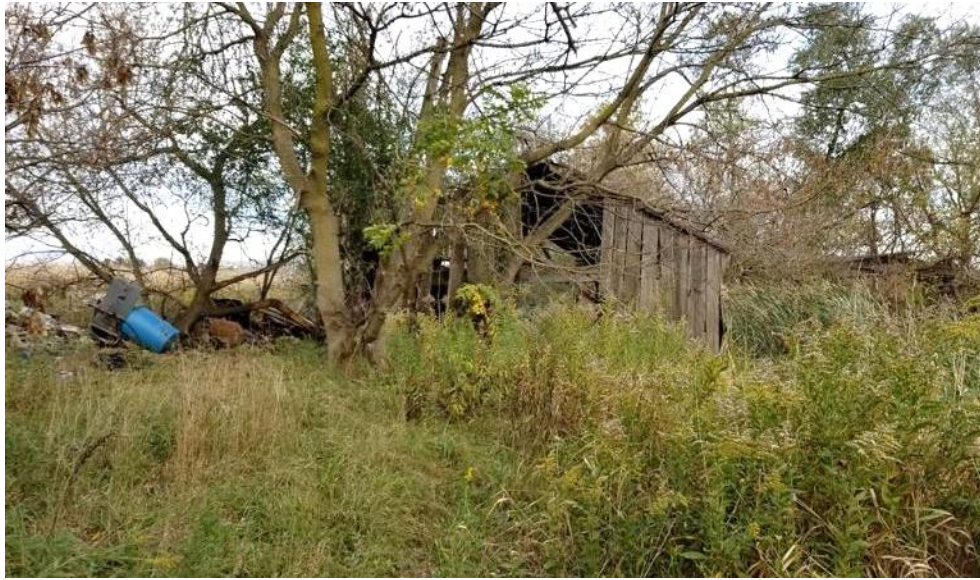
**Figure 66: The west façade of the northeast outbuilding.**

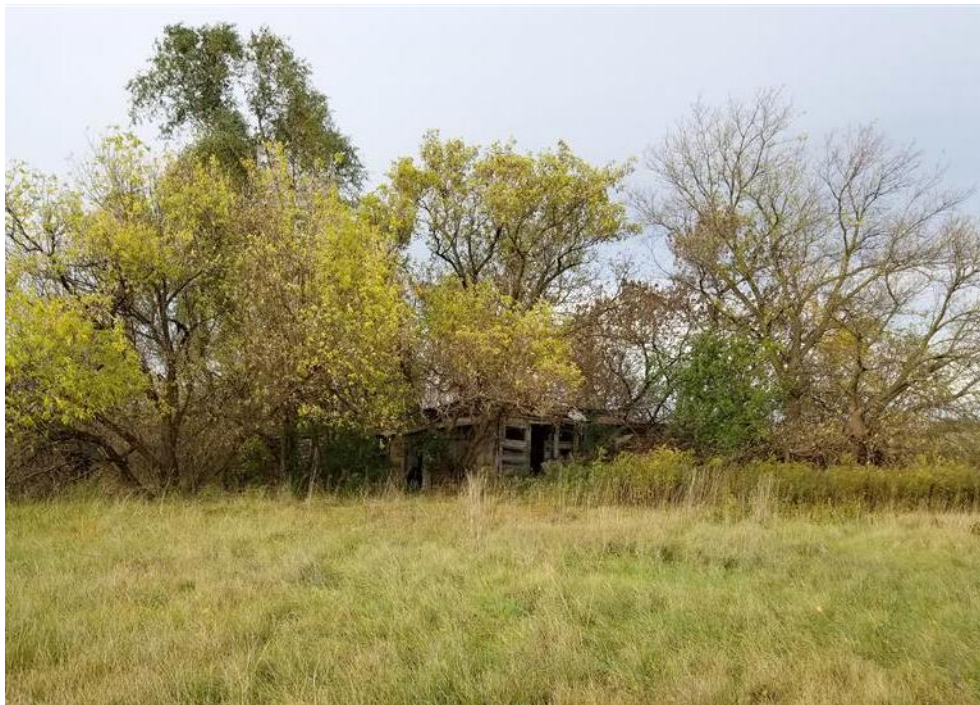
**Figure 67: East outbuilding.**

The mid-20<sup>th</sup> century East Outbuilding is a one-storey, wood frame structure with a low gable roof (Figure 67). It is currently surrounded by trees on the east side of the residential area and is barely visible within the trees and bushes that are growing through the structure.

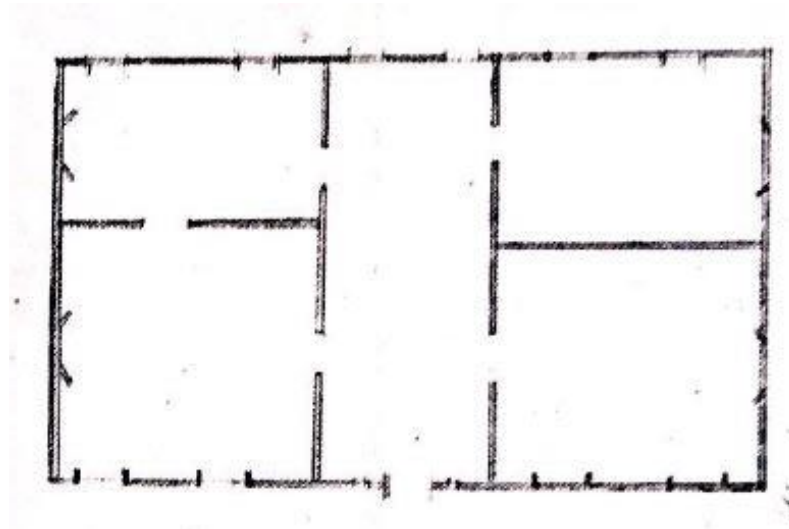
**Figure 68: Georgian floorplan, William Dickson house (Blumenson 1990:6).**

East Wing, with rooms to the north and south. The typical Georgian floorplan is fairly symmetrical, such as this example from Blumenson (1990:6) of the William Dickson House, built in 1794. John Fleming house is nearly symmetrical, with one large room on either side of the central hallway, but a smaller room behind the staircase on the north side of the house which is currently used as a small bathroom.

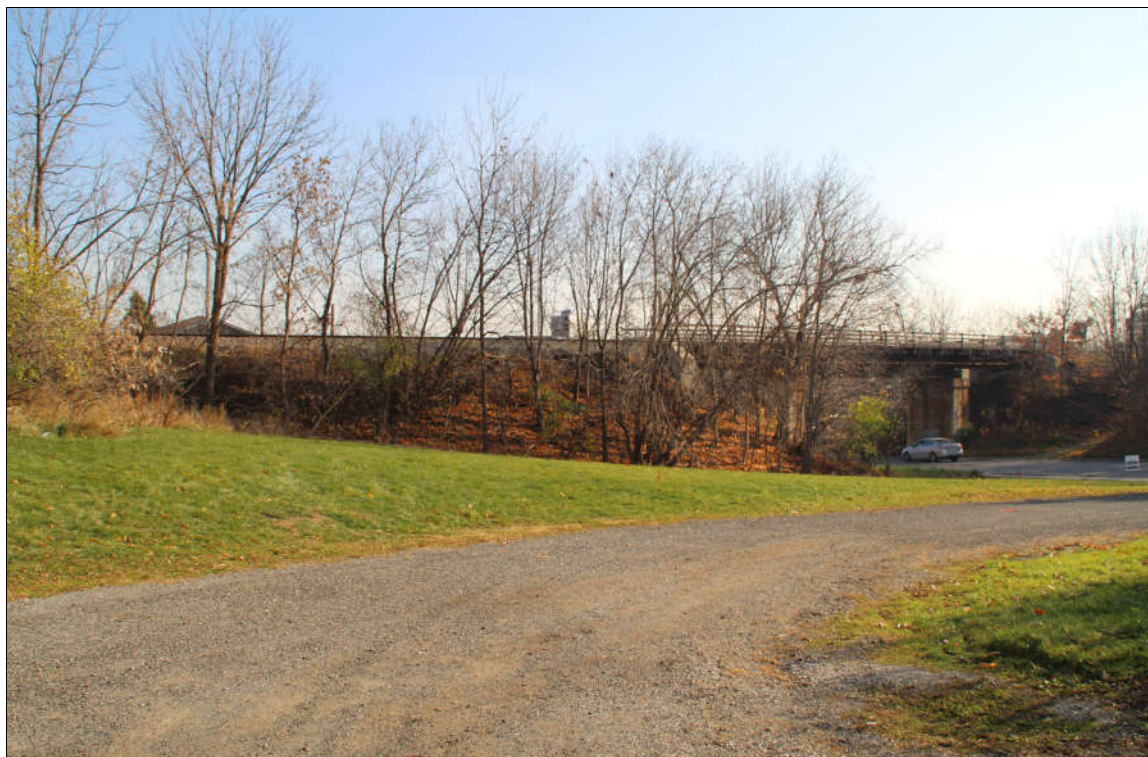
Figure 23

C.P.R. railway and Woodbridge Avenue railway bridge from project site

The property itself is occupied by a temporary sales office building (Figure 24). The site is relatively flat. It is 3 to 4 metres lower than the lots on William Street and screened by a dense hedgerow (Figure 18). It is also 2 to 3 metres lower than the adjacent 268 Woodbridge Avenue property at the rear where the house is located. The Donald Grant House is heavily screened by mature coniferous and deciduous vegetation (Figure 19). The adjacent CP Railway tracks are 4 to 5 metres above the grade of the property (Figure 23).

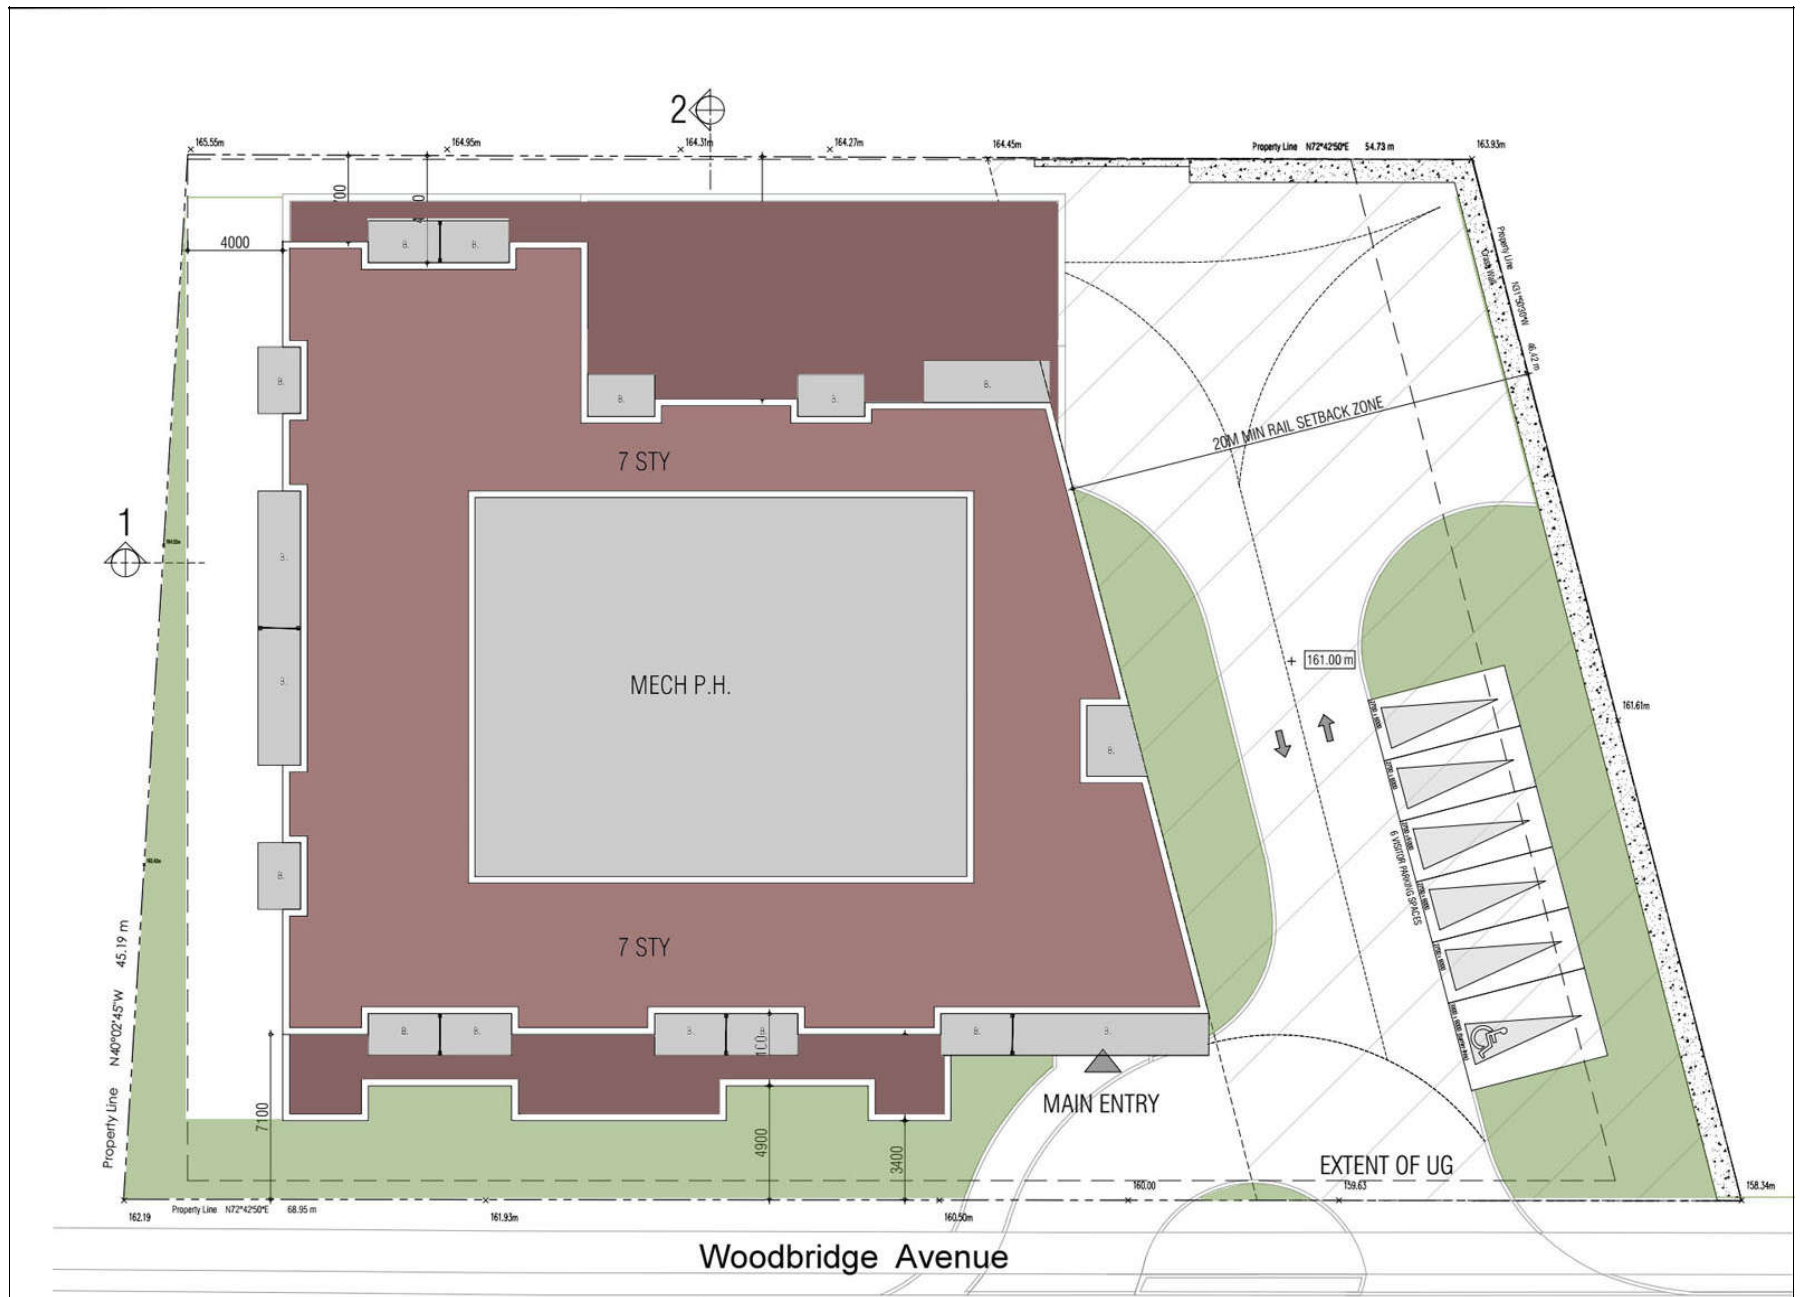
Site Plan - after Graziani + Corraza Architects Inc., May 28, 2020

The proposed building is set back 20 m on the east due to the railway, which provides a buffer to mitigate noise. This creates the service and landscape spaces. The majority of the building faces south and west with adequate exposure to sunlight and open views. The building steps back to the north creating a play of terraced levels. Figure 26 is a proposed Site Plan for the development of the property.
