**CITY OF VAUGHAN  
HERITAGE VAUGHAN COMMITTEE  
AGENDA**

**248 - 260 Woodbridge Avenue  
Woodbridge Heritage Conservation  
District (HCD)  
City of Vaughan**

Revised  
Heritage Evaluation of Existing Structures  
10568 Islington Avenue, Kleinburg, ON  
In the City of Vaughan

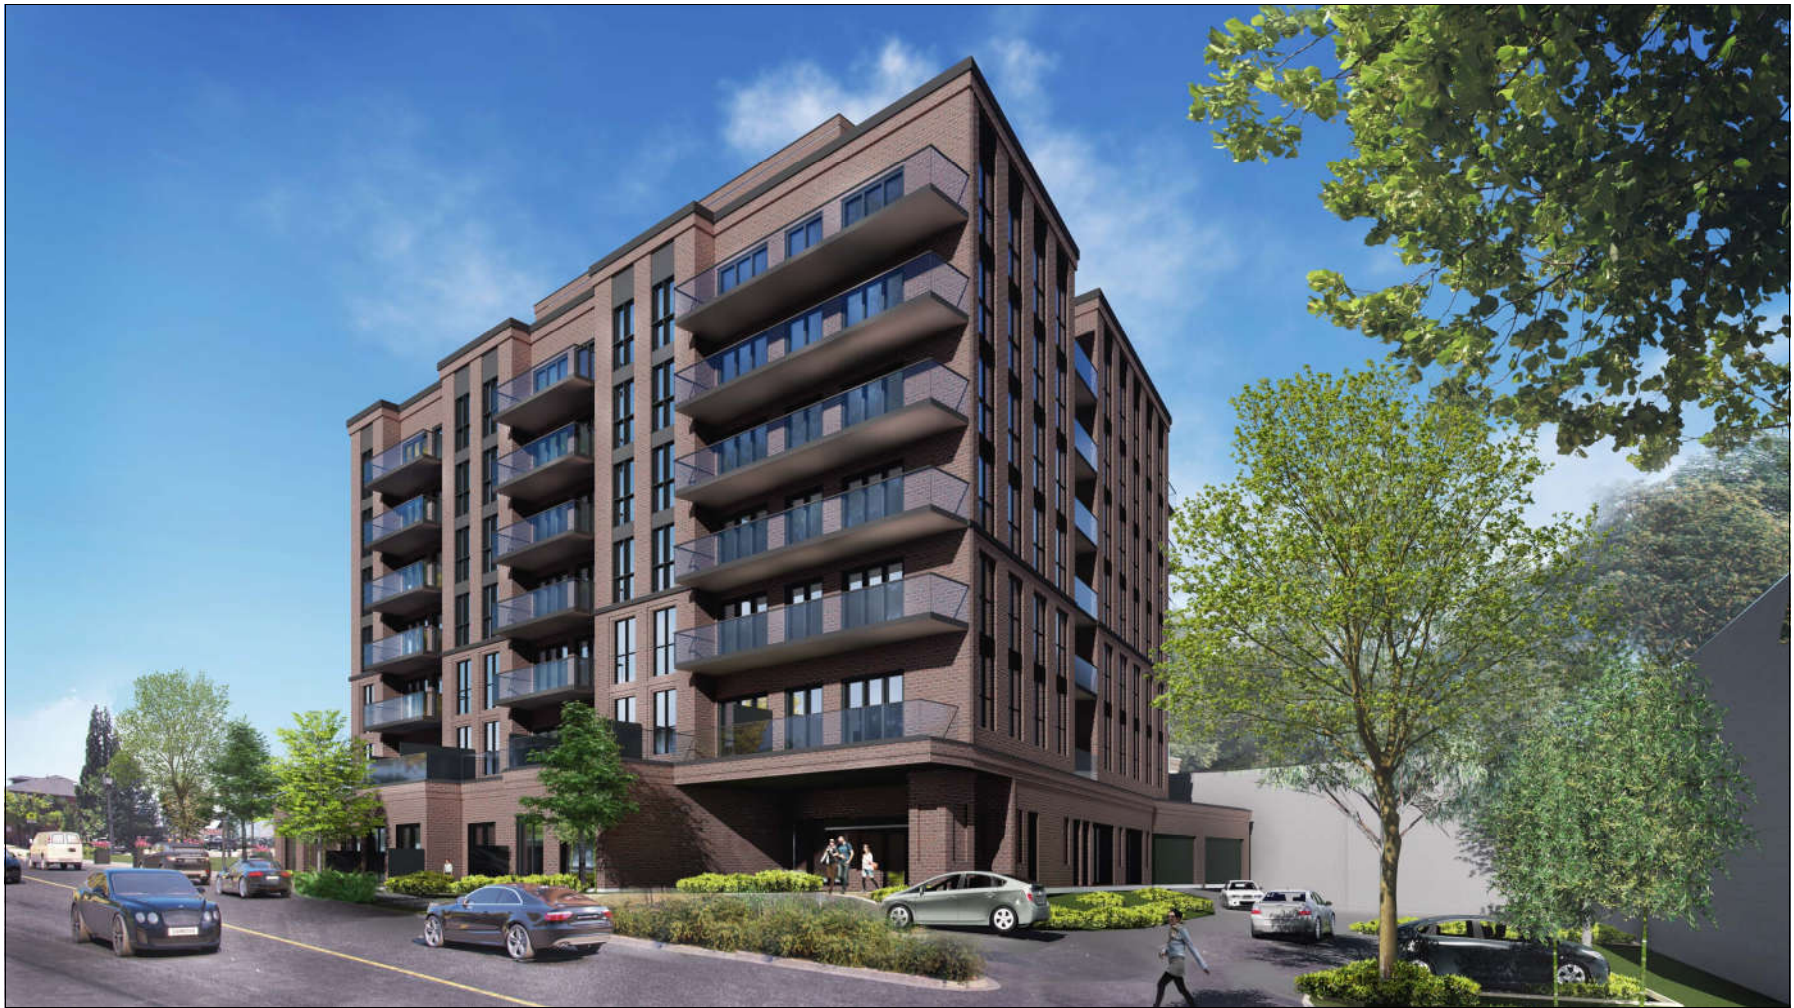
south elevation (Woodbridge Avenue) - *Graziani + Corraza Architects Inc.*, June 2020

Figure 28 is a view of the 7 storey building from the southeast, showing the railway crash wall to the east, a single storey podium of 4.5 metres, and the main entrance facing the street.

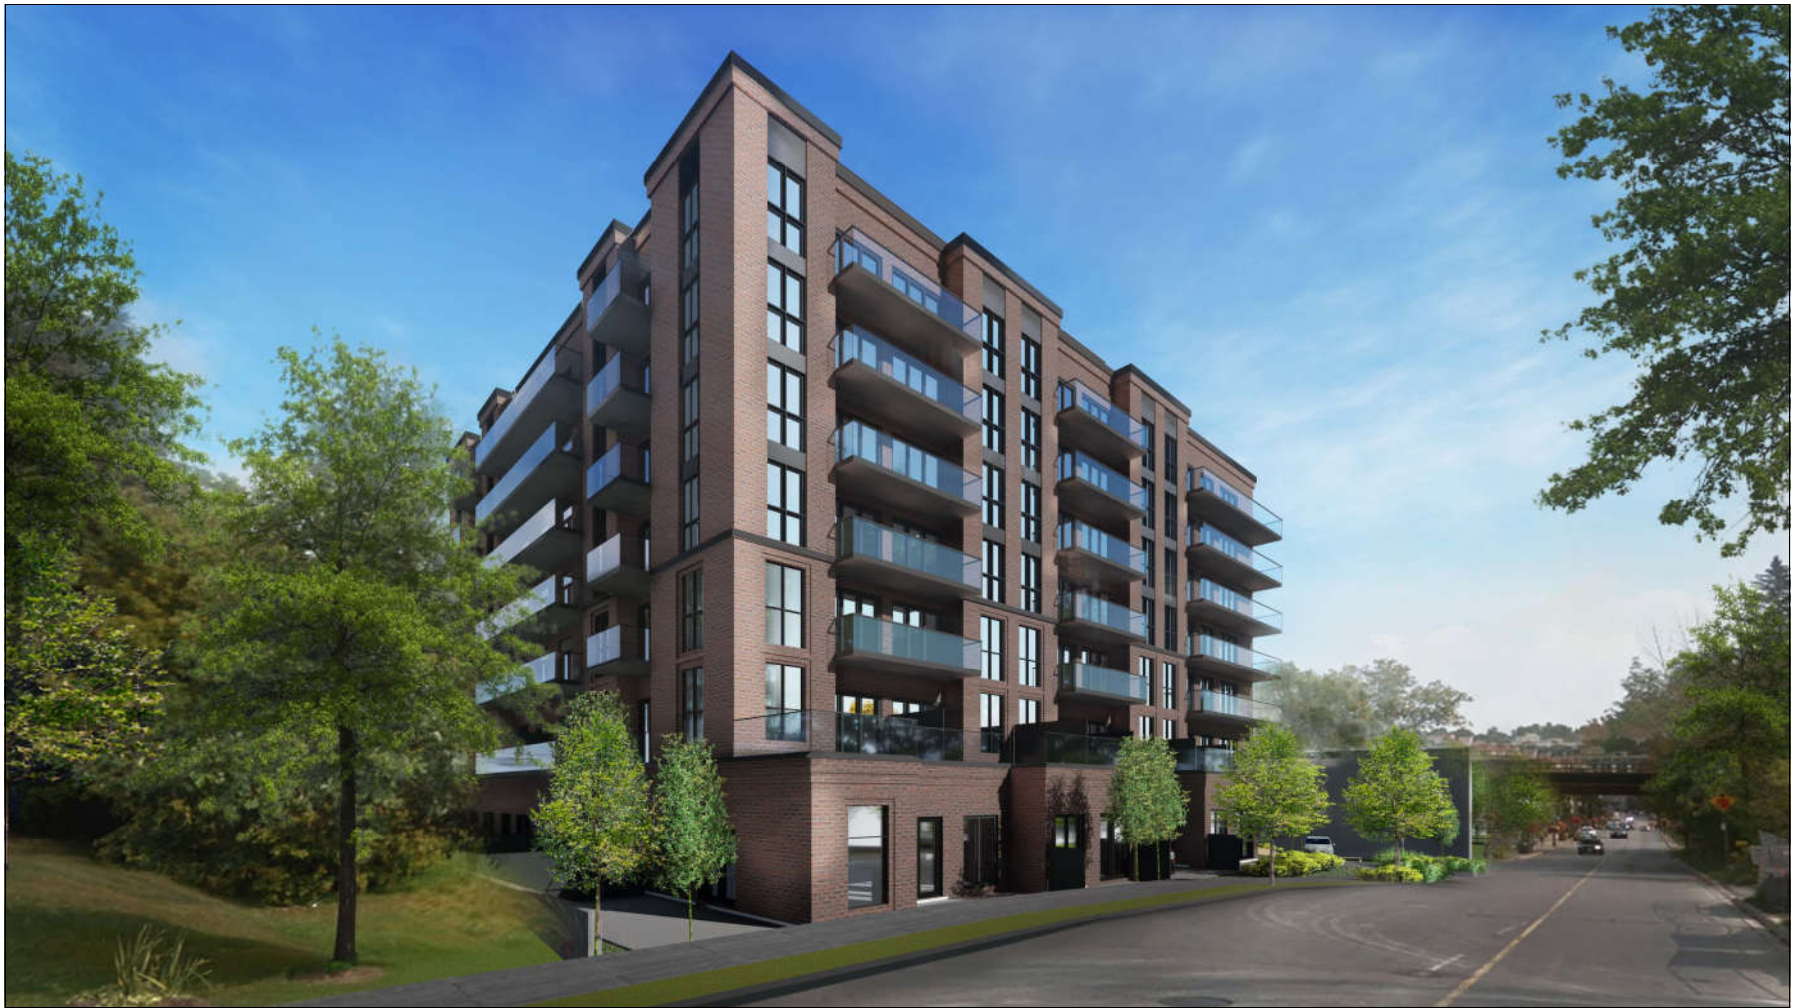
south (Woodbridge Avenue) elevation - *Graziani + Corraza Architects Inc.*, June 2020

Figure 29 is a view from the southwest along Woodbridge Avenue. The railway bridge is in the background.

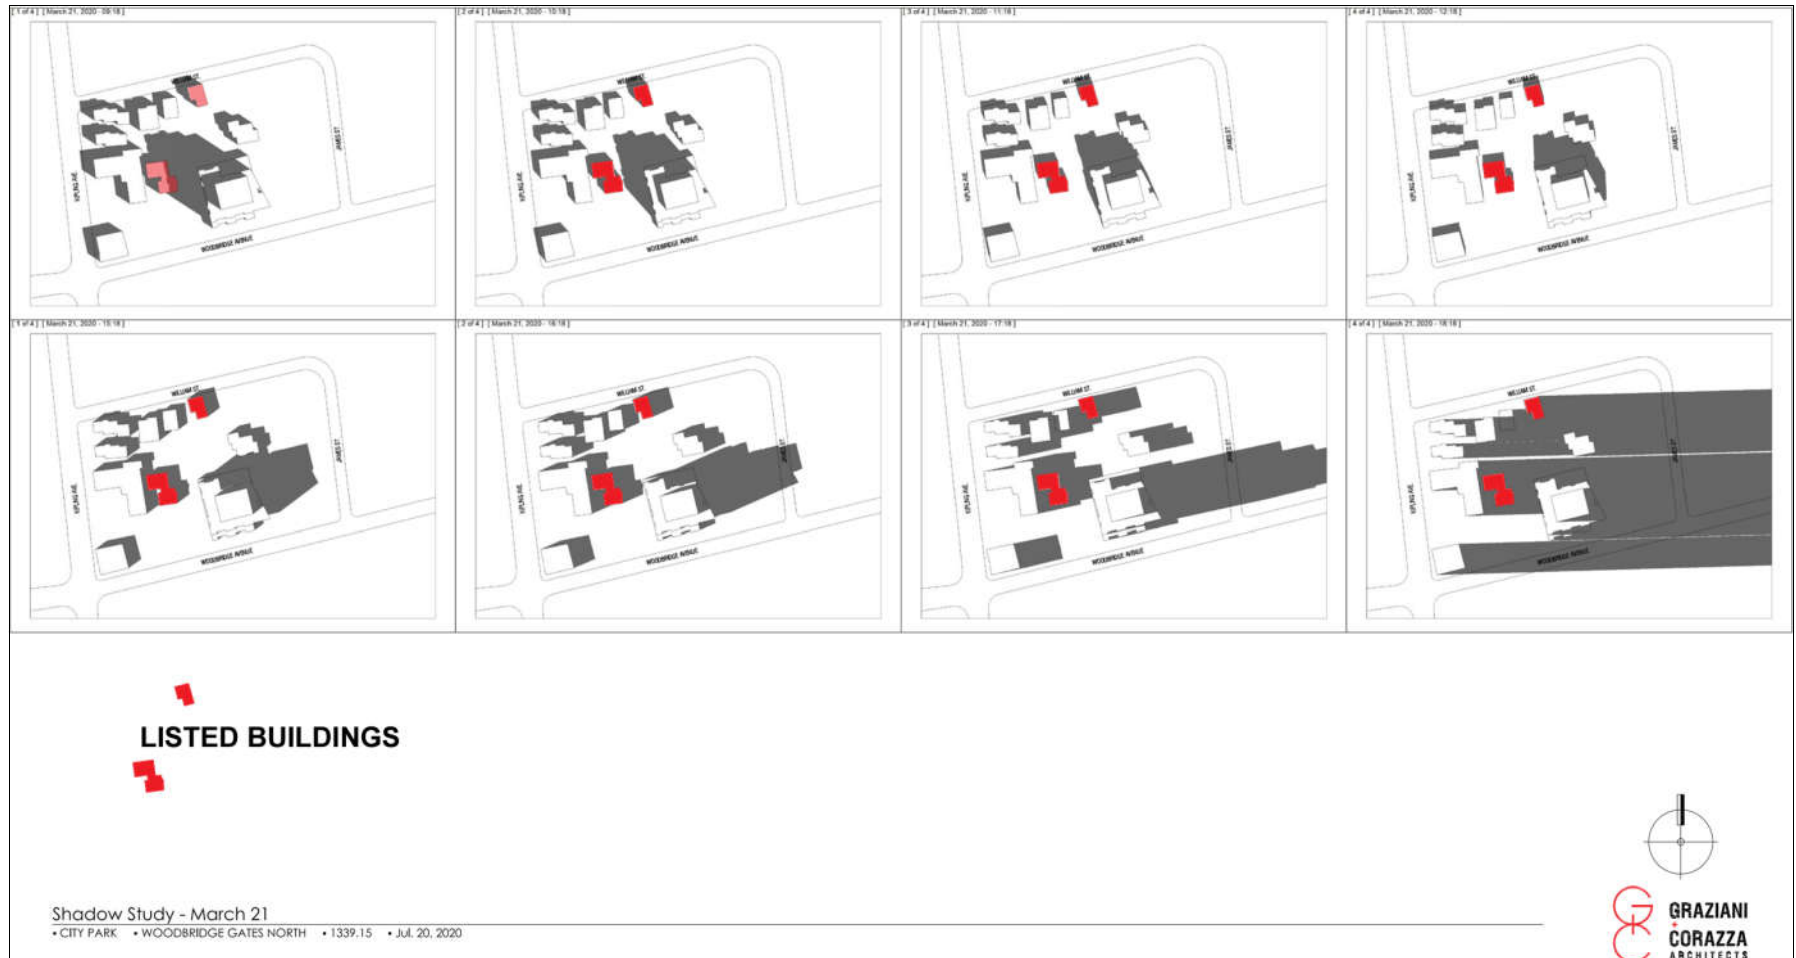
## Appendix 2 Shadow Study

The listed building at 69 William Street is not affected by the proposed building on Woodbridge Avenue.

The listed building at 268 William Street is in partial to full shadow from 4:00 PM to evening from the church building on Kipling Avenue. It is not affected by the proposed building on Woodbridge Avenue.

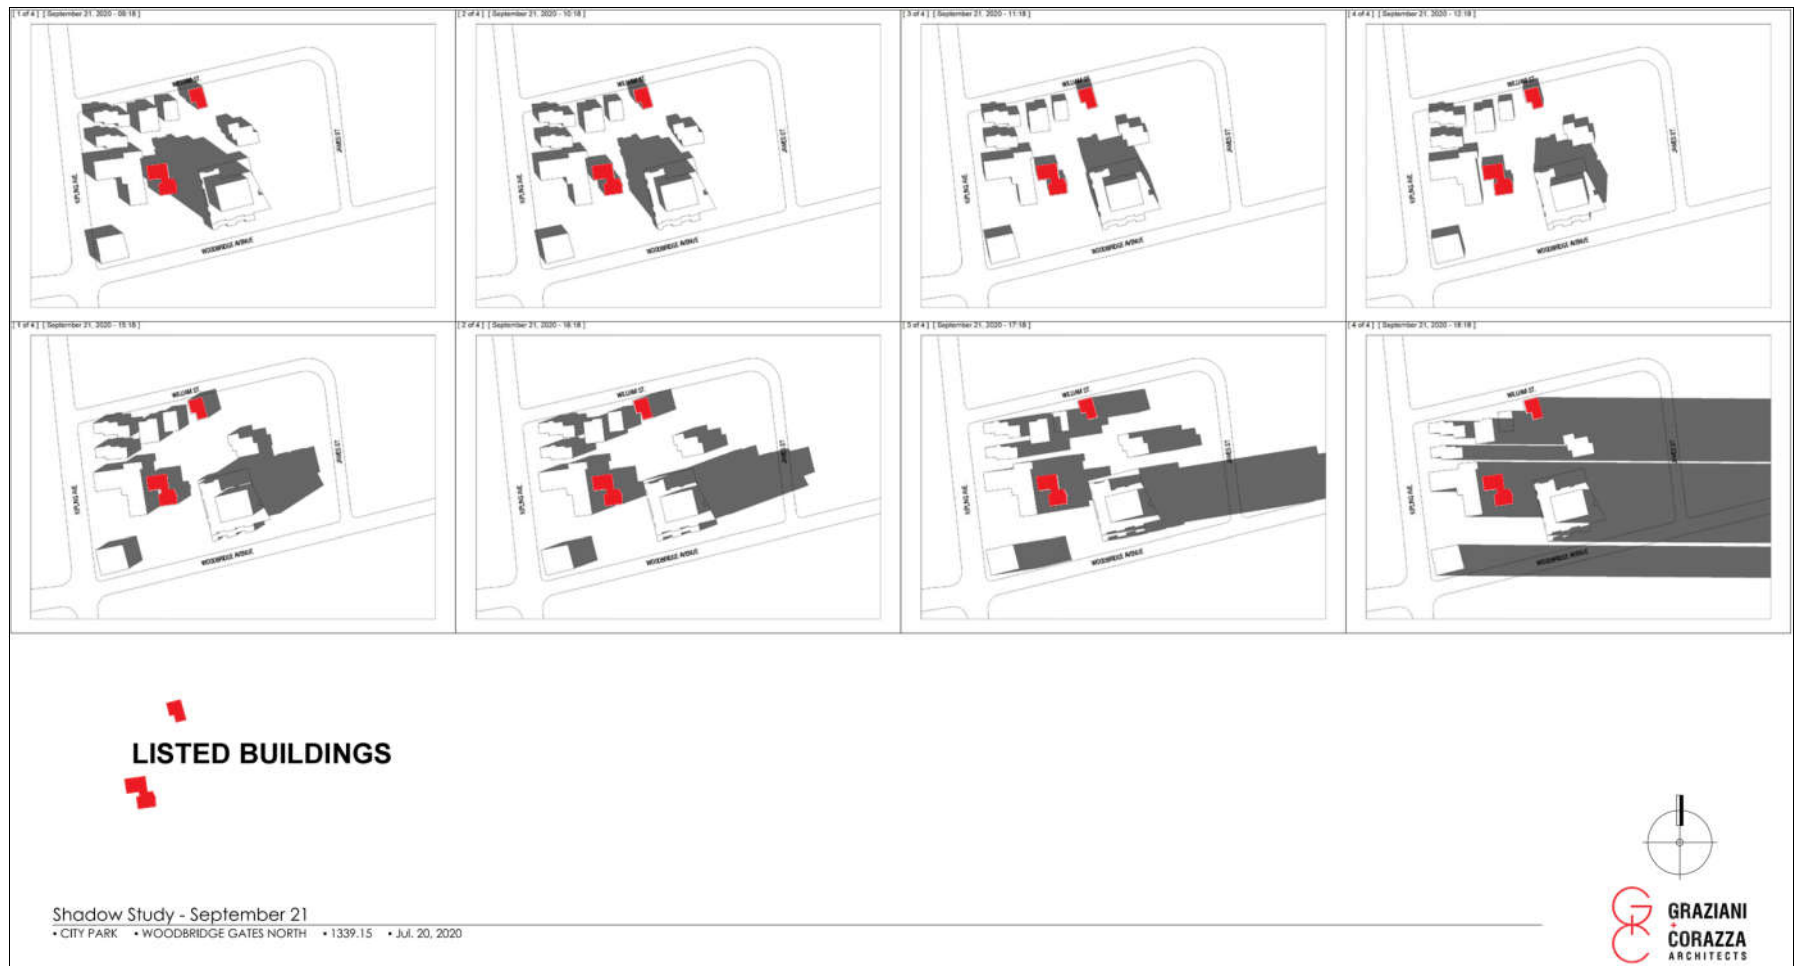
## Appendix 2 Shadow Study

The listed building at 69 William Street is in partial shadow from the building to the west from 5:00 PM on. It is not affected by the proposed building on Woodbridge Avenue.

The listed building at 268 Woodbridge Avenue is in partial to full shadow from 4:00 PM to evening from the church building on Kipling Avenue. It is in full to partial shadow from the proposed building on Woodbridge Avenue from 9:00AM to 10:20AM. However, what is not taken into account is the shadows created by the mature coniferous trees on the lot on its easterly property boundary and that created by the building on the south side of Woodbridge Avenue as shown in the photographs on the following page.

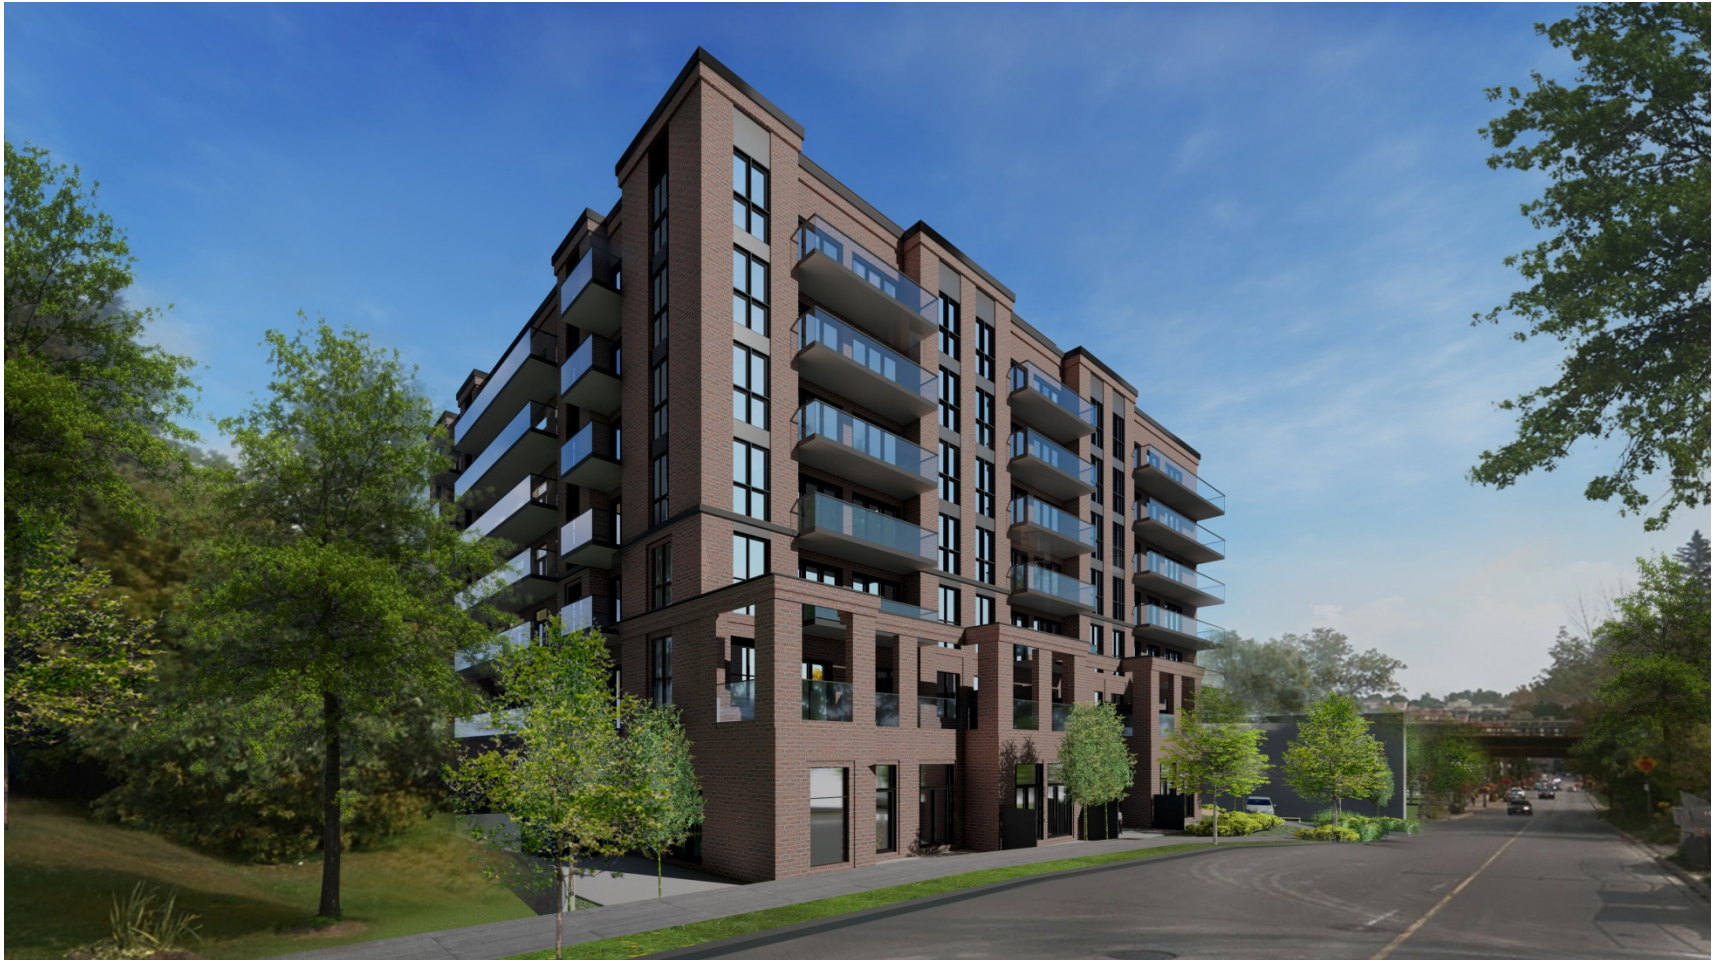
Looking northeast – crash wall and railway in background
