Heritage Vaughan Committee Report

TITLE: REDEVELOPMENT OF HERITAGE PROPERTY AND NEW INFILL DEVELOPMENT LOCATED AT 2291 MAJOR MACKENZIE DRIVE, MAPLE HERITAGE CONSERVATION DISTRICT

To seek a recommendation from the Heritage Vaughan Committee for the proposed adaptive reuse of the existing Heritage house and the construction of an attached 3-storey four three townhouse development with garages. The property is located at 2291 Major Mackenzie Drive, in the Maple Heritage Conservation District and designated under Part V of the *Ontario Heritage Act*, as shown on Attachments 1 and 2.

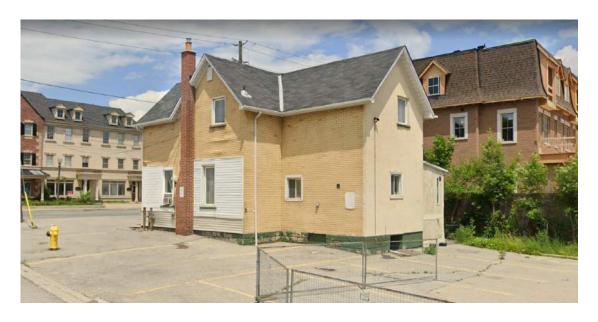
Google Street View Rear of Building

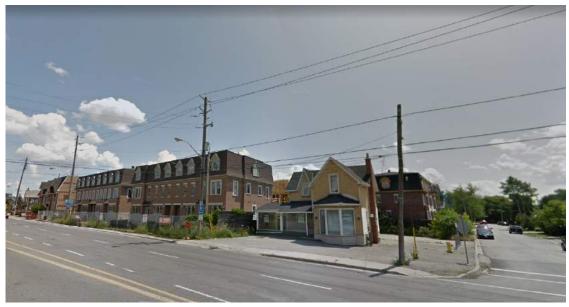
Google Street View Front of Building

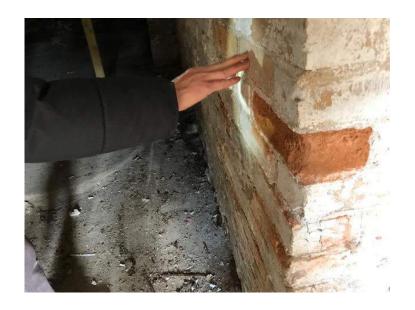
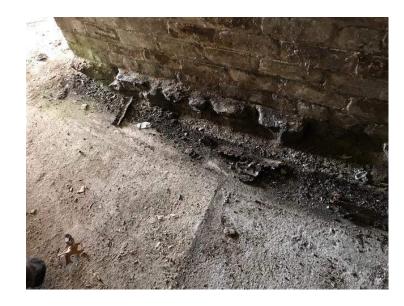
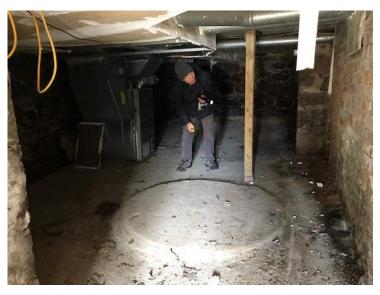
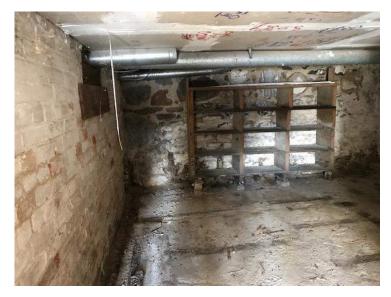
Basement

Salvation mitigation is not considered applicable in this case, except that some of the original field stone in the basement foundation is planned to be reused for small retaining walls required to address the sloping grade as it relates to the planned redevelopment.

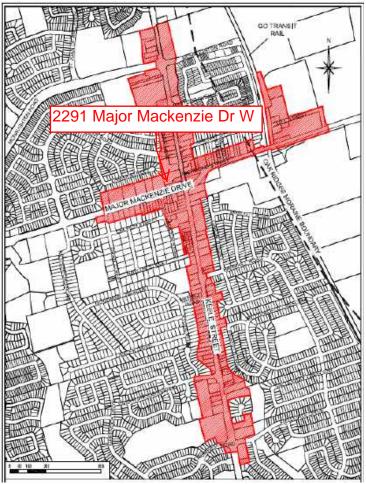
Map 3. The Boundary of the Village of Maple Heritage Conservation District. The District provides protection for the heritage resources in the old village, and controls the appearance of future development that will form their setting.

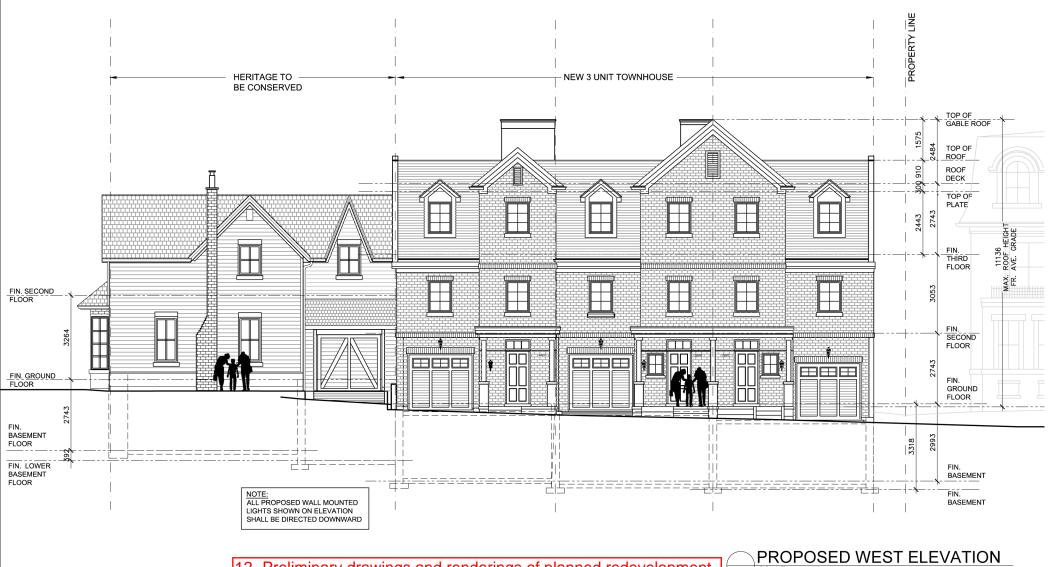
12- Preliminary drawings and renderings of planned redevelopment

PROPOSED WEST ELEVATION SCALE: 1:100

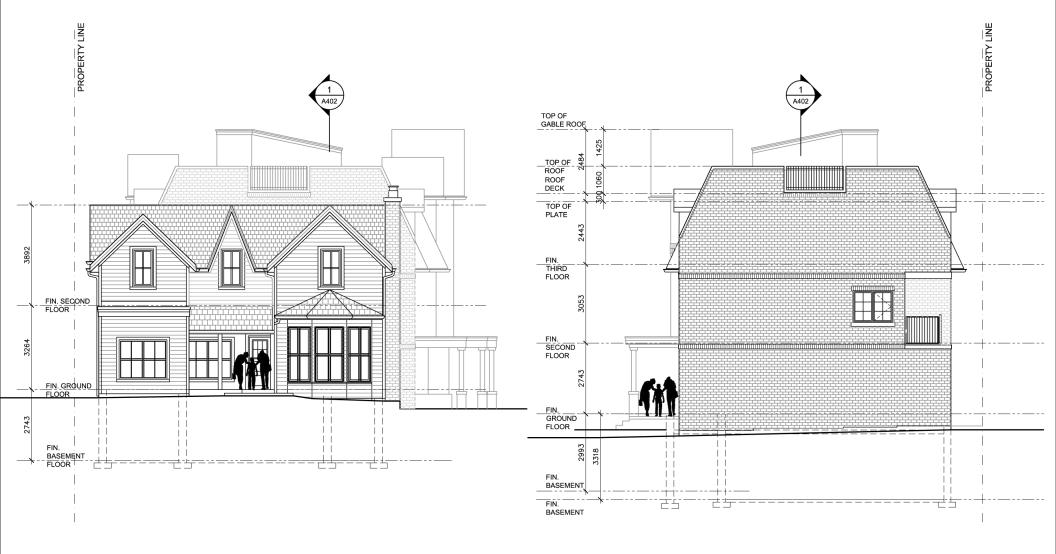
PROPOSED NORTH ELEVATION SCALE: 1:100

PROPOSED SOUTH ELEVATION SCALE: 1:100

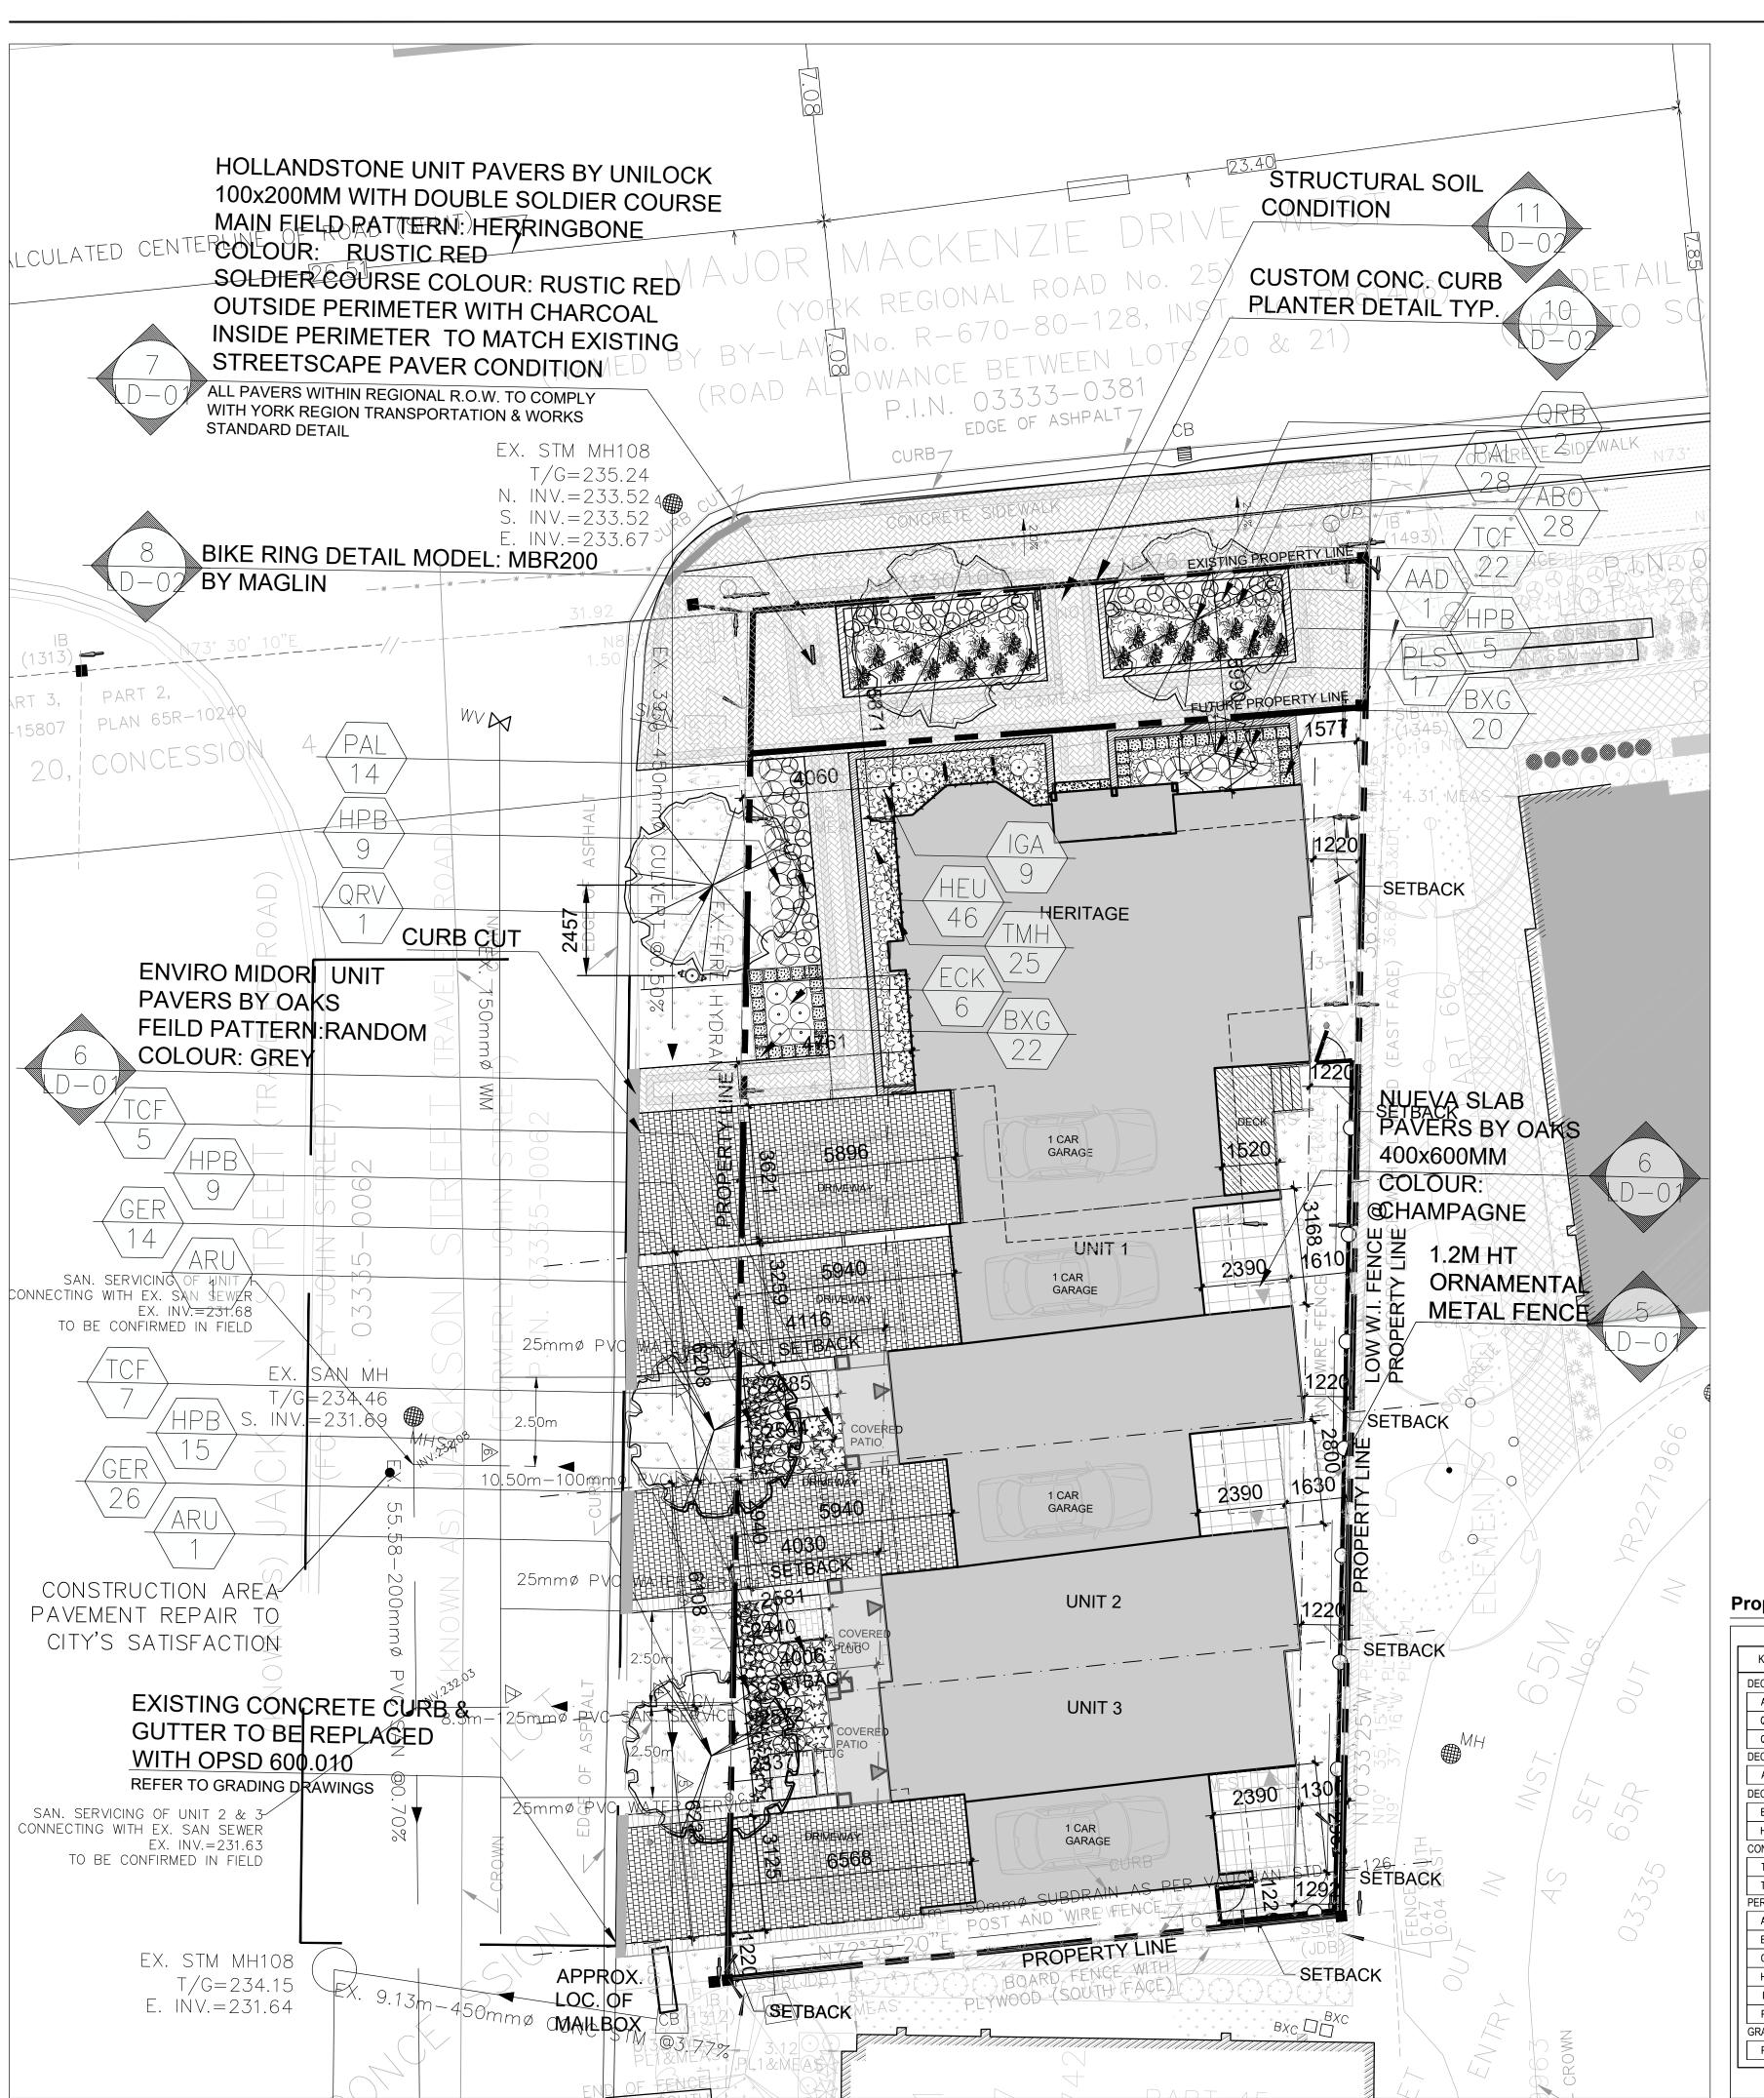
Project No. 19118 L1-01

Landscape **Master Plan**

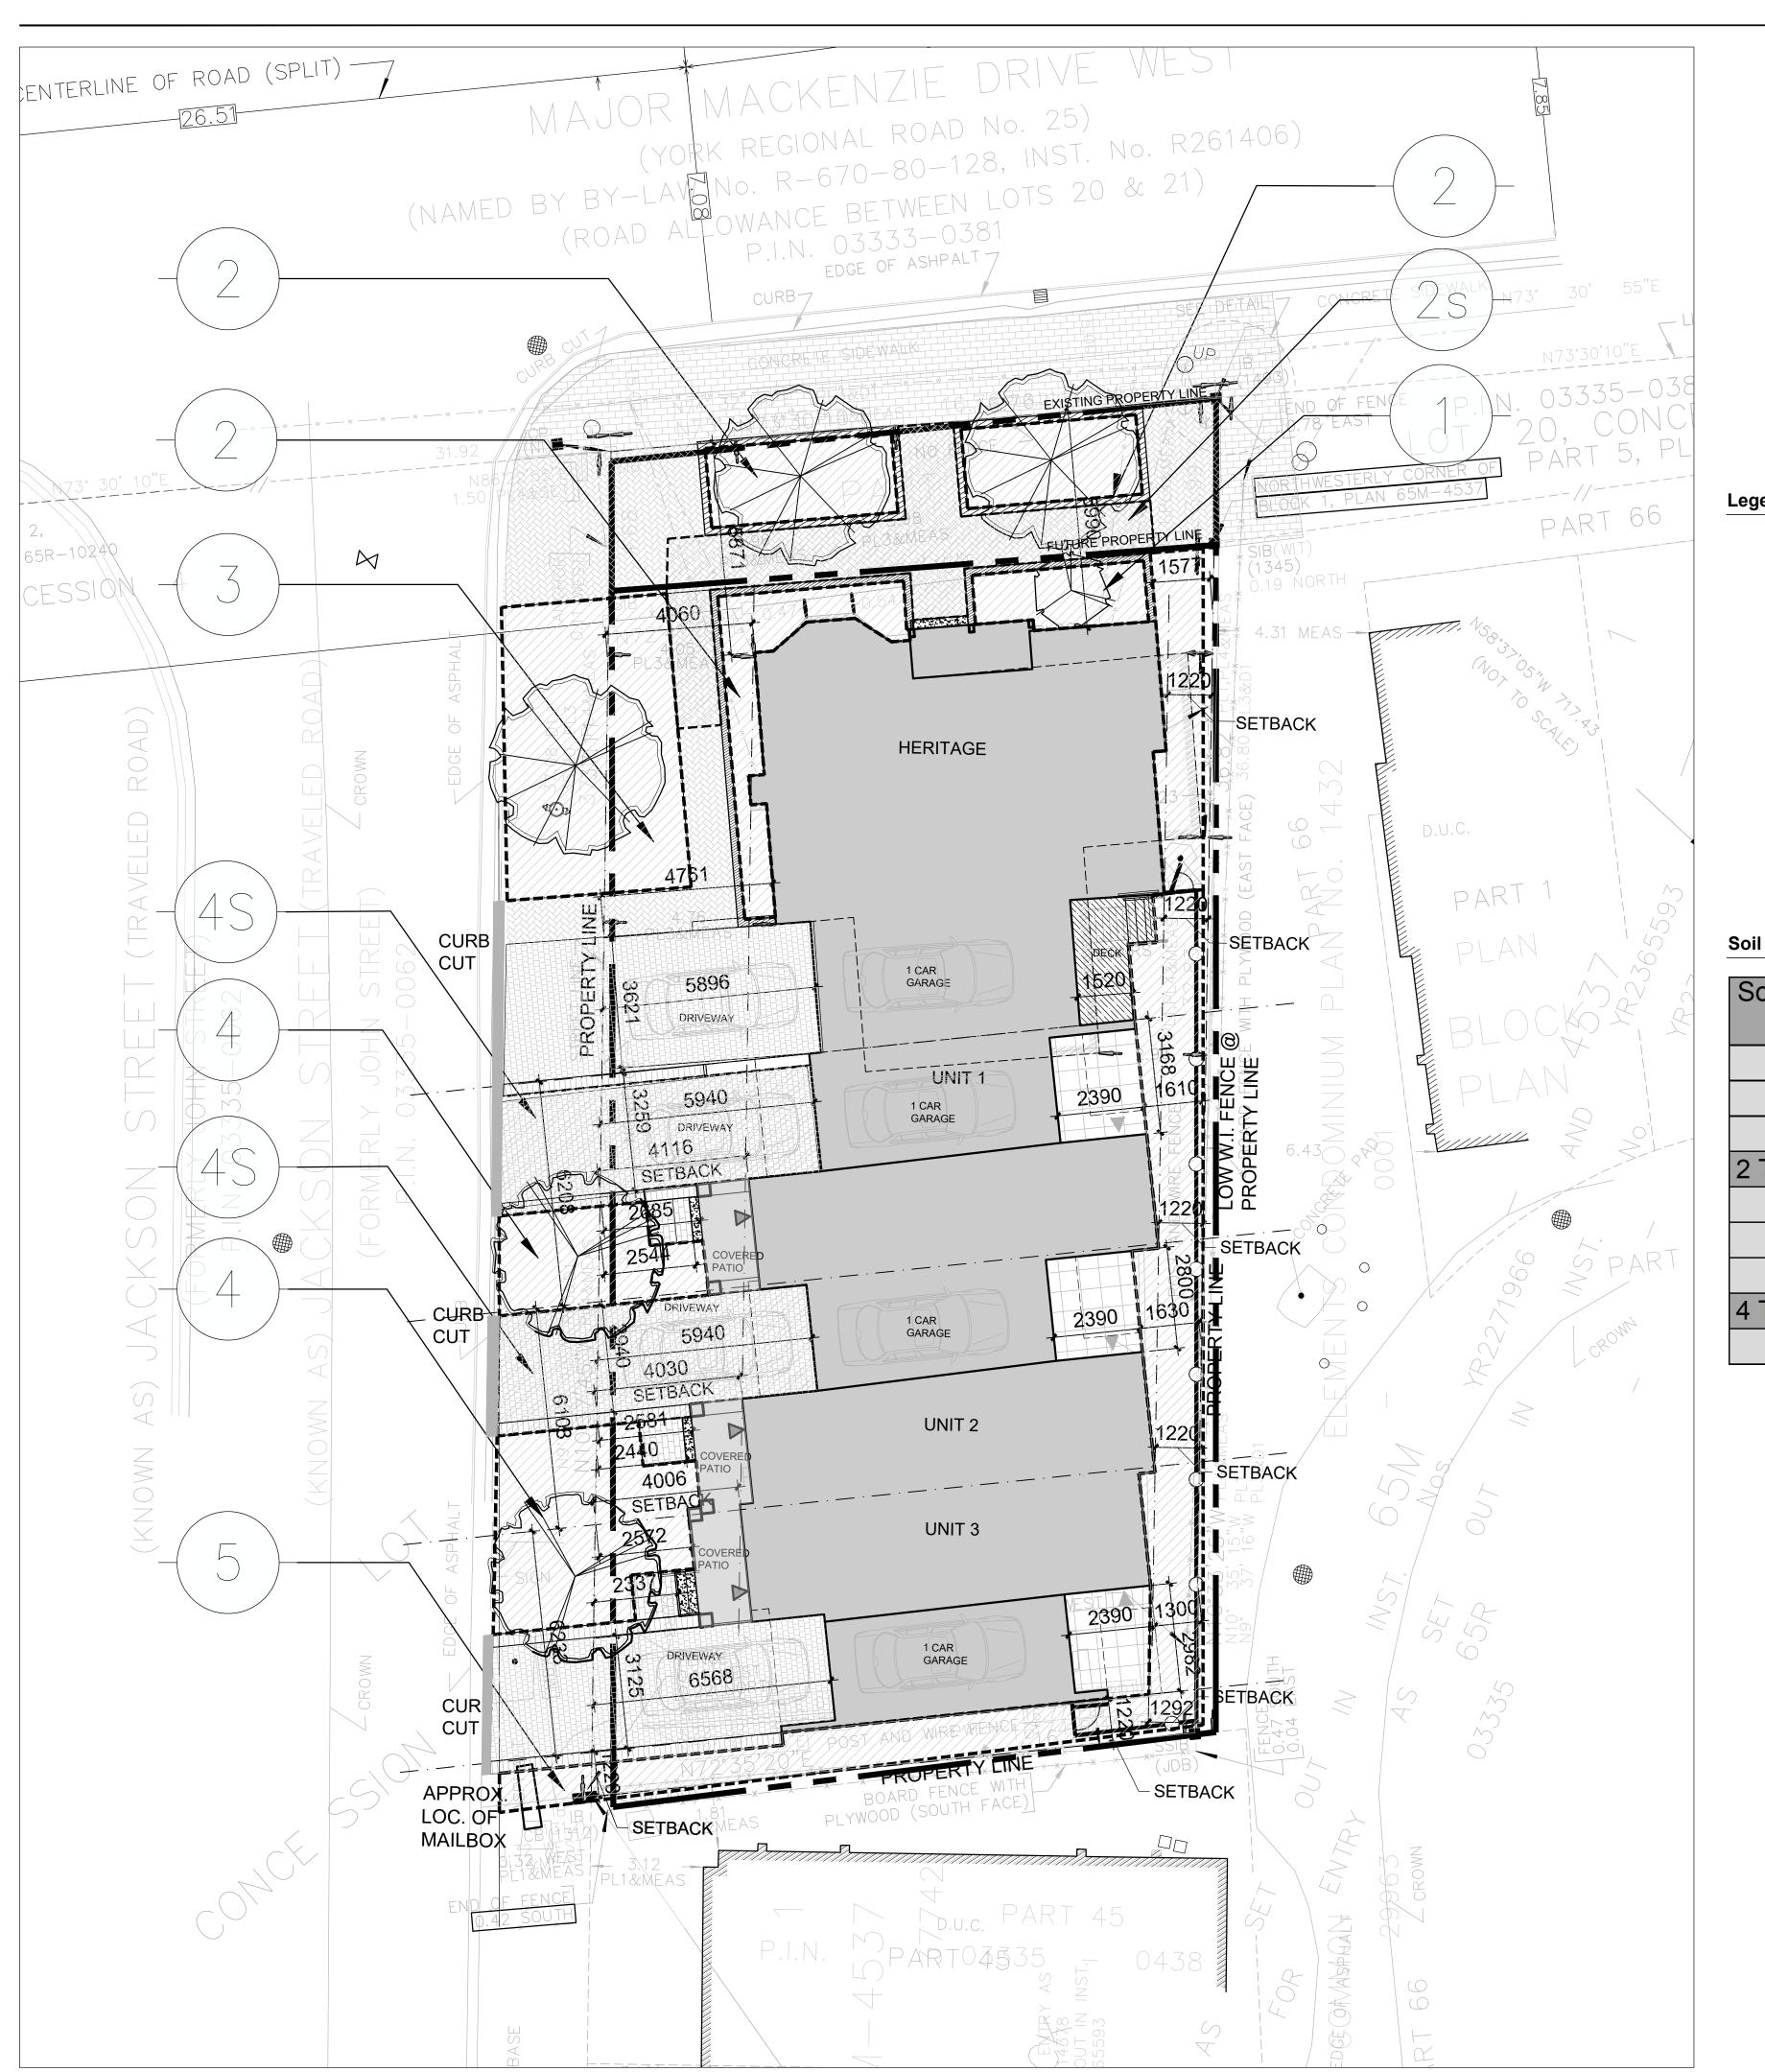
Sheet No. 19118 L1-02

Soil Volume Plan

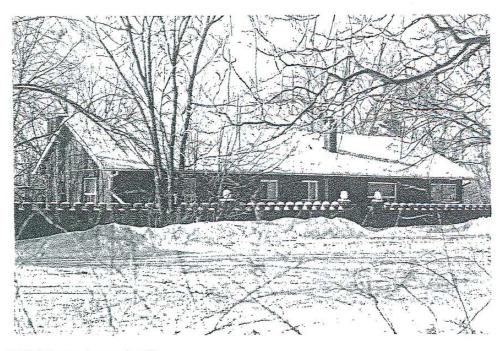
7 - undated photo and description of 10432 Islington Ave. (north portion)

10432 Islington Avenue (south)

- Ranch-style house built of textured red-brick with pitched roof and altered windows (c. 1970).
- Description Suburban bungalow is set well back from road, behind unusual, low brick wall with crenellated top and square concrete copes at raised portions. House contains varied windows, including bottom-sliders under fixed upper panes which replace larger, original, sliding sashes. Wide brick chimney projects from low-pitched gable at south end, and gable ends are clad in vertical aluminum siding. Soffits are clad in stained wooden board, and gutters and downspouts are in conventional modern aluminum profiles. Roof is clad in dark-brown asphalt shingles.

The existing south building at 10432 Islington Avenue is a one storey ranch-style house. The exterior wall finish is textured red coloured brick, with a pitched roof and replaced windows, dating from around 1970. It is set well back from Islington Avenue and has a perimeter low crenelated wall (upper and lower concrete coping sections, similar to a castle) at the parking area in front of the home. There are various window types, including bottom sliders under fixed upper panes, which replaced larger original sliding sashes. A wide brick chimney projects from a low pitched roof at the south end. Gable ends are clad in vertical aluminum siding. Soffits are clad in stained wood. Gutters and downspouts are conventional modern aluminum profiles. Asphalt shingle roof has been replaced with red tile roof to match the adjacent north building.

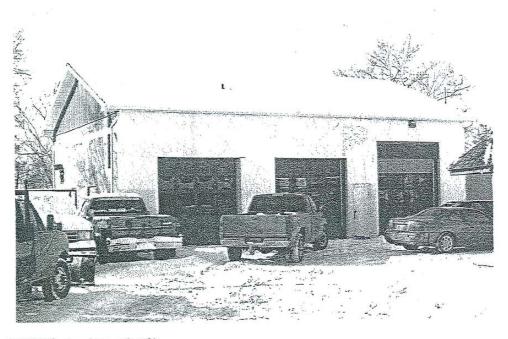
10432 Islington Avenue (north)

- Pitched-roof, triple-bay, painted brick garage (c. 1950).
- Description Large garage is set well back from Main Street, and is built of painted bricks. Pitched roof perhaps indicates some different, previous use. Roll-up, panelled doors have two glazed sections within total of four, and lintel at right-hand door has recently been raised to accommodate five-panel door. Soffits, gutters and downspouts are in conventional modern aluminum, and roof is clad in dark brown shingles.

The existing north building at 10432 Islington Avenue, then "constructed around 1950," is a pitched roof garage with three overhead doors, with a walk-out basement area to the west. It is set well back from Islington Avenue, and the exterior walls are brick which has been painted. All three original overhead doors have been replaced by new glazed aluminum overhead doors. The opening for the overhead door furthest north has been raised to accommodate a taller over head door (6 panels high). The original asphalt shingles have been replaced with textured roof tiles with aluminum soffits, gutters and downspouts. The original brick veneer finish has been covered in stucco for the exterior walls. The rear or west side of the building is two storey with two glazed overhead doors on the lower level and three aluminum windows on the upper level. There is a brick chimney located in the centre of the rear wall of the building.

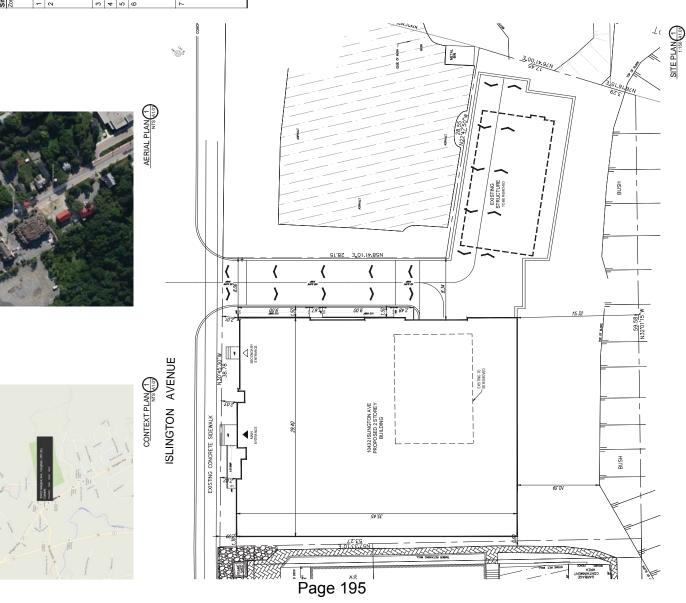
coning: mainstreet commercial (CTT)				
	Permitted	itted	Prop	Proposed
1 Min Lot Area	742.5 m ²	7992.2 ft²	2576.8 m ²	27736.4 ft²
2 Setbacks				
Front (min/max)	2.0/6.0 m		2.0/2.0 m	
Rear (min)	15.0 m		15.3 m	
Sides (min)	1.8 m		1.3/0.6 m	
3 Coverage	30.0%	773.0 m ²	40.2%	1035.0 m ²
4 Gross Floor Area	9:0	1546.1 m ²	1.0	2690.5 m ²
5 Building Height	9.5 m		9.5 m	
6 Occupancy				
Residential (15 Units)			1346.7 m ²	14495.2 ft ²
Technical School			1091.6 m ²	11750.2 ft²
Common			252.2 m²	2714.5 ft ²
7 Parking Spots				
Dwelling with Visitor/ Unit	1.75	17.5	1.5	22.0
Tecnichal School/ 100m ²	6.0	65.5	1.4	15.0
Barrier Free Parking (10-100)	1.0	1.0	1.0	1.0
Total Parking Spots		84.0		38.0

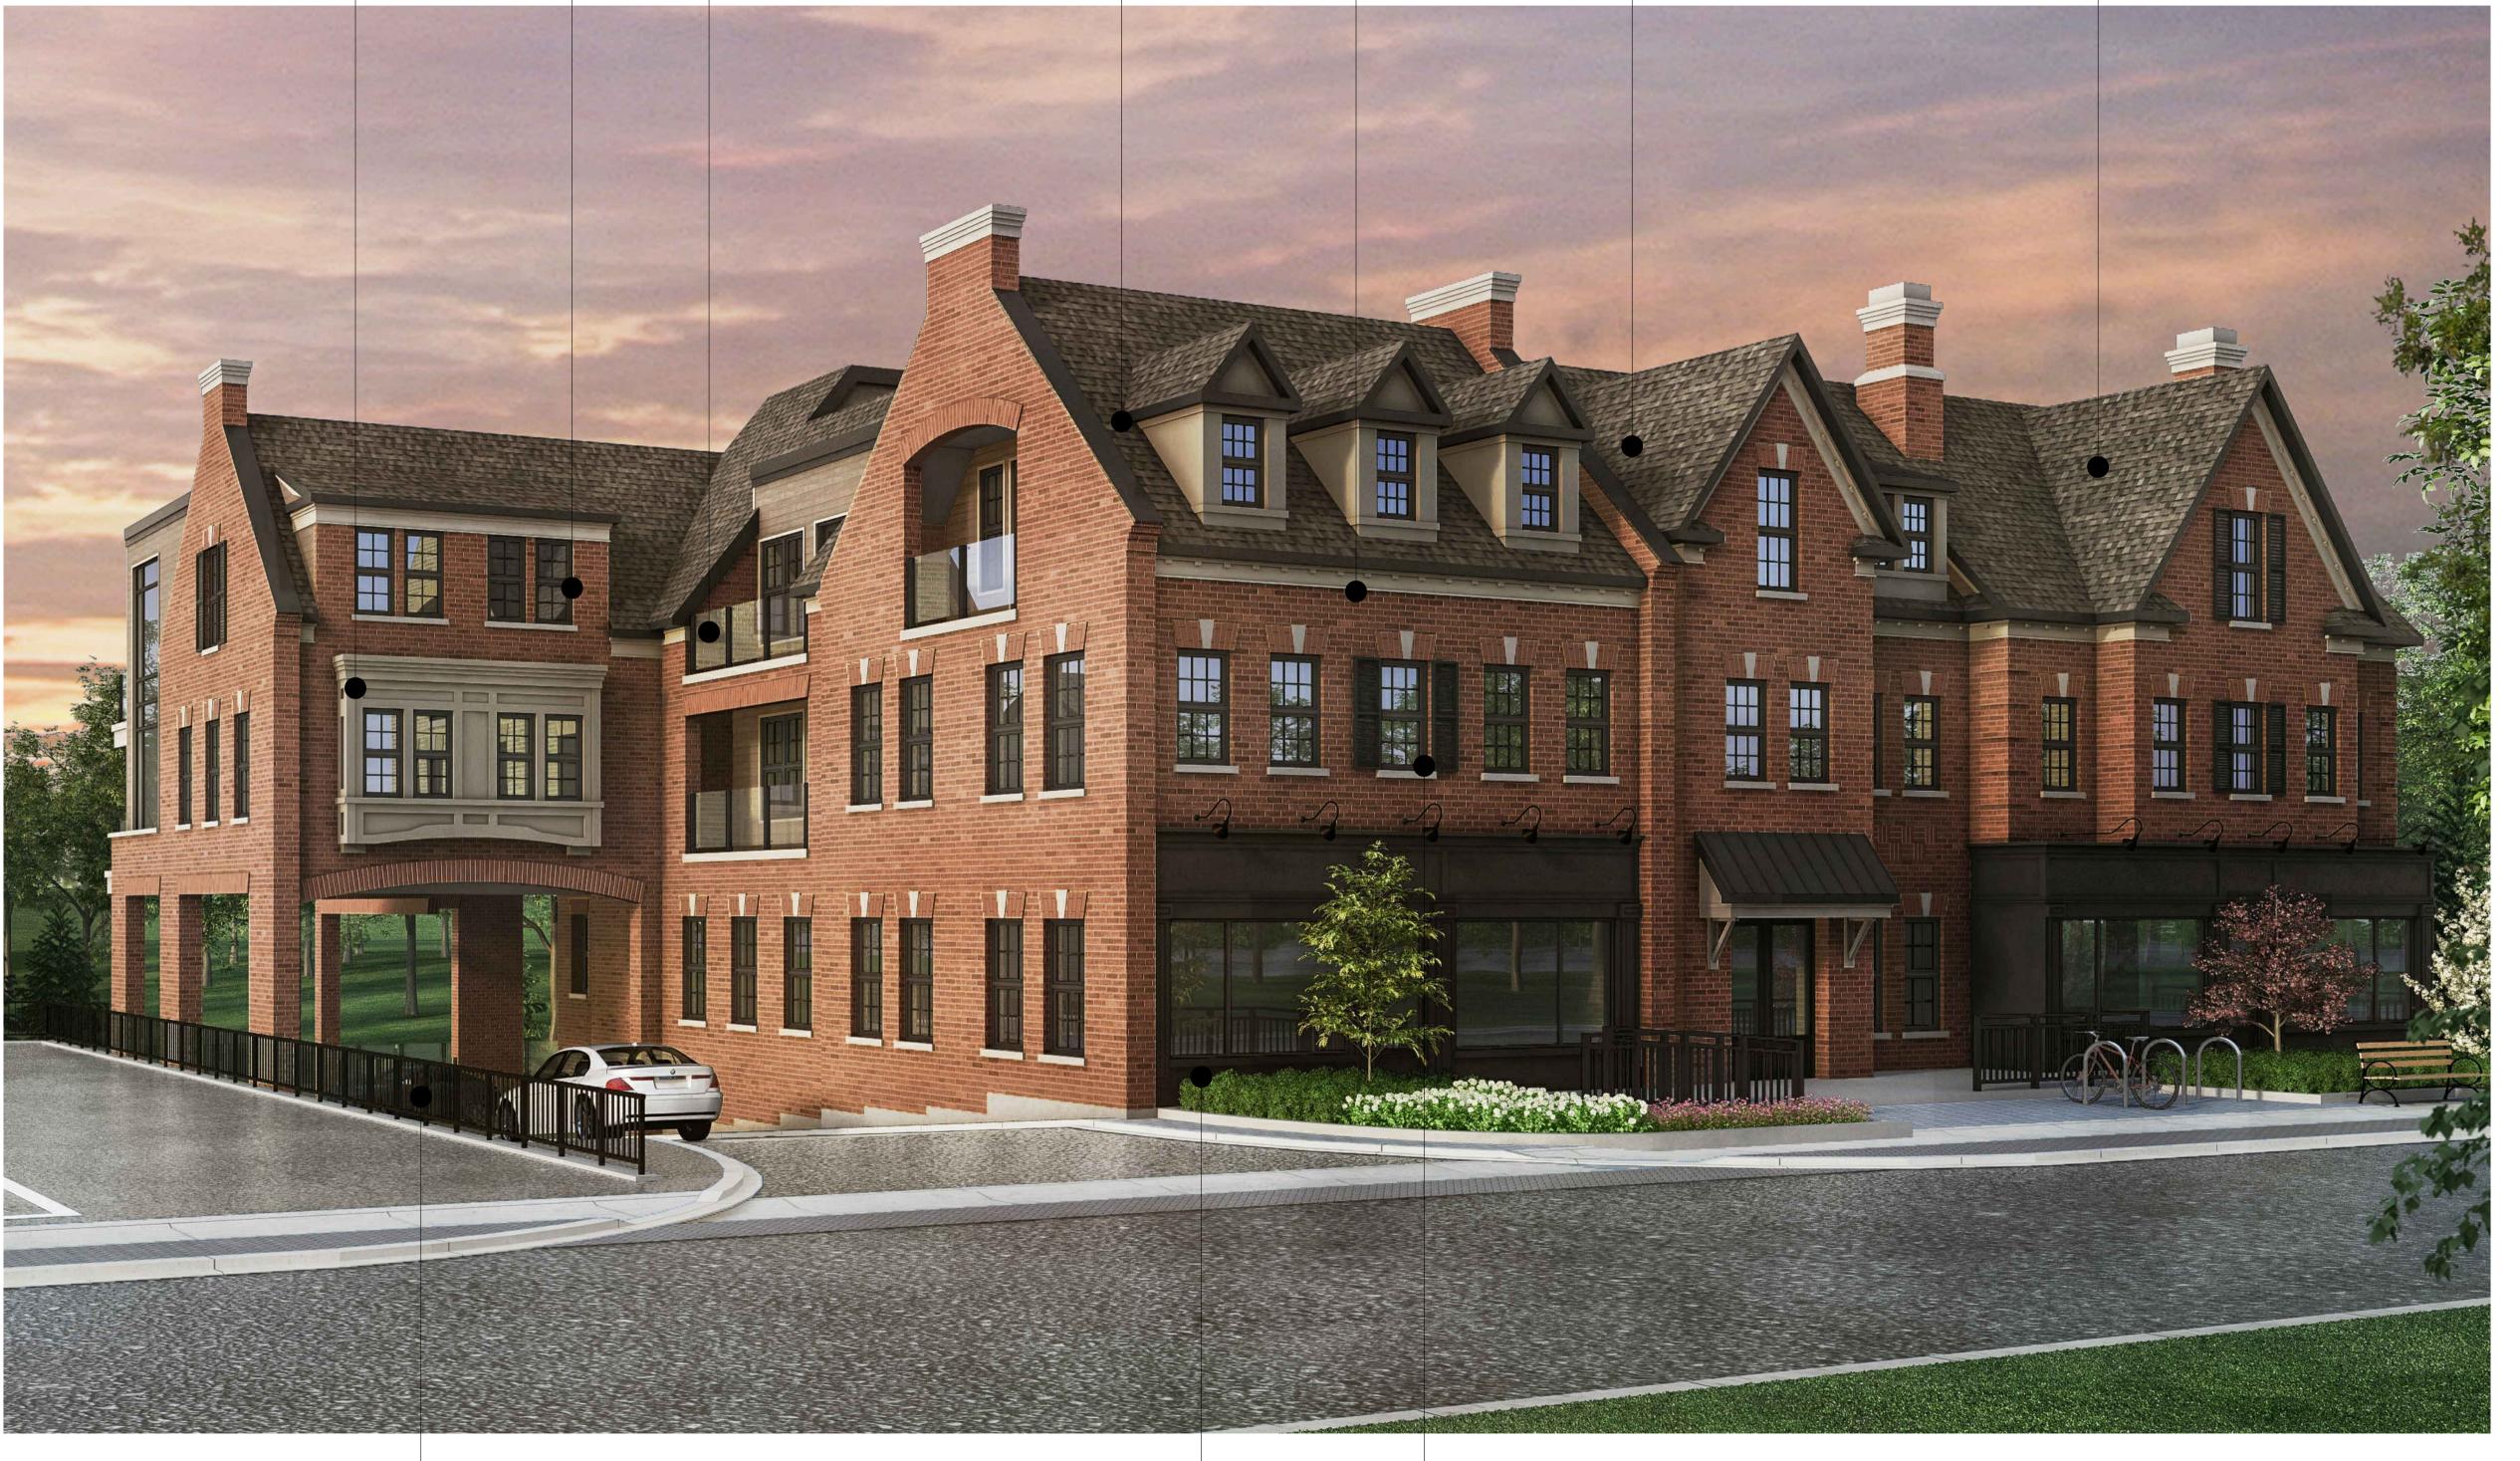
ALUMINUM CLAD. COLOUR MATCH TO SAVANNAH WICKER. OR EQUIVALENT

PRE-FINISHED FASCIA BOARD & SOFFIT. COLOUR MATCH TO SAVANNAH WICKER. OR EQUIVALENT

PRE-FINISHED METAL RAILING. BLACK COLOUR. OR EQUIVALENT

ALUMINUM WINDOWS, DOORS AND PANELING. COMMERCIAL BROWN COLOUR. OR EQUIVALENT

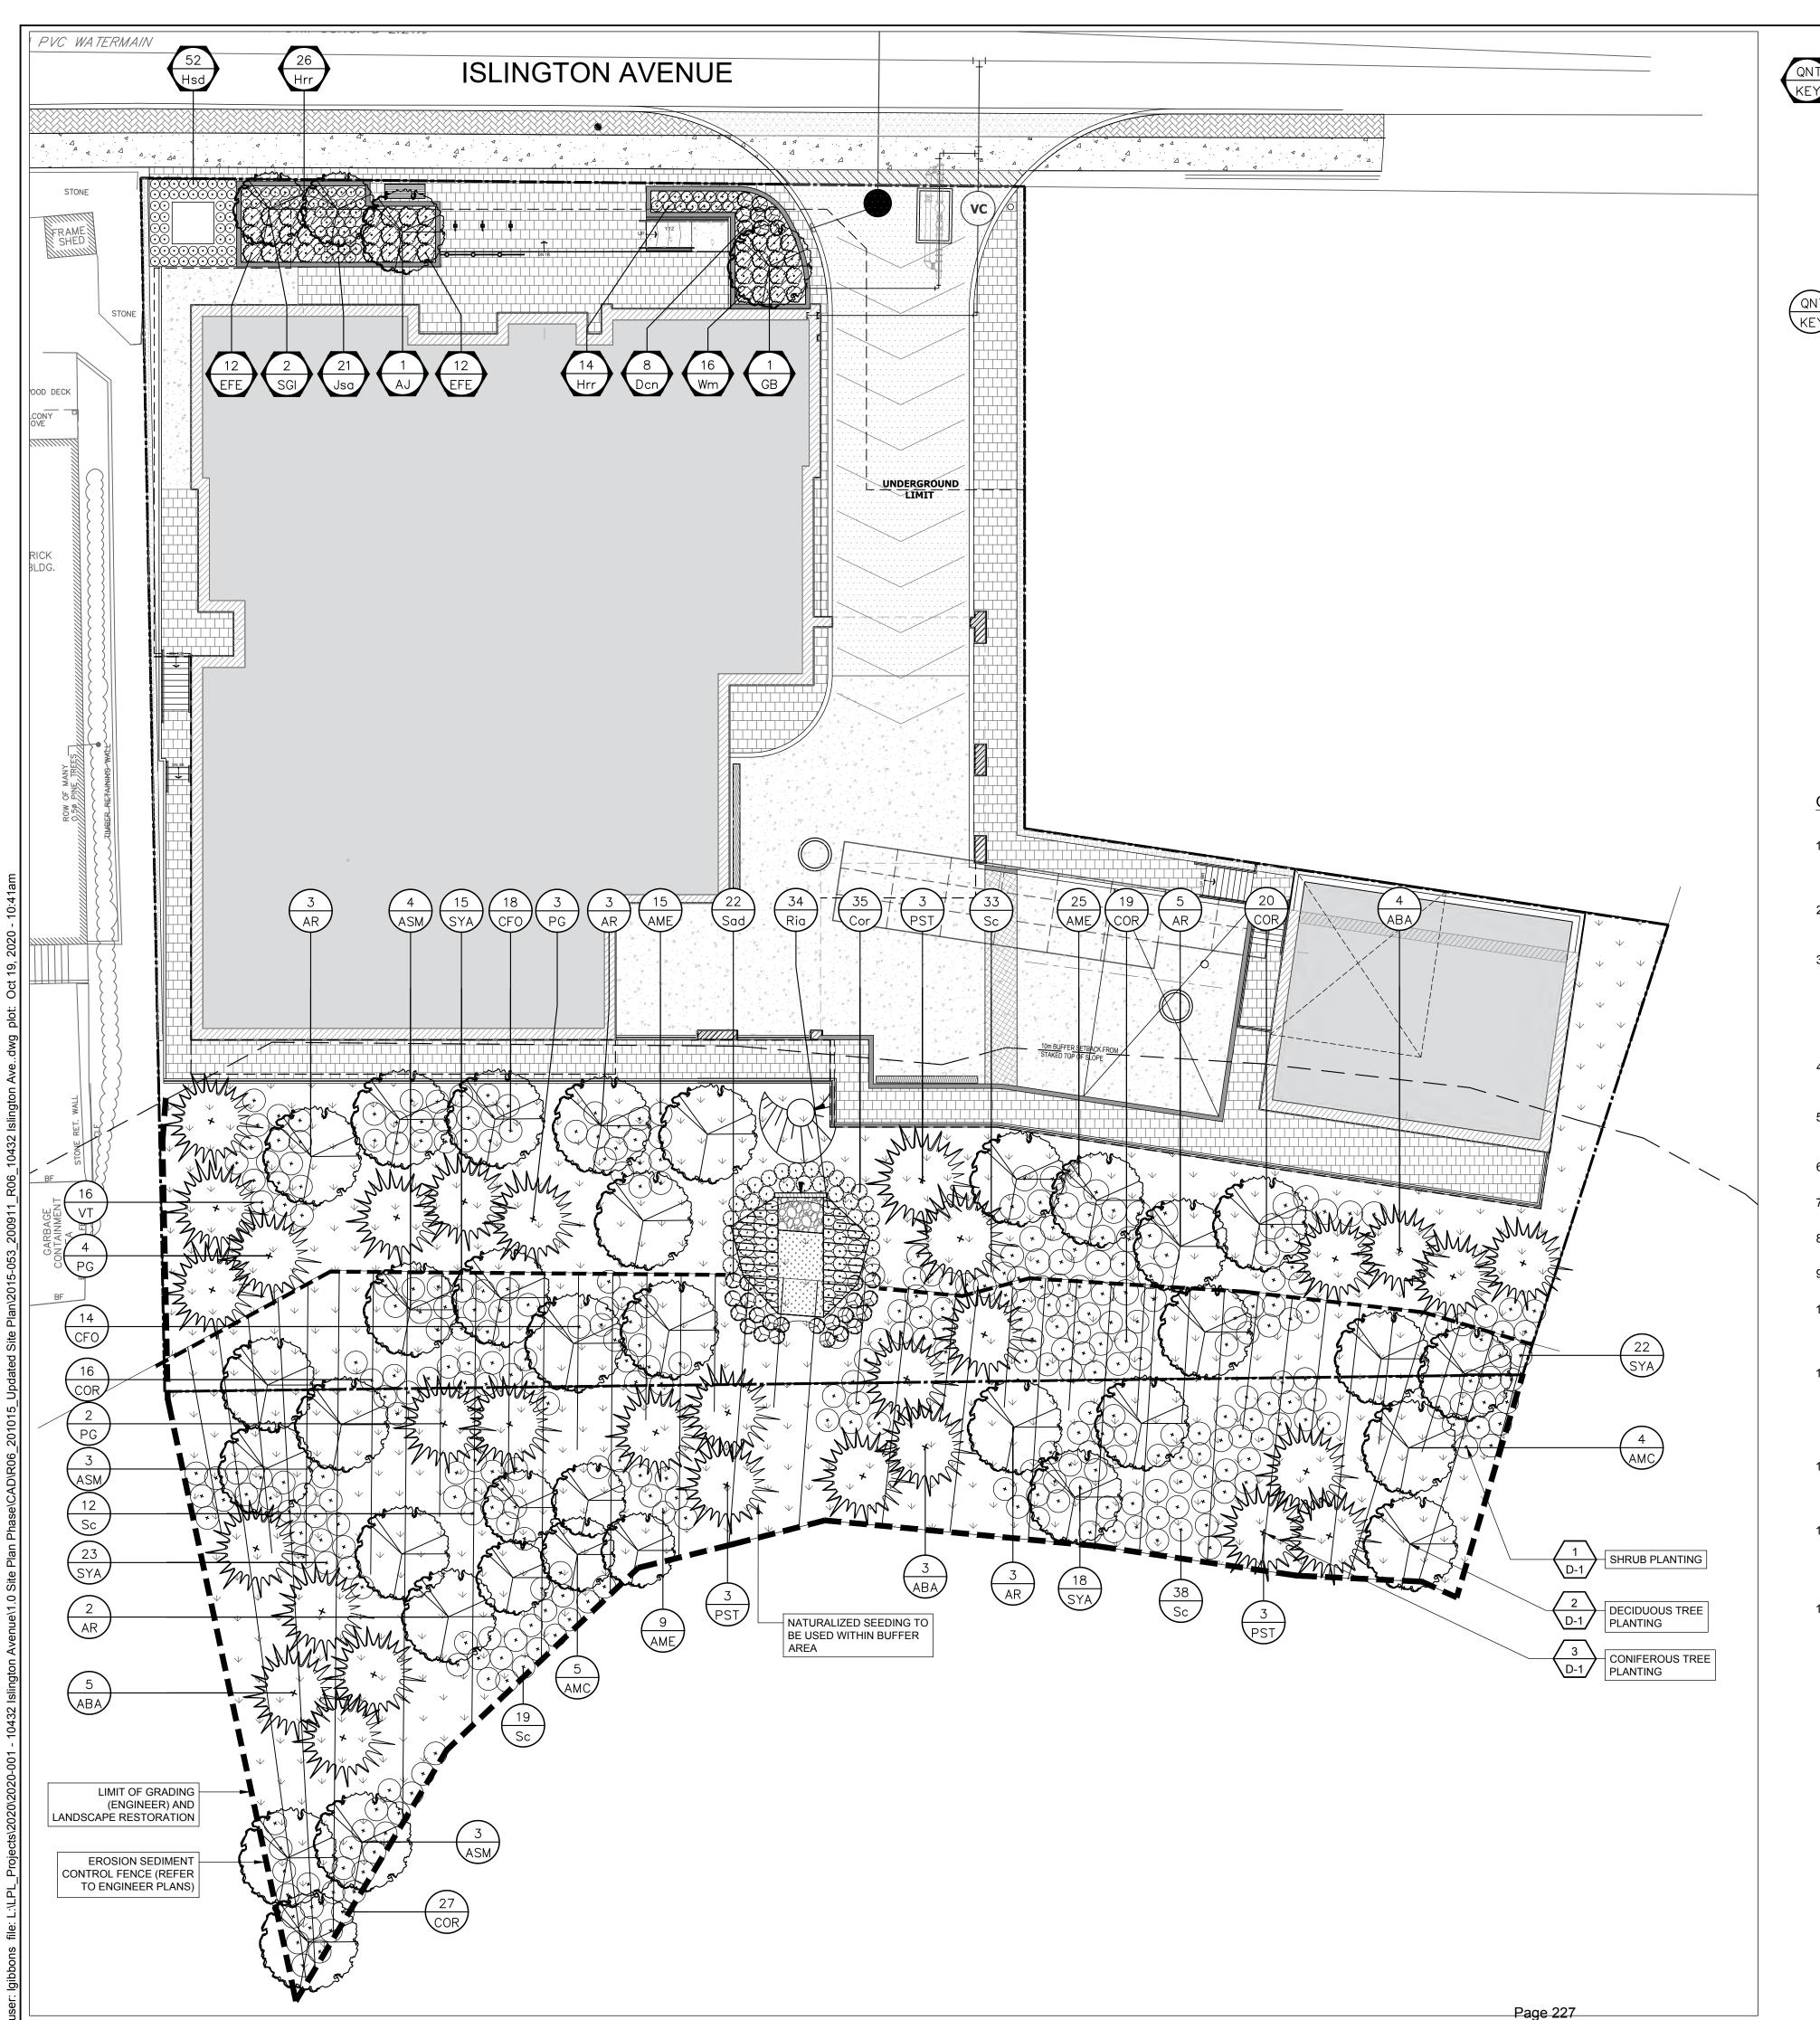
STREETSCAPE PLANTING

Count	Key	BOTANICAL NAME	COMMON NAME	CALIPER	HEIGHT	ROOT	SPREAD	NOTE
1	AJ	Acer palmatum	Japanese Maple	60mm	-	W.B.	-	-
1	GB	Gingko biloba	Maidenhair Tree	60mm	-	W.B.	-	-
2	SGI	Syringa reticula "Ivory Silk"	Ivory Silk Tree Lilac	60mm	-	W.B.	-	-
8	Dcn	Deutzia crenata "Nikko"	Dwarf Nikko Deutzia	-	50CM	3 GAL.	-	-
16	Wm	Weigela florida "Minuet"	Minuet Weigela	-	50CM	3 GAL.	-	-
24	EFE	Euonymus fortunei "Emerald Gaiety"	Emerald Gaiety Euonymus	-	60CM	3 GAL.	-	=
21	Jsa	Juniperus sabina 'Arcadia'	Arcadia Juniper	-	50CM	3 GAL.	-	=
40	Hrr	Hemerocallis "Rosy Returns"	Rosy Returns Daylily	-	-	1 GAL.	-	-
52	Hsd	Hemerocallis 'Stella D'oro'	Stella d'Oro Daylily	-	-	1 GAL.	-	-
