REVISED REPORT

Cultural Heritage Impact Assessment

Henry Burton House, 8811 Huntington Road, Lot 13, Concession 9, City of Vaughan, Regional Municipality of York, Ontario

18107463-R01-Rev0

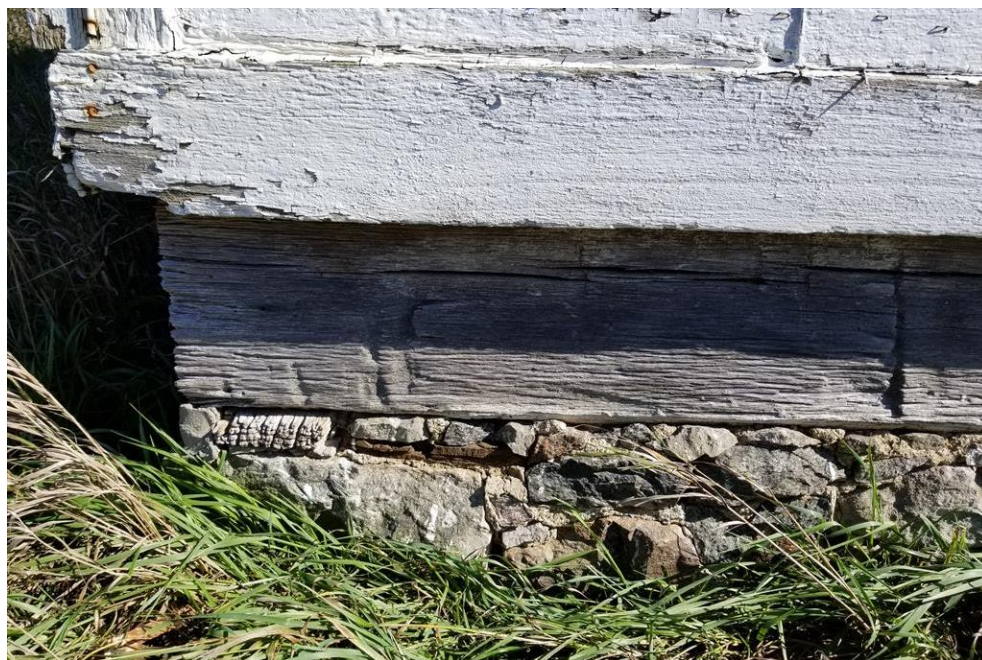
Figure 21: Coursed rubble foundation of the Main Block.

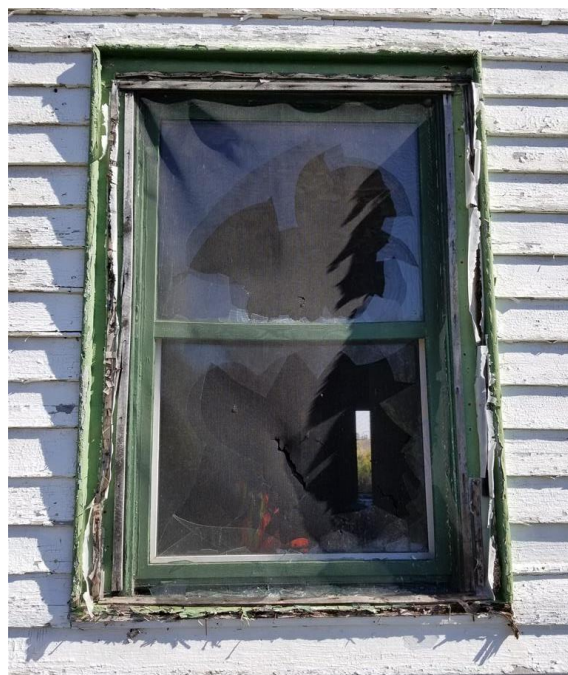
Figure 22: Typical window on the ground floor, Main Block.

Fenestration is symmetrical, with a central flat-head door with a moulded frame flanked by two tall, one-over-one flat head single-hung windows with a plain exterior wood frame and no sill, on the principal southwest façade with plain wood exterior frames (Figure 22). The door is undecorated with a plain exterior frame. Second storey windows on the main façade are wide single-pane with plain wood frames and no sills, which are symmetrical with ground-floor windows. Visible in the basement foundation are several additional wide two-pane, small wood-frame flat-head windows with no sills and plain exterior trim.

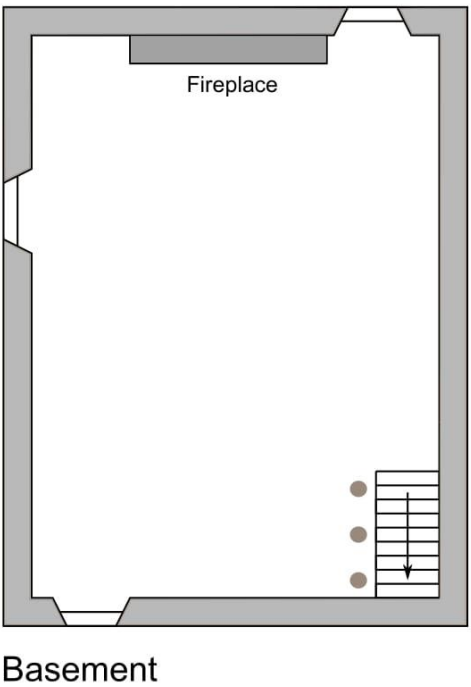
Figure 23: 8811 Huntington Road floorplan (not to scale)

On the ground floor, there are three major room divisions as well as one staircase. Two of room divisions appear to have been used as bedrooms, and one as a bathroom (Figure 23). Upon entering the central doorway, a hallway extends through the centre of the residence, with one doorway on the north side of the hallway, and three on the south side (Figure 24). Walls are likely lath and plaster and covered in cream wallpaper with a floral border at the top. The paint shows evidence of extended water damage. A tall baseboard runs the length of the hallway, and the wood floor has been covered by a low-pile carpet. The west door on the south side of the hallway, the first door encountered upon entering the house, has a wide flat-head, wood-frame transom above it (Figure 25). Only one window is present within the room, surrounded by a moulded wood frame but no other decoration. The floor is covered by a warped laminate which overlays older flooring below, as is evidenced by the lack of alignment with the baseboards. This room, as well as the hallway, has seen extensive damage from moisture and other pests, with paint and wallpaper peeling away from the walls and ceiling (Figure 26). Doorframes on the ground floor of the main block indicate that the walls are thin, and likely of wood-frame construction.

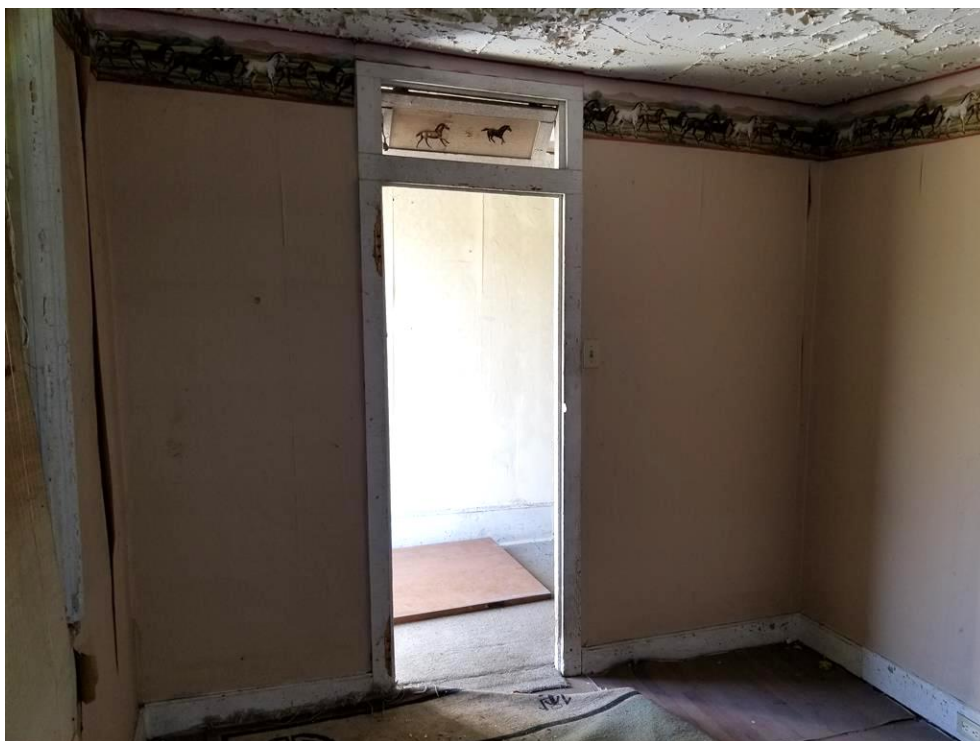
Figure 25: Interior transom above southwest room, ground floor.

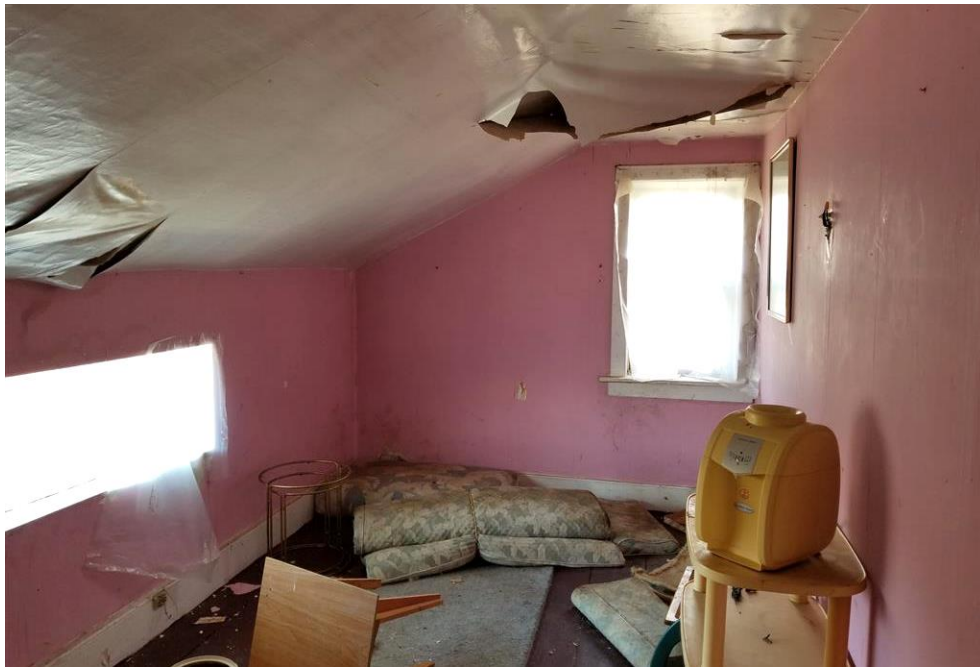
Figure 36: Northwest bedroom, second storey.

The second storey of the Main Block is separated into three rooms. At the top of the staircase (Figure 34), bordered by a white-painted wood balustrade, is a room with two windows that comprise the south half of the upper level (Figure 35). In the corner of the staircase is a small rectangular protrusion from the wall, which corresponds to the exterior chimney in the east corner of the roof. A wall running through the middle of the space sections off two identically sized bedrooms, each with a window at the north wall. All three rooms are brightly coloured with moderately sized baseboards and narrow plain doorframes (Figure 36). Floorboards on the second storey are very wide hardwood planks that likely date to the original construction of the residence (Figure 37).

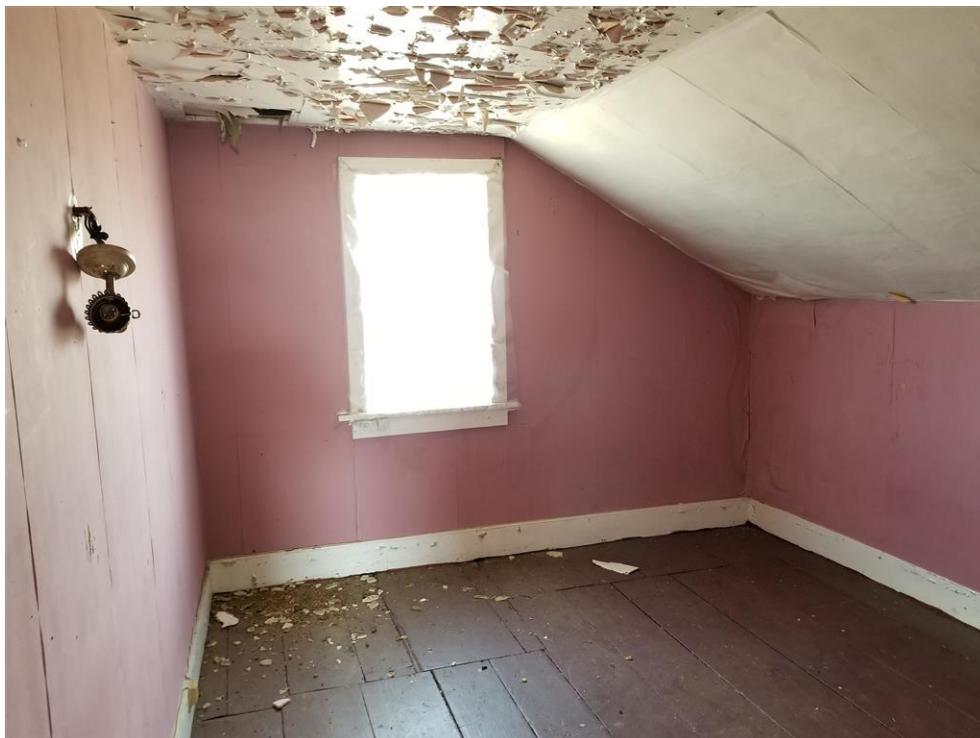
Figure 37: Northeast bedroom, second storey. Note the wide baseboards.

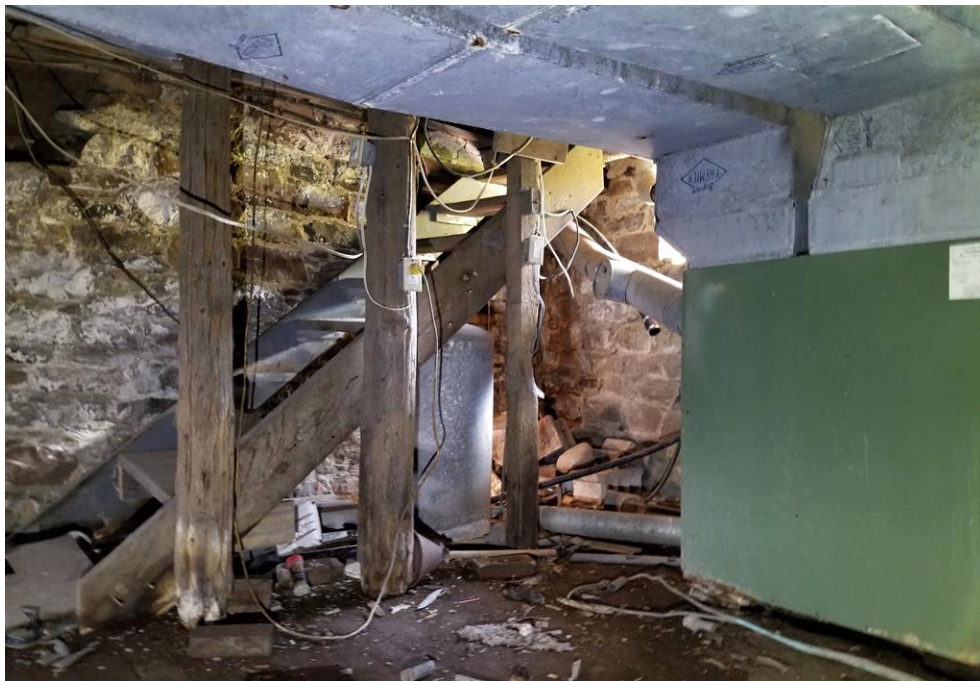
Figure 38: Stairs in the southeast corner of the basement, with three support posts.

The basement is located beneath the Main Block of the residence and consists of a single full-height room with coursed stone rubble walls. A simple wood staircase leads downstairs from the exterior southeast corner, and three tree trunks are braced alongside the stairs, creating support for the floor above (Figure 38). An interesting feature of the basement is its brick floor, which spans the entire room (Figure 39). There are three wide single-pane, flat-head windows set into the stone walls, one on the north wall, one west, and one facing south, although the west window was filled in with stone rubble. At the north end of the basement, a large stone fireplace with a wood lintel is built into the foundation and would have extended into the ground and second storey at one point (Figure 40).

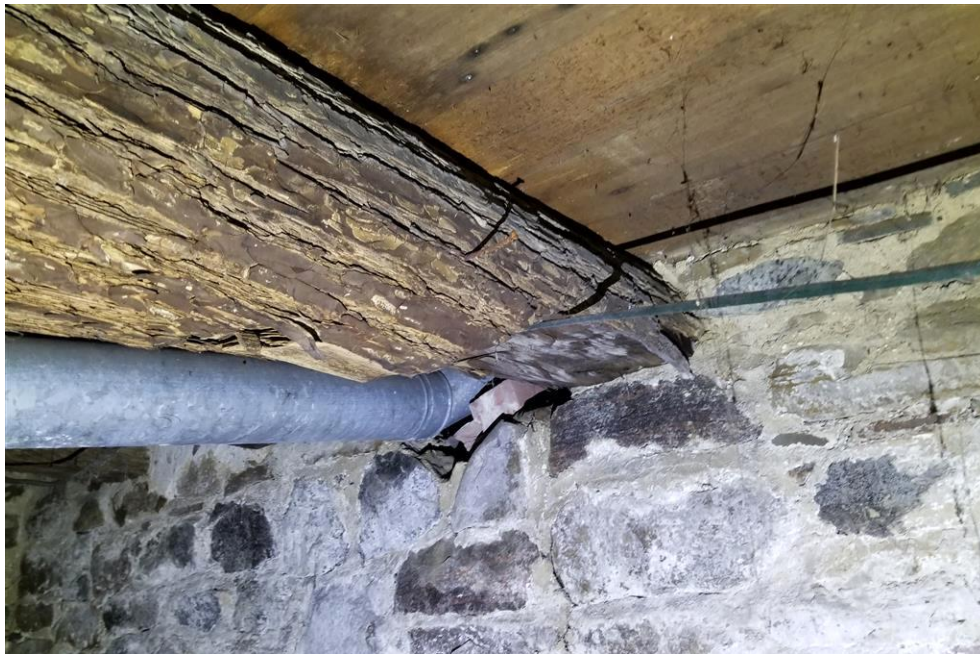
Figure 41: Example of overhead sleeper.

Resting on top of the stone foundation are a series of lateral beams running east-west, unsupported in the centre of the room save for the tree trunks. The beams are also made primarily from unshaped logs, known as sleepers, both with and without the bark removed, which have been cut to a square or flat-bottomed at either end to sit in the wall (Figure 41). At the east end of the room, a small crawl-space is visible extending east beneath the East Wing and South Addition (Figure 42). Adze marks are evident on a visible beam within the crawlspace in the East Wing, and machine lumber is present beneath the South Addition (Figure 43).

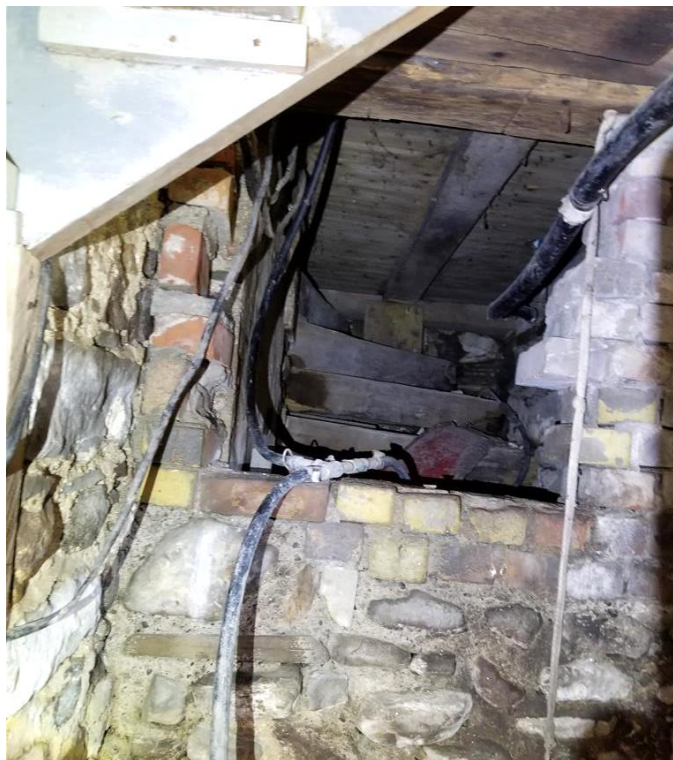
Figure 42: Crawlspace in east wall of basement. Crawlspace is below the East Wing.

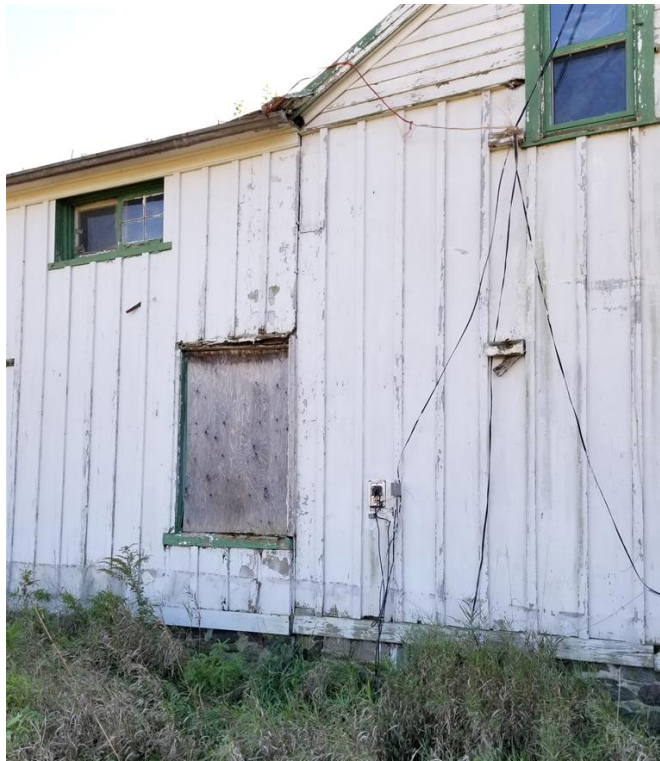
Figure 48: Visible join between East Wing and Main Block. Note the small horizontal sliding window.

Sitting on a coursed rubble foundation similar to that of the Main Block, there is a visible joint between the two structures (Figure 48 and Figure 49). Only the north and east walls of the structure are visible from the exterior, due to its connections to the Main Block to the west and the South Addition to the south.

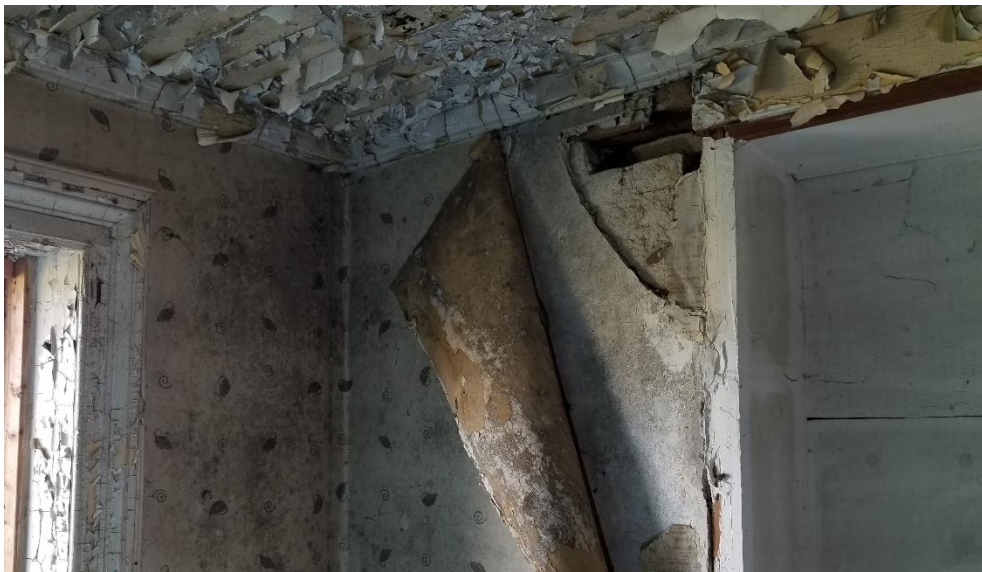
Figure 52: Bricks visible behind wallpaper and plaster, southeast corner of the ground floor room.

The East Wing can be entered from the exterior door on the east façade, or through the adjoining Main Block door on the west interior wall. The ground floor itself has only one, large room, and it was likely added as an extension for kitchen space to the structure (Figure 50 and Figure 51). While the exterior walls of the Wing are clad in wood, exposed brick around a blind window on the south interior wall suggest that the interior or exterior may have been previously clad in brick (Figure 52).

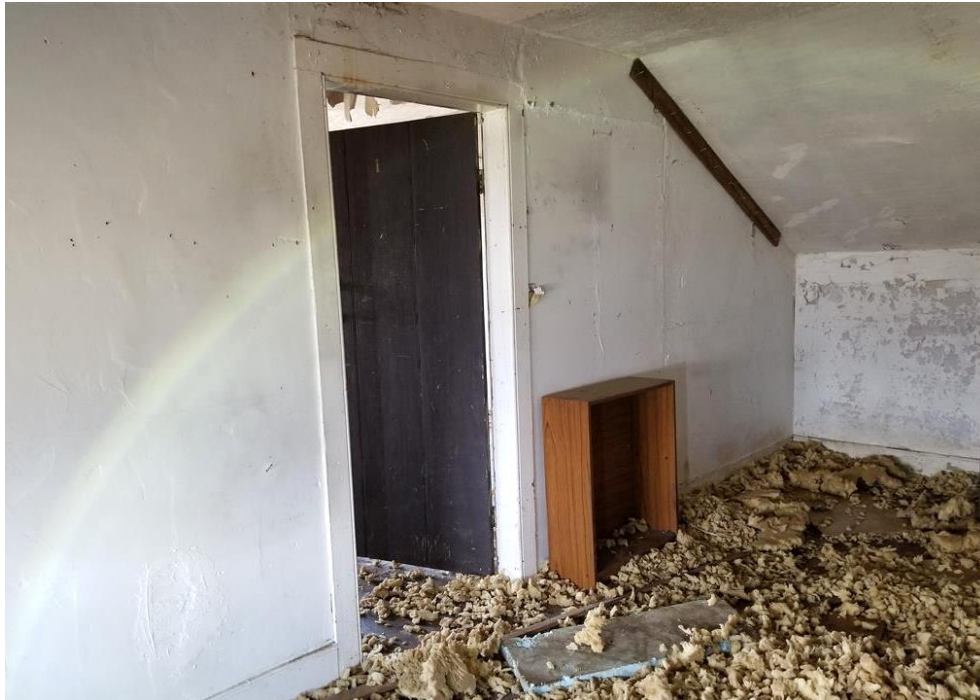
Figure 59: Blind door on the central wall.

At the top of the north staircase (Figure 54), the East Wing's second storey does not connect to that of the Main Block. This level is divided into two rooms, an east and a west, that comprise the entire floor. Directly adjacent to the staircase on the east wall is a large brick chimney with a stove flashing near the roof, which has been covered over in stones and cement, but has since been decommissioned (Figure 55). Brick is visible beneath the plaster on the exterior walls as well, confirming the brick construction of the Wing (Figure 56). Both rooms are floored with wide-plank hardwood, have plain plaster walls with hand-split lath, and sloped ceilings (Figure 57 and Figure 58). A blind door in the east wall of the west room suggests that the central doorway was either relocated, or the west room used to be two rooms, mirroring the second storey of the Main Block (Figure 59).

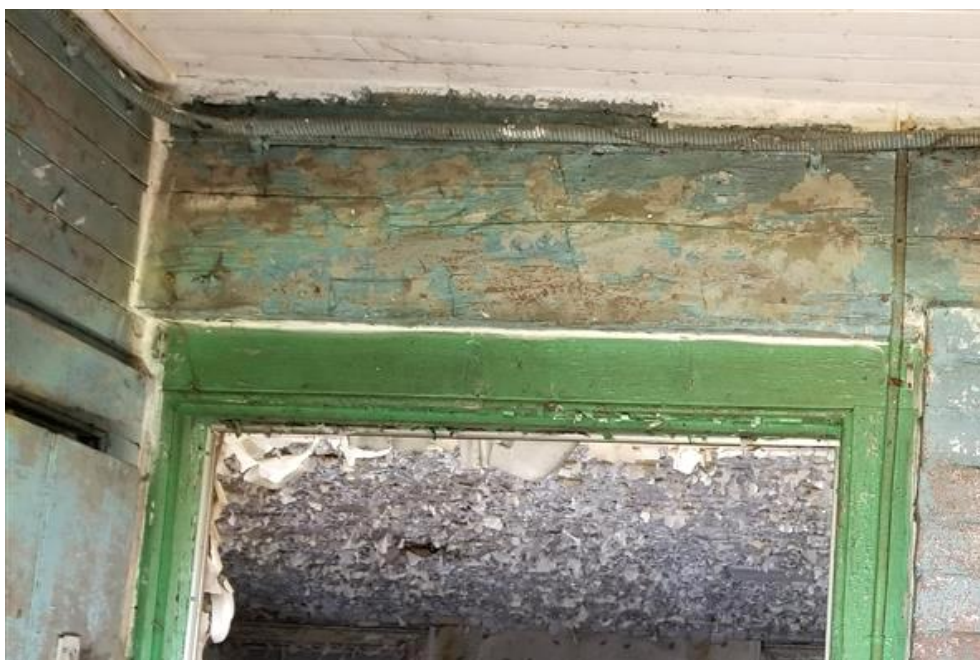
Figure 65: Adze marks on wood lintel above the door to the South Addition.

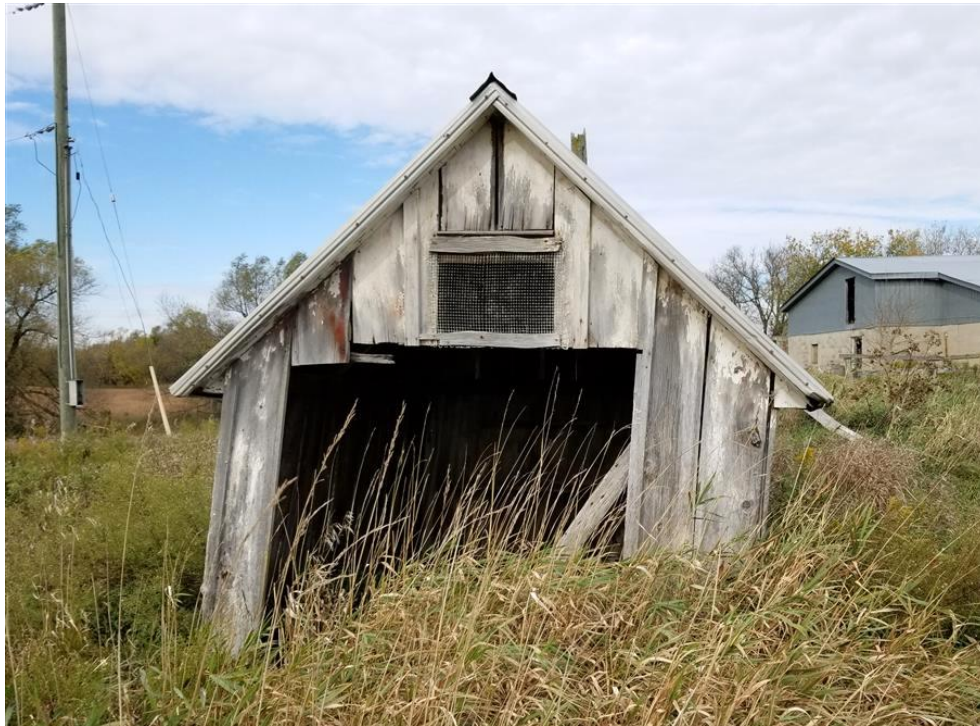
Figure 69: South façade of Northeast outbuilding.

Northeast of the residence is an additional small outbuilding with vertical board and batten siding and a medium gable roof (Figure 69). The doorway is nearly as wide as the south façade of the structure with a metal mesh opening in the centre of the gable. The structure is leaning to the east.

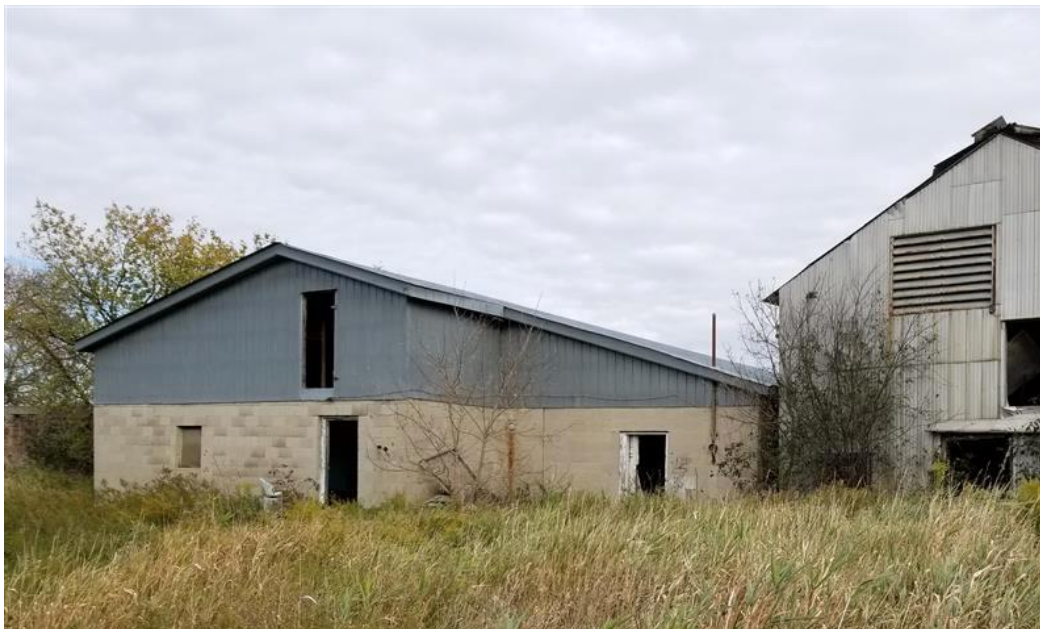
Figure 73: West façade of the North Barn.

Adjacent to the south barn is the two-storey, three-bay, low gable roof structure with a central portion and a north and south wing (Figure 73 and Figure 74). The ground floor walls are made from concrete masonry units (CMUs), with a door on the west façade of each portion of the structure. The second storey is only at full height in the central portion of the structure, and is covered by vertical board and batten siding, and is painted blue. The barn is directly south of the stone foundation of the old barn, which still stands (Figure 75).

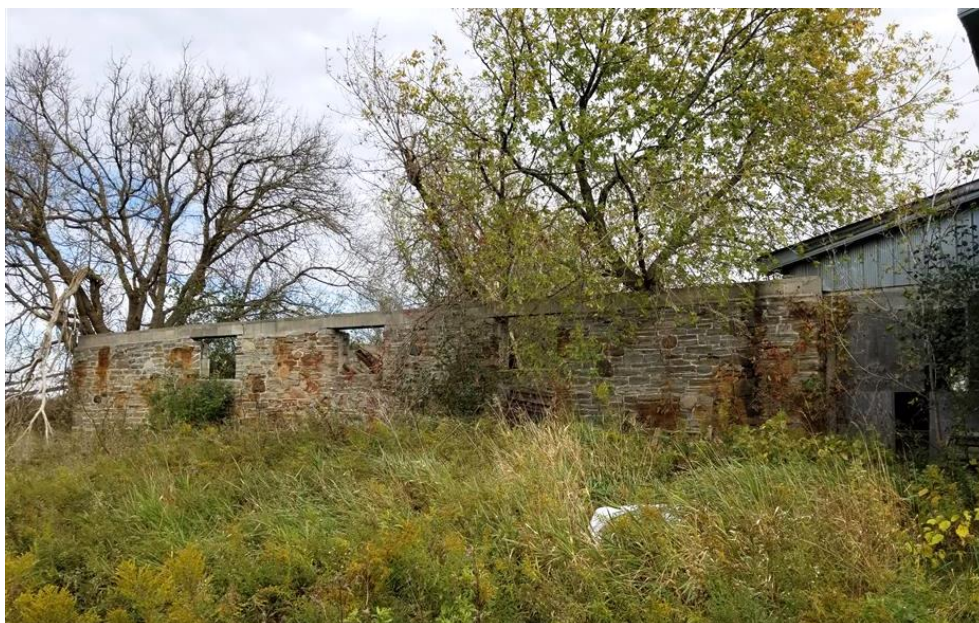
Figure 76: West façade.

North of the outbuildings is the foundation of the 'Old Barn', made from coursed rubble with a three-bay west façade (Figure 76). This structure is all that is left of the barn which was originally associated with Henry Burton House, prior to its collapse. Significant areas of iron staining are visible on the exterior walls, and no evidence of the upper frame construction remain intact.

All that remains of the Old Barn today is the stone foundation, which reportedly burned down in the 1960s and was completely gone save for the stone foundation by 1978, according to aerial photos provided by the York Region interactive maps.

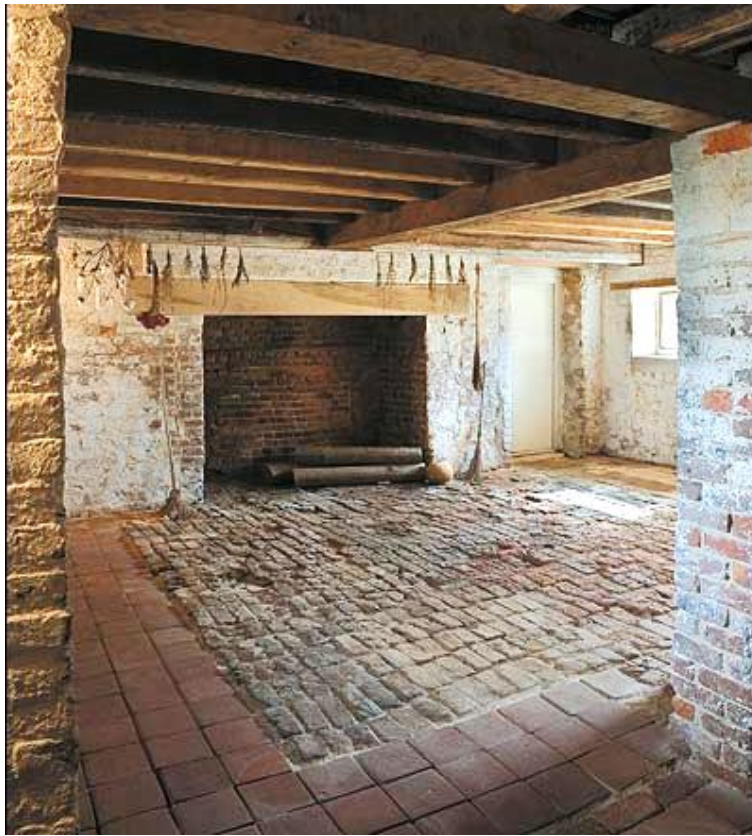
Figure 77: Image from the basement of the 17th-century ‘Bacon’s Castle’ in Surry County, Virginia (Colonial Williamsburg 2018).

A further clue to the date of the structure lies in its basement, with a former winter kitchen fireplace on the north wall of the foundation. The great stone fireplace is built into the basement wall with a timber lintel and a brick hearth extending out across the basement floor. Brick is resistant to heat, therefore making the sensible choice for the flooring in a winter kitchen. Such a space would have been used to cook food during the winter months away from the wood construction of the upper levels of the structure, as well as help heat the entire house by means of the large fireplace. Examples can be seen in Virginia dating to the 17th century (Figure 77), and were employed for decades, but aren’t common in Ontario beyond the mid-1800s. Another example can be seen at the John Fleming House to the north of Henry Burton House at 9151 Huntington Road, which dates to the mid-1800s and also has a large stone fireplace in the basement of its Georgian house.
