**CITY OF VAUGHAN  
HERITAGE VAUGHAN COMMITTEE  
AGENDA**

**Wednesday, January 15, 2020**

**TITLE: DE-LISTING APPLICATION FOR PROPERTY AT 7141 HWY.50,  
VICINITY OF HWY.50 AND HWY.407**

"Nathaniel Clark Wallace House"  
249 Clarence Street,  
Woodbridge, Vaughan, ON

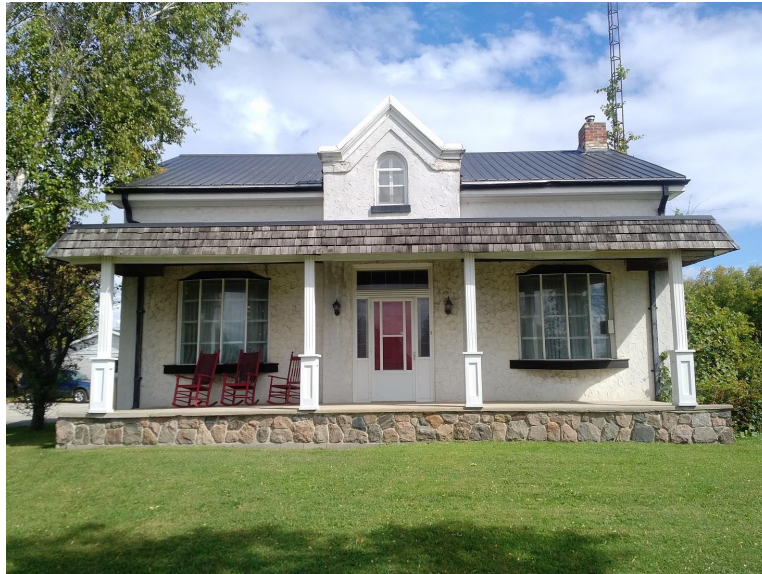
3.1.5.1.A – Existing West (Front) Elevation

The home was fully renovated in 1967-8 when the second generation of the family moved into the home. The front windows were replaced with bow windows; The rear porch was enclosed; a new kitchen was built internally; a fireplace was added in the rear addition; a front porch was (re)built in a non-original neo-classical style with wood shingles; The central dormer was rebuilt in a non-original neo-classical style; a metal roof was installed; the entire home was stuccoed,

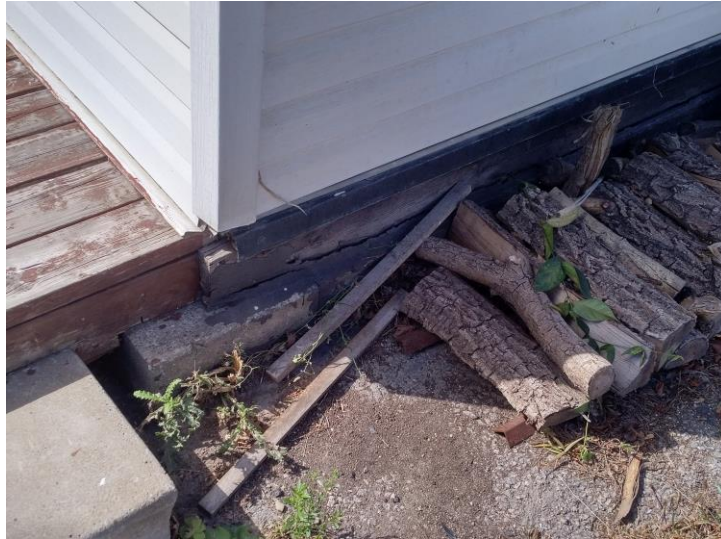
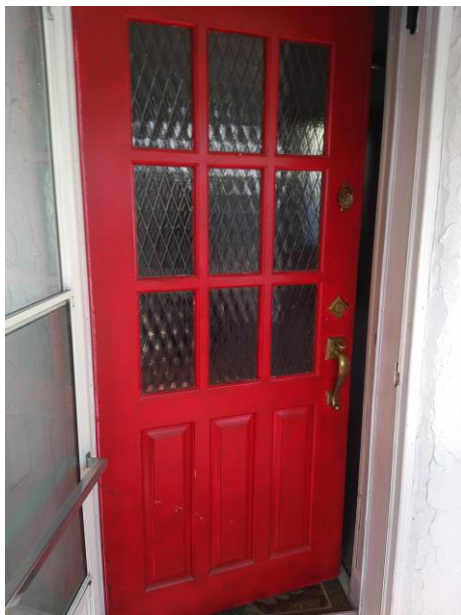
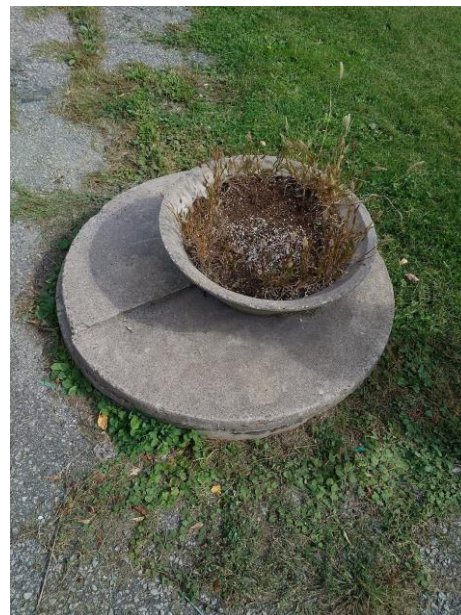
3.1.5.1.H - Exterior Details

Cladding - the original masonry has been covered with stucco	- poor
Windows – not original; replaced by wood and aluminum windows and aluminum storms; bow windows	- poor
Interiors – interior plan floor plan has been largely altered	- poor
Finishes – interior is mid-20th century materials	- poor
Stairs – mid-20 <sup>th</sup> century detailing	- poor
Flooring – non-original, mid-20 <sup>th</sup> century	- poor
Structure – original, but not compliant with local design standards	– fair
Foundation – rubble wall foundation/underpinned	- poor
Roof – non-original – metal roof installed in 1960's	- poor
Example of Heritage Architectural Ontario Farmhouse/ Gothic Revival style – neo classical styled dormer not in keeping with heritage style	- poor
Contribution to the neighbourhood character	- poor

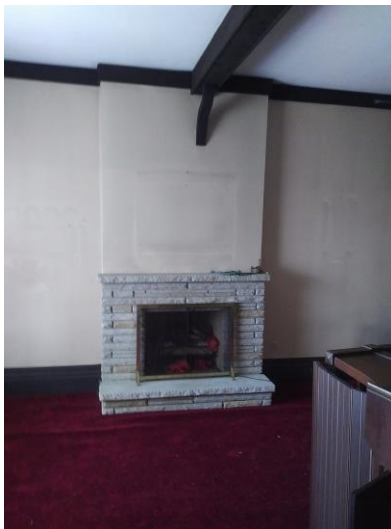
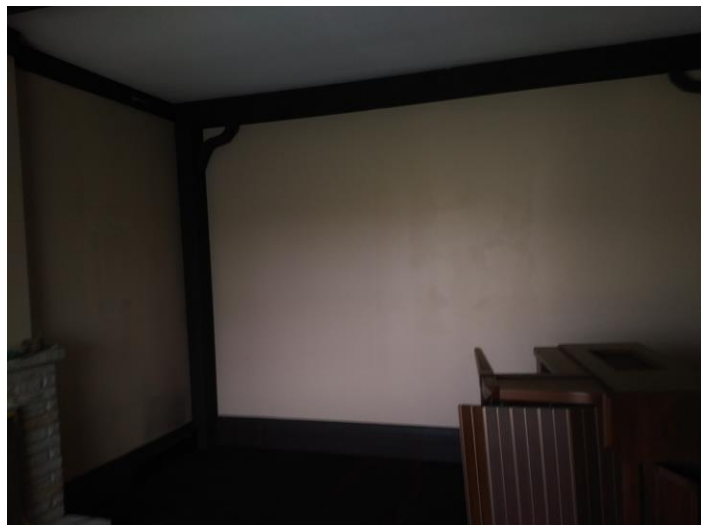
3.1.5.1.G – Original Home – Ground Floor Details

The floor plan is a 3-bay plan with a central front door and bow windows on either side. A dormer with a circle top window sits directly above the front door. A masonry fireplace with a projecting exterior masonry chimney on the south side was added at a later date which was also stuccoed over. Then northerly chimney was removed when a new furnace system was installed. The floor plan is symmetrical with a central hall and internal stair leading up to a second floor within the roof which housed 4 small bedrooms.

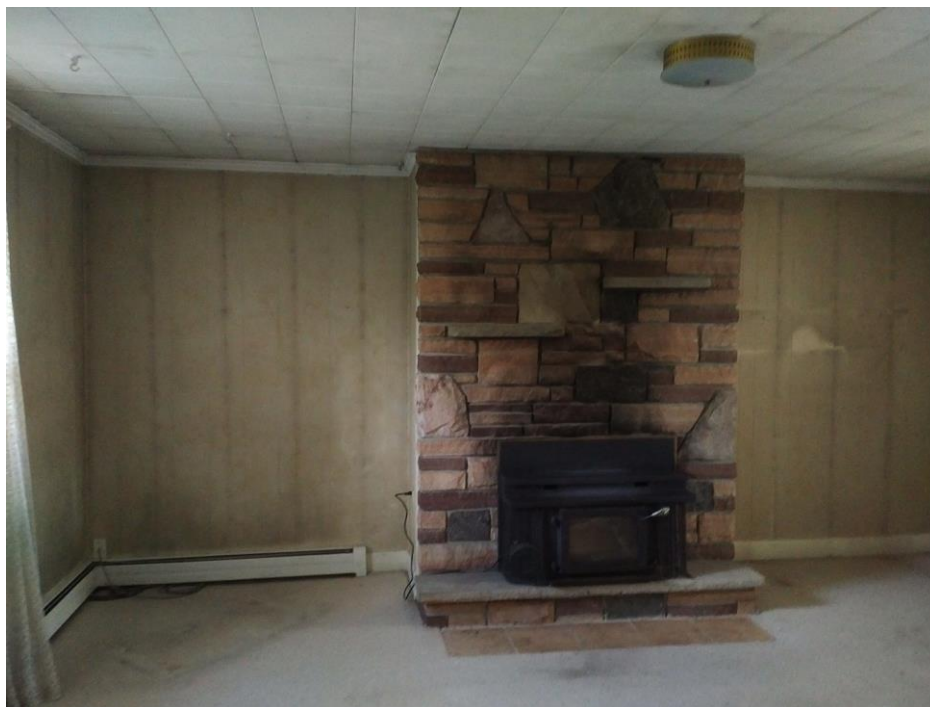
3.1.5.1.H – Addition – Ground Floor Details

The addition – typically a country kitchen - consists of a large family room with a powder room and an added fireplace. Upstairs, a washroom was added.

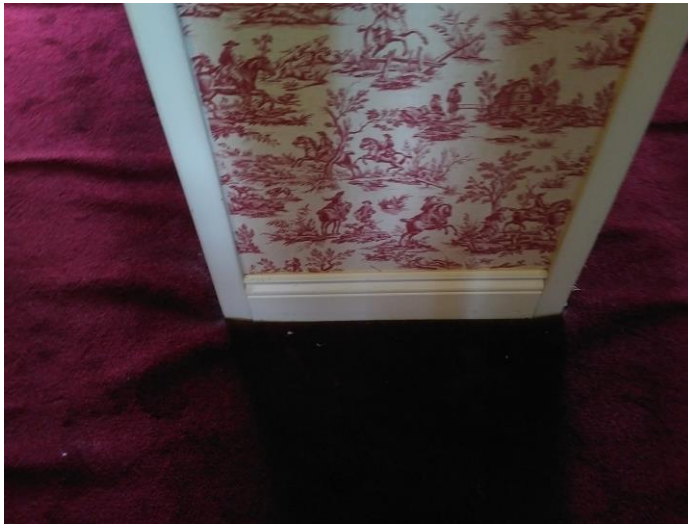
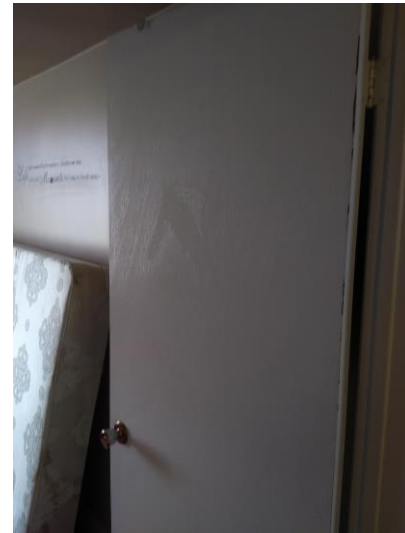
## 3.1.5.1.I – Original Home - Second Floor – Interior Details

The interior floor plan of the overall building has been largely altered due to the major renovation in the 1960's. The kitchen has been re-located to the front part of the home; a study has been subdivided out of the parlour room.

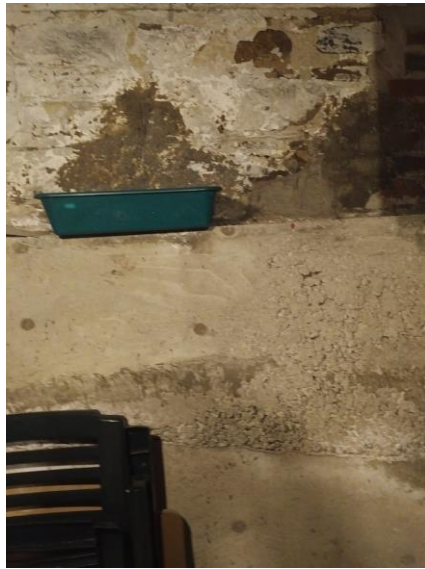
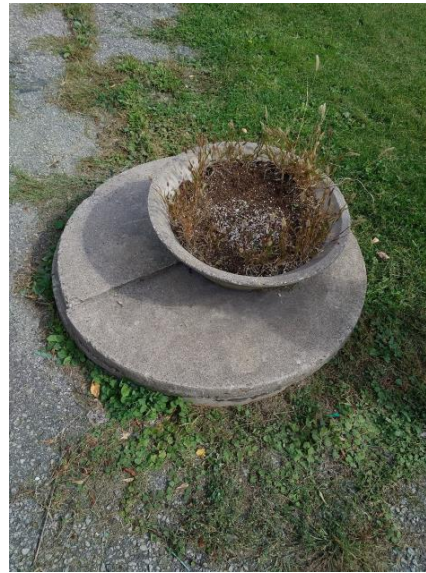
## 3.1.5.1.K – Basement

The house is on well water and septic bed. The heating system is oil and hot water radiators.

A rubble foundation wall, partially parged, underpinned with concrete  
A 2 x 4 wood frame stud walls with veneer masonry stuccoed over  
a combination of painted plaster and lath on the interior,  
(It was not possible to confirm the existence of any insulation in the walls.)  
Floors of 2 x 8 cedar floor joists and 1" T & G wood sheathing,

The cellar area has a simple stair leading to it from under the main stairs. It is unfinished, and of rubble wall construction. The basement has also been lowered as shown by the concrete foundation wall extension/underpinning. It houses electrical service and heating equipment. The ceiling height is approximately 7'-0" clear.

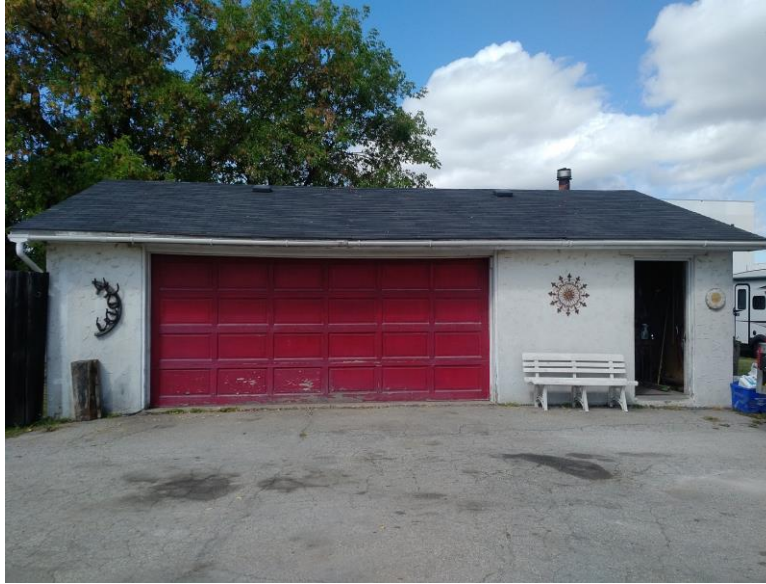
3.1.5.2.A – Garage/Accessory Building – Existing South (Front) Elevation

A review of aerial photography over the past 60 years reveals a variety of smaller out buildings on the site. A small barn was demolished in the 1940's. A garage was predominant in the northern rear yard. All the outbuildings have been demolished over time. The current garage was built in the mid 1960's when the house was renovated. It is constructed of stuccoed concrete block walls and wood frame roof structure.

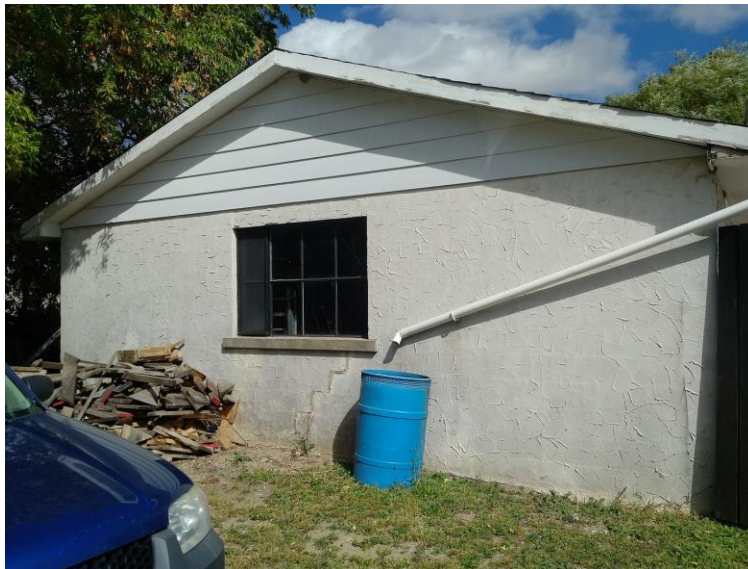
3.1.5.2.B – Garage/Accessory Building – Existing West (Left) Elevation

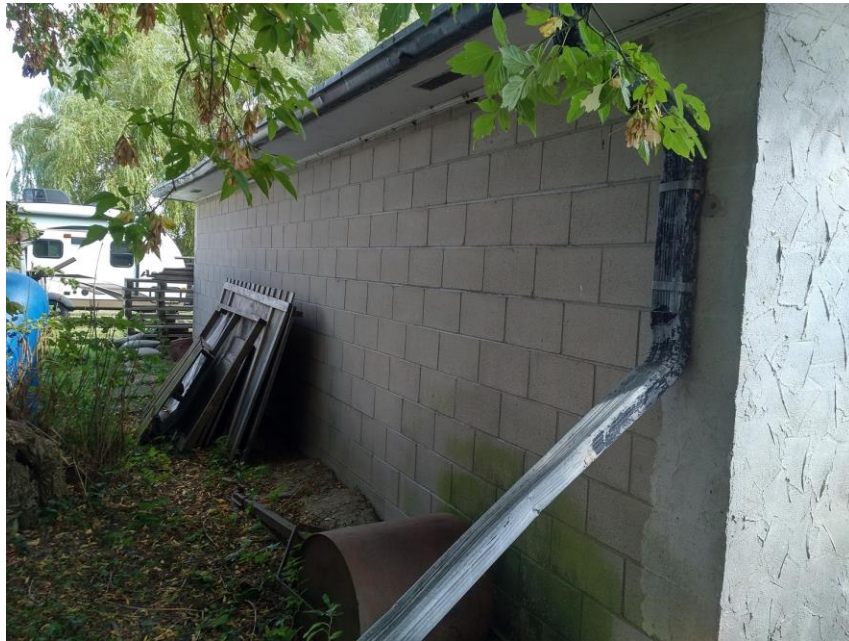
3.1.5.2.C – Accessory Building – Existing North (Rear) Elevation

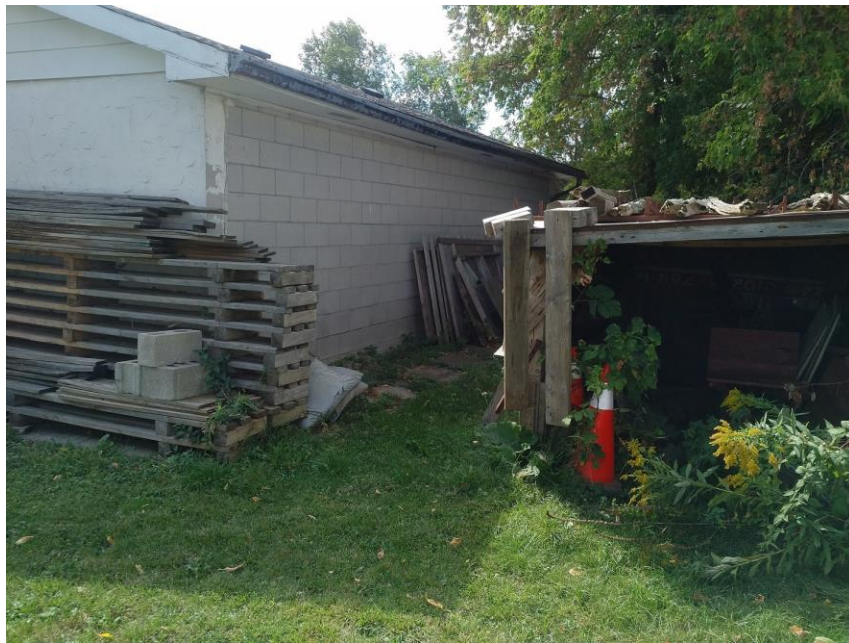
3.1.5.2.D – Accessory Building – Existing North (Rear) Elevation

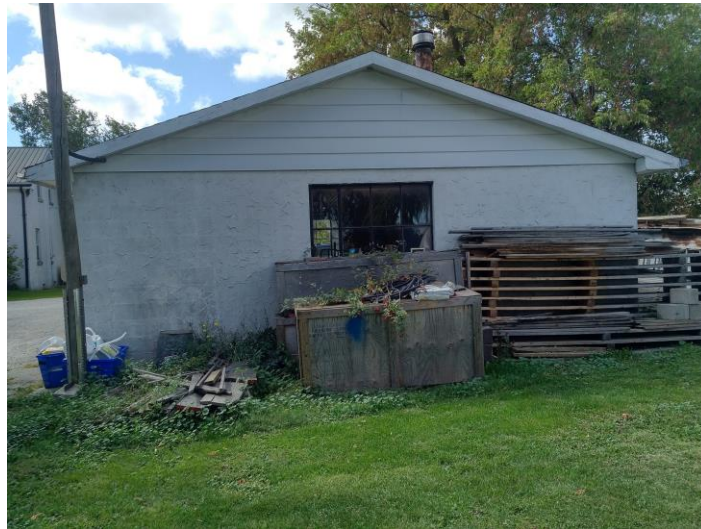
3.1.5.2.E – Accessory Building – Existing South (Front) Elevation

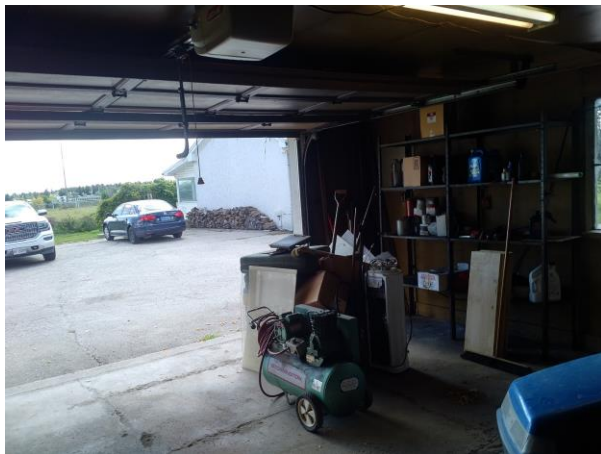
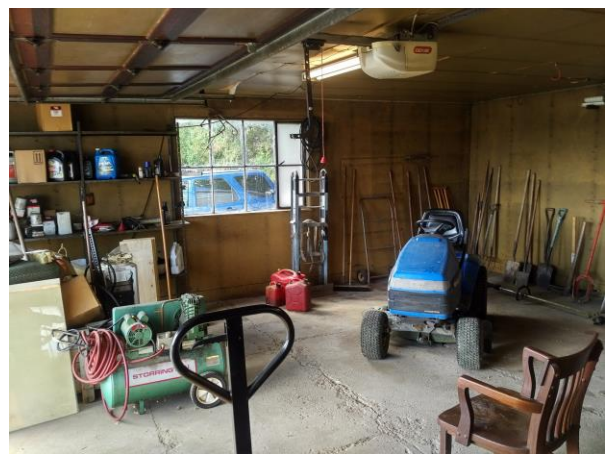
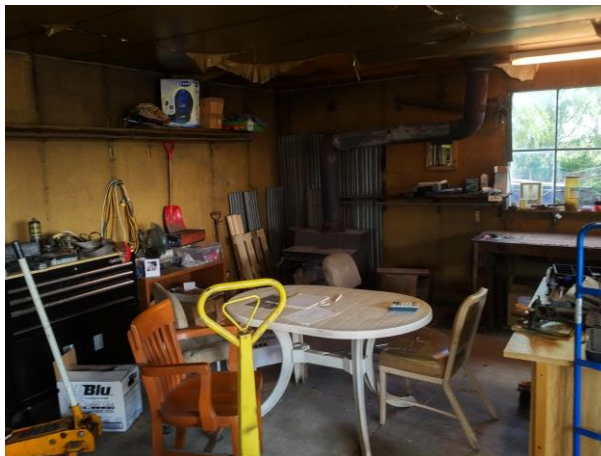
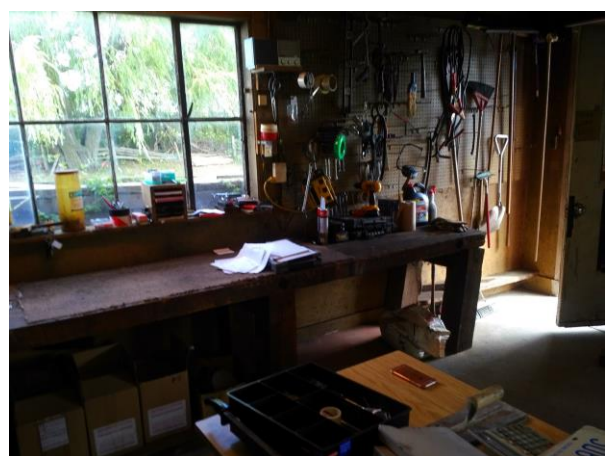
3.1.5.2.F – Accessory Building – Interior

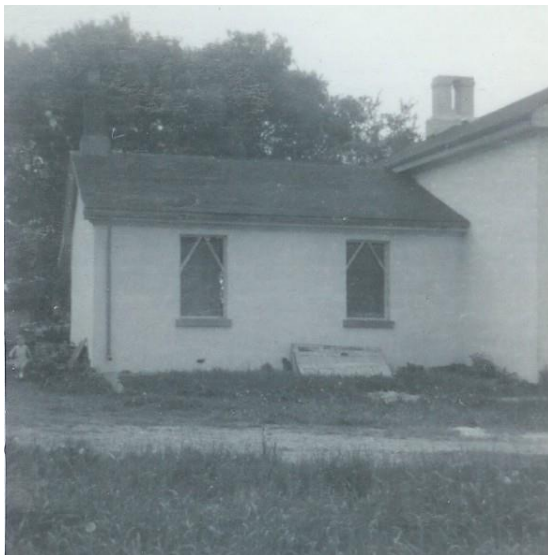
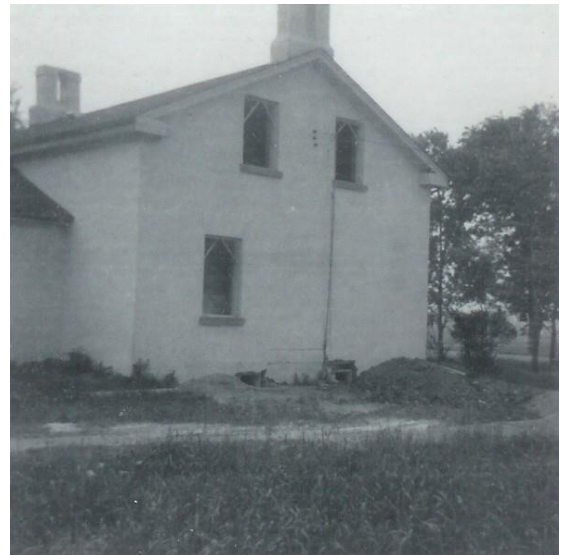
## 3.2.2.E. Renovation of the House 1967/8

- The basement was dug out
- Foundation walls were reinforced with concrete
- The second floor was gutted to the bare walls
- New plumbing was installed
- One fireplace was removed for a new furnace's chimney
- New doors and windows
- Wall in kitchen and dining room removed
- A wall installed in living room to create office
- A new verandah was built on the back of the house
- A new chimney, fireplace and powder room was built in the family room
- A new front porch was added at the front.

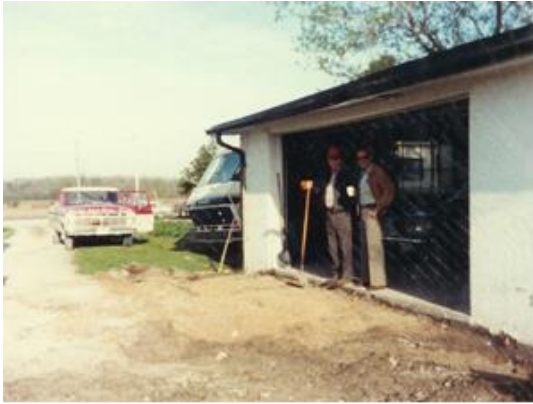
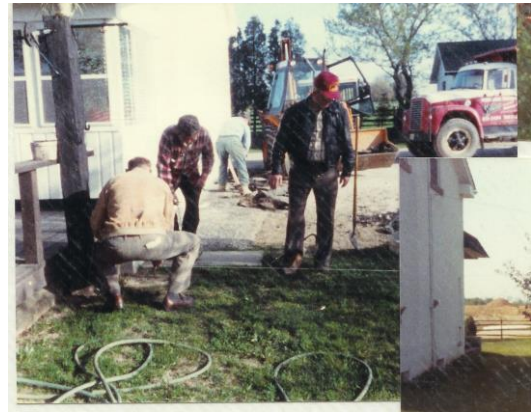
3.2.2.F. Construction of garage 1967/8

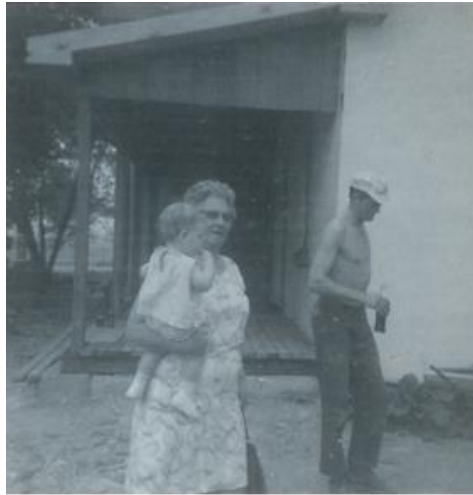
3.2.2. G. Enclosing the porch

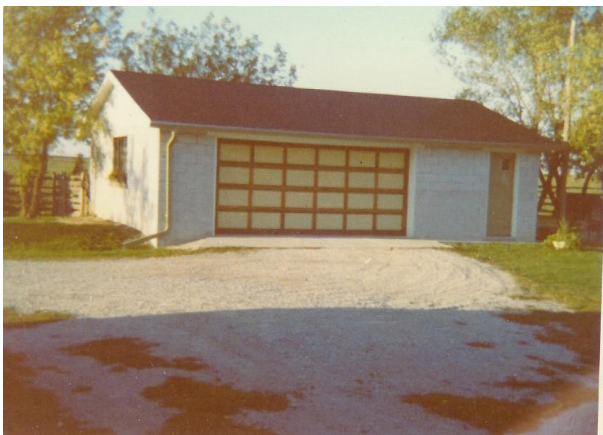
3.2.2.H. Finished garage 1968

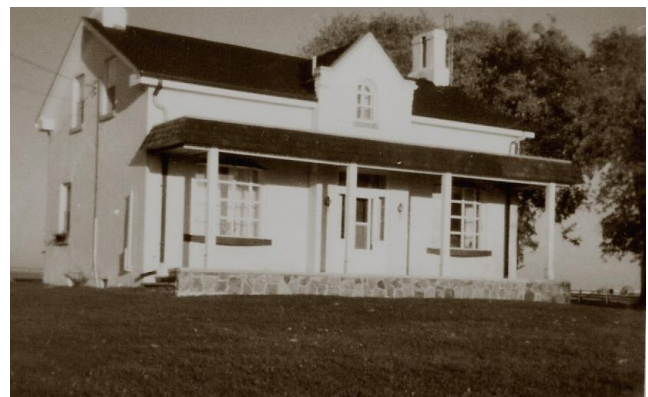
3.2.2.I. Finished House 1968

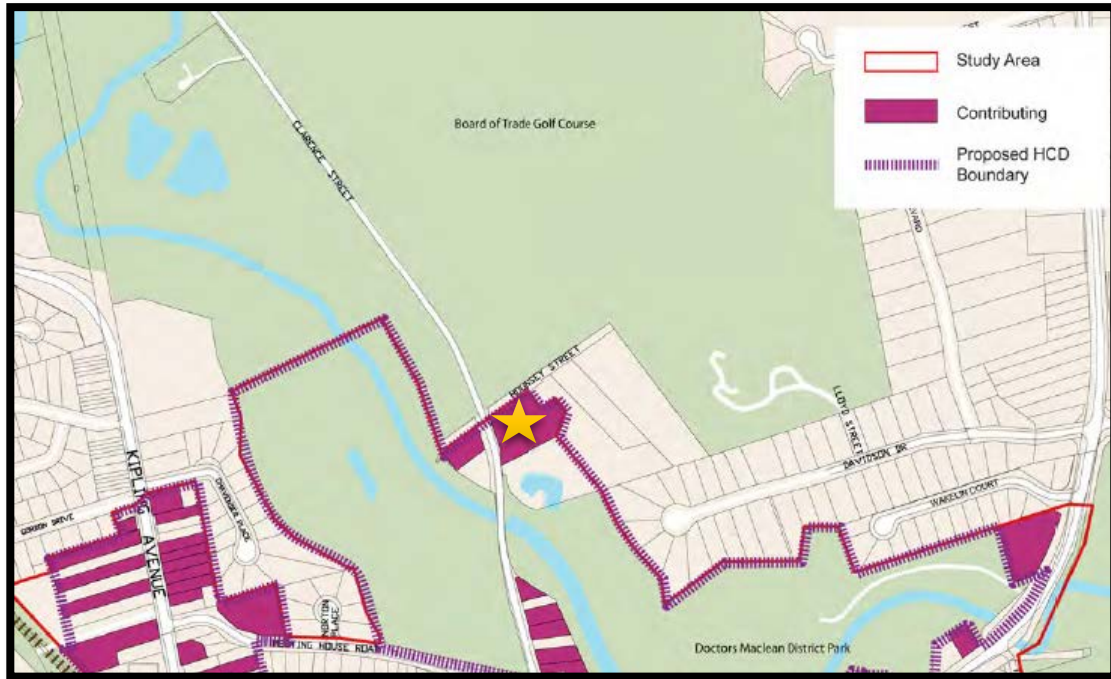
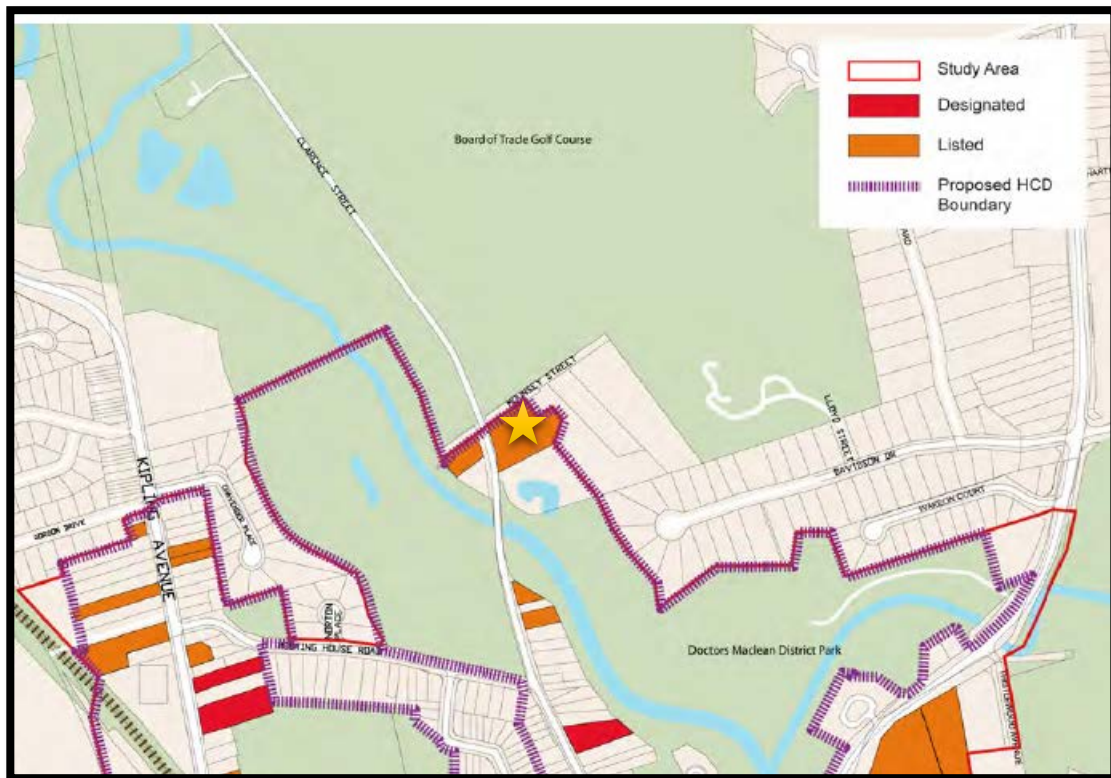
Figures 2 & 3: (Above) Excerpt from Schedule 3 of the HCD Plan (Below) Excerpt from Schedule 4 of the HCD Plan; yellow stars indicate the location of the subject land (Woodbridge HCD Study and Plan, 2009)

The Woodbridge Heritage Conservation Study and Plan (2009) identifies the property as listed prior to the HCD and a contributing resource to the District (p 52-54, Figures 2 & 3). The subject property is also located within a defined boundary of properties that are considered to be the “concentration of properties that contribute to the heritage character [of the HCD]” (Schedule 8 of the HCD Study and Plan, 2009). The subject property is located within the Clarence Street and Park Drive HCD Character Area (Schedule 9, of the HCD Study and Plan, 2009).

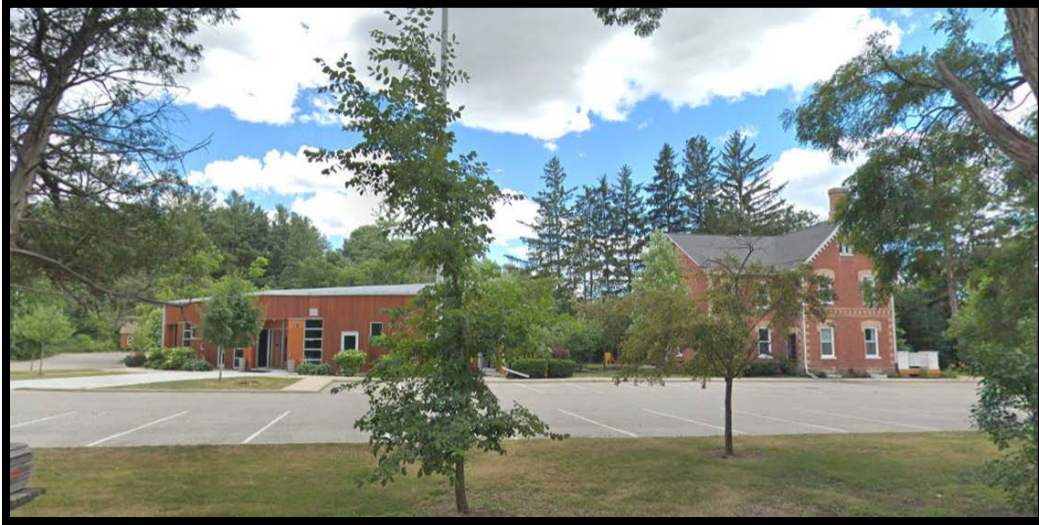
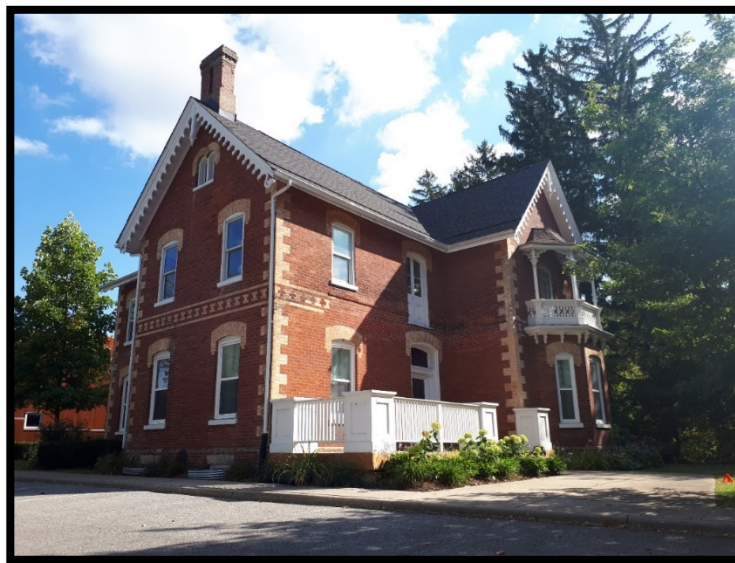
*Figures 4 & 5: (Above) View of heritage house and Rock Community Church looking southwards on Mounsey Street;  
(Below) Perspective view of heritage house (MHBC, 2019))*

The property consists of a 2.5 storey, Gothic Revival house built between 1850 and 1875 as described in the *Woodbridge Heritage Conservation District Study and Plan* (2009) (p 55-57). A more detailed analysis of the heritage building's architectural features is discussed in Section 4.2 of this report. The property also includes a contemporary building that facilitates the Rock Community Church. This building is to the rear of the heritage house.

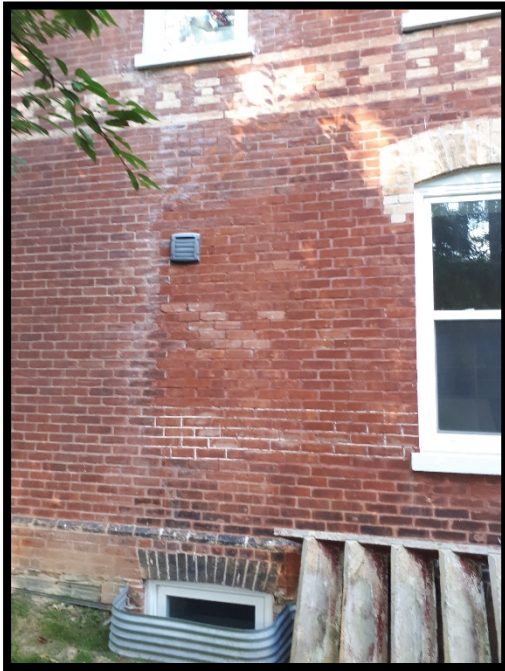
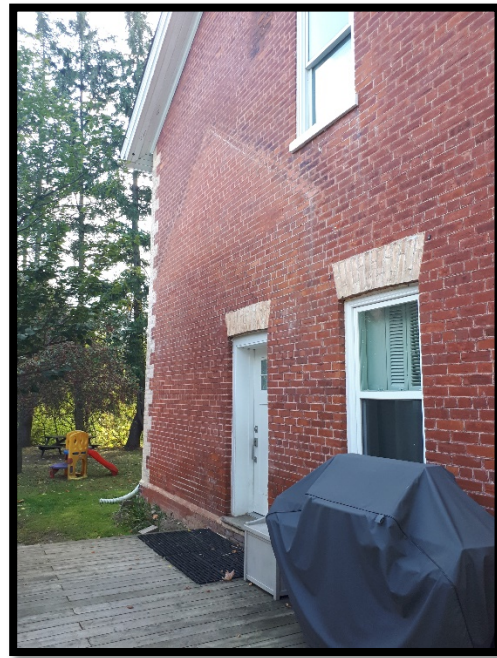
*Figures 13 & 14: (Left) View of markings of former addition on the south elevation (Right) Markings on east elevation from former addition (MHBC, 2019)*

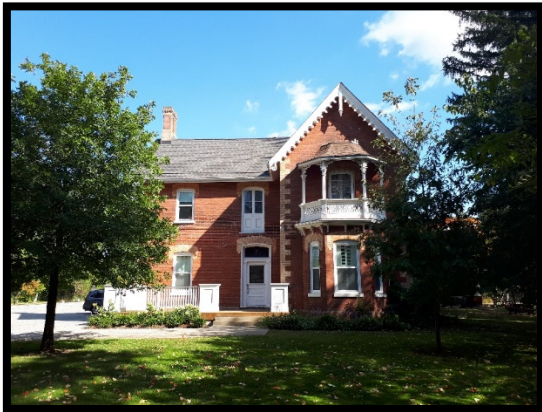
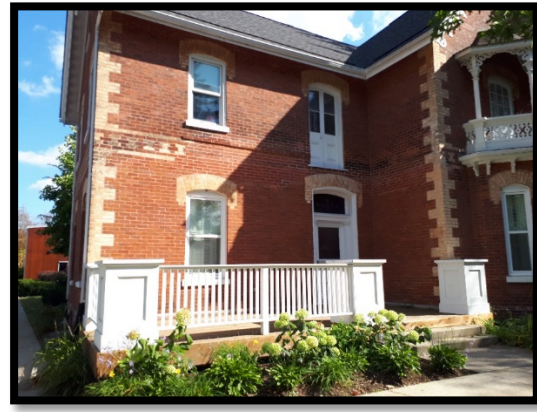
The second bay includes a bay window (3 window openings) and wooden decorative brackets and corncicing that support the balcony above. The balcony is embellished with various woodwork design and includes one door opening. The balcony is composed of four bases with capitals which support four columns with decorative brackets. The open gabled roof includes decorative wooden trim moulding and lower half of a finial. There is alternating brick detailing in the form of yellow brick quoins and a portion of yellow brick ribbons with 'X' detailing. The current porch is a basic construction of large capitals with basic spandrel handrails.

*Figures 15 & 16: (Left) View of front façade including bay window and balcony;(Right) Close view of reconstructed porch on front façade; (MHBC, 2019)*

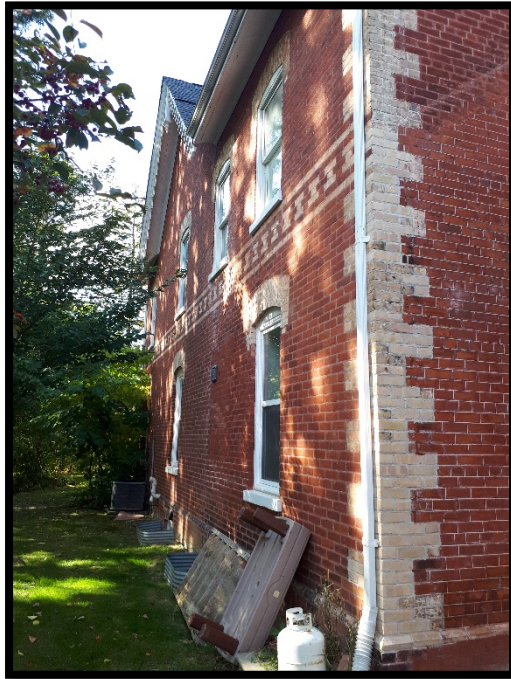
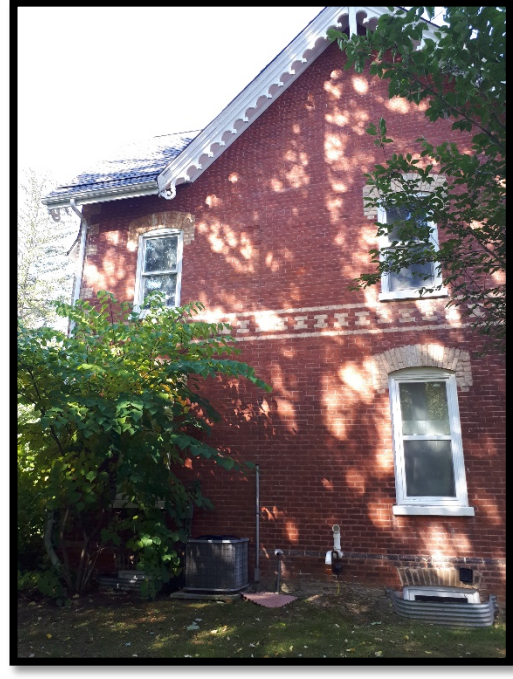
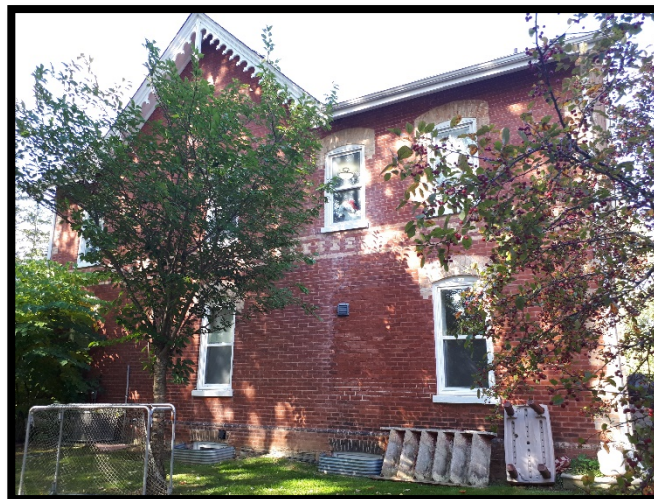
The south elevation consists of an open gable roof with similar decorative trim mouldings as the front façade as well as finial. A yellow brick ribbon course divides the first and second storey levels. Yellow brick headers are above each window. Windows have been replaced with contemporary, single, double hung windows. Either side of the façade is adorned with a yellow brick quoin. There are three (3) window sills at the basement level, three (3) window openings on the first storey and four (4) window opening on the second storey level. The window sill openings include brick headers. Part of the brick foundation sill is apparent on this elevation.

*Figures 17, 18: & 19 (Left) View of south elevation from the south-east corner of the house; (Right) View of the left side of the south elevation including gabled roof detail; (Below) View of entirety of south elevation from south yard (MHBC, 2019)*

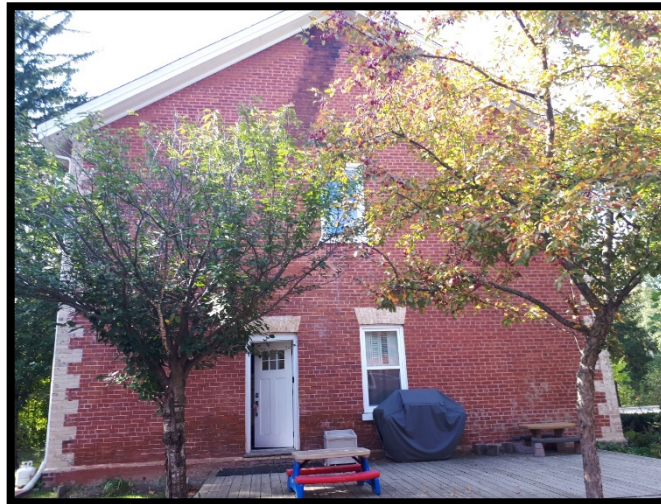
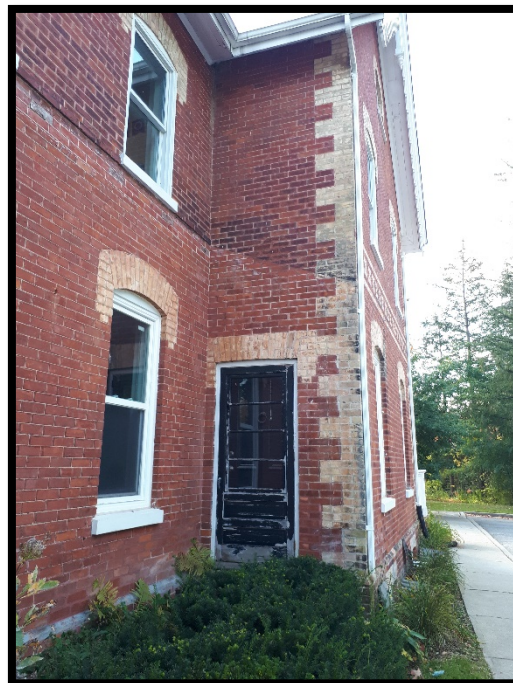
The east elevation includes one door opening and one window opening on the first storey level and one window on the second storey level. Both windows have been replaced with contemporary, single, double-hung windows and the original door has also replaced. The window and door opening have vertical brick headings which are less elaborate than those on the other three elevations. Both sides of the façade are adorned with yellow brick quoins. The low-rise gabled roof is simplistic in design including plain soffits and corncicing which contrasts with the detailing of the gables on all other elevations. There is also a door opening as part of the east elevation between the main house and rear portion which includes an arched, yellow brick header.

*Figure 20 & 21: (Above) View of east elevation from Rock Community Church west elevation; (Below) Door opening on east elevation (MHBC, 2019)*

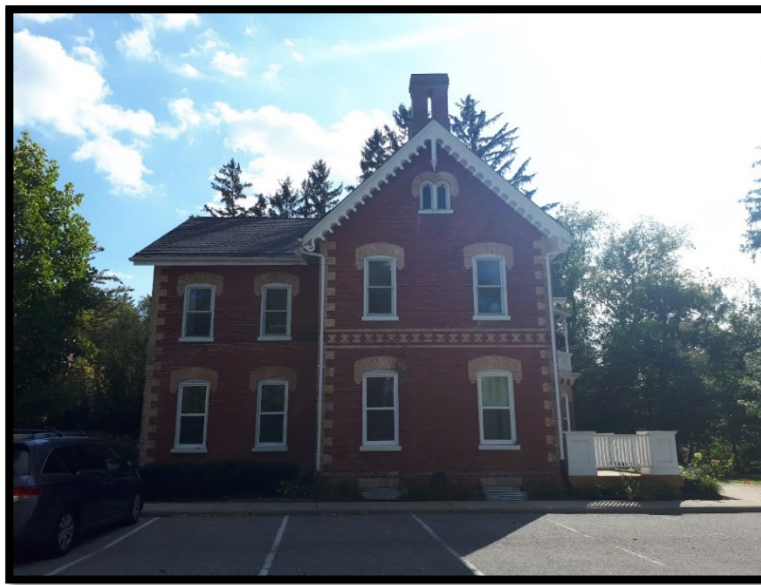
The north elevation consists of two bays. The bay closest to the front façade includes two window openings with arched yellow brick headers divided from the second storey by a yellow brick ribbon course with 'X' brick motifs. The second storey includes two window openings with yellow brick headers. The upper half storey includes a paired arched window with yellow arched headers. Either side of the bay includes a yellow brick quoin. The open gabled roof includes decorative trim moulding. The stone chimney can be viewed along this elevation. The second bay to the rear of the building includes two window openings on the first floor and two window openings on the second floor; all have arched, yellow brick headers. There is a yellow brick quoin to the left of this bay. This elevation shows the contrast between the medium pitched gabled roof of the main portion of the house versus the low pitched gable at the rear.

*Figure 22: View of north elevation from parking lot to the north of the property.*

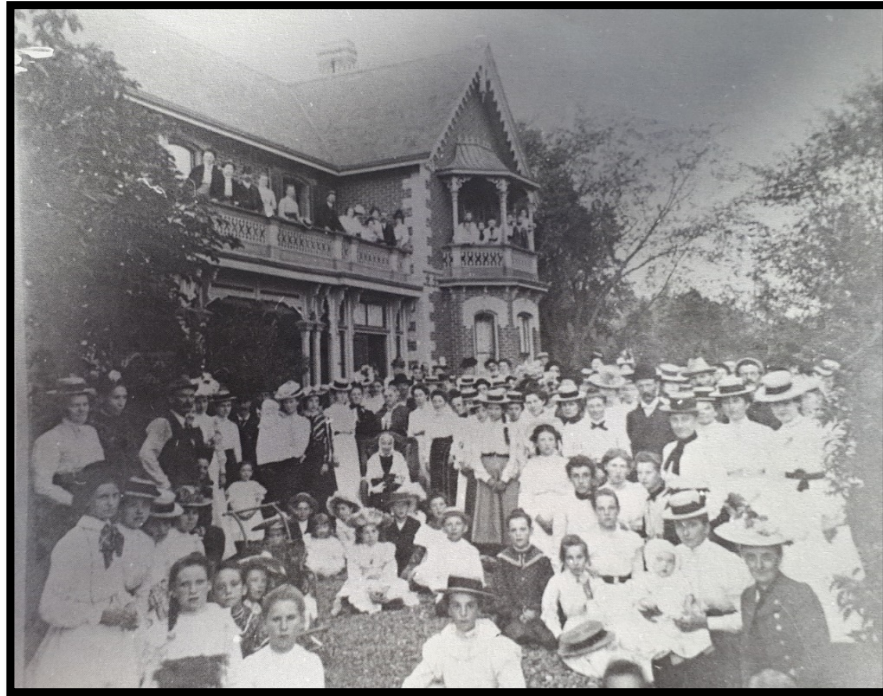
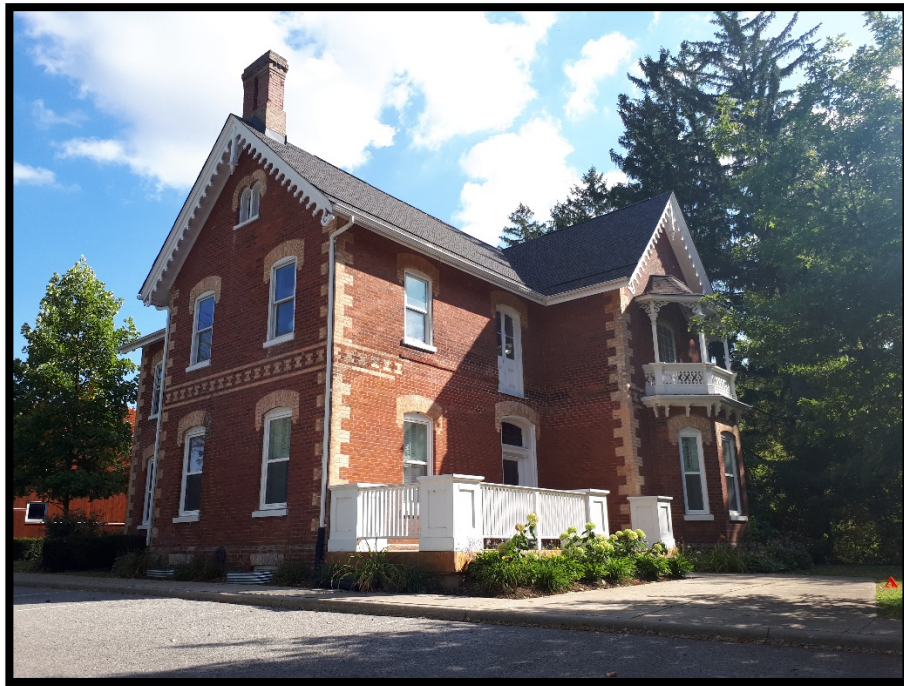
Figures 26: & 27: (Above) Photograph of the house at 249 Clarence Street, “Wallace Farm Home” from Wood’s Pictorial Woodbridge c. 1915 (Below) Perspective view of heritage home from parking lot (MHBC, 2019).

The Wallace Family had considerable amount of influence on the local community. The house stayed in the Wallace Family for several years. The photograph in Figure 26, demonstrates the original aesthetic appearance of the house in the early 20<sup>th</sup> century including the front verandah with upper balcony which has since been removed (see Figure 27).

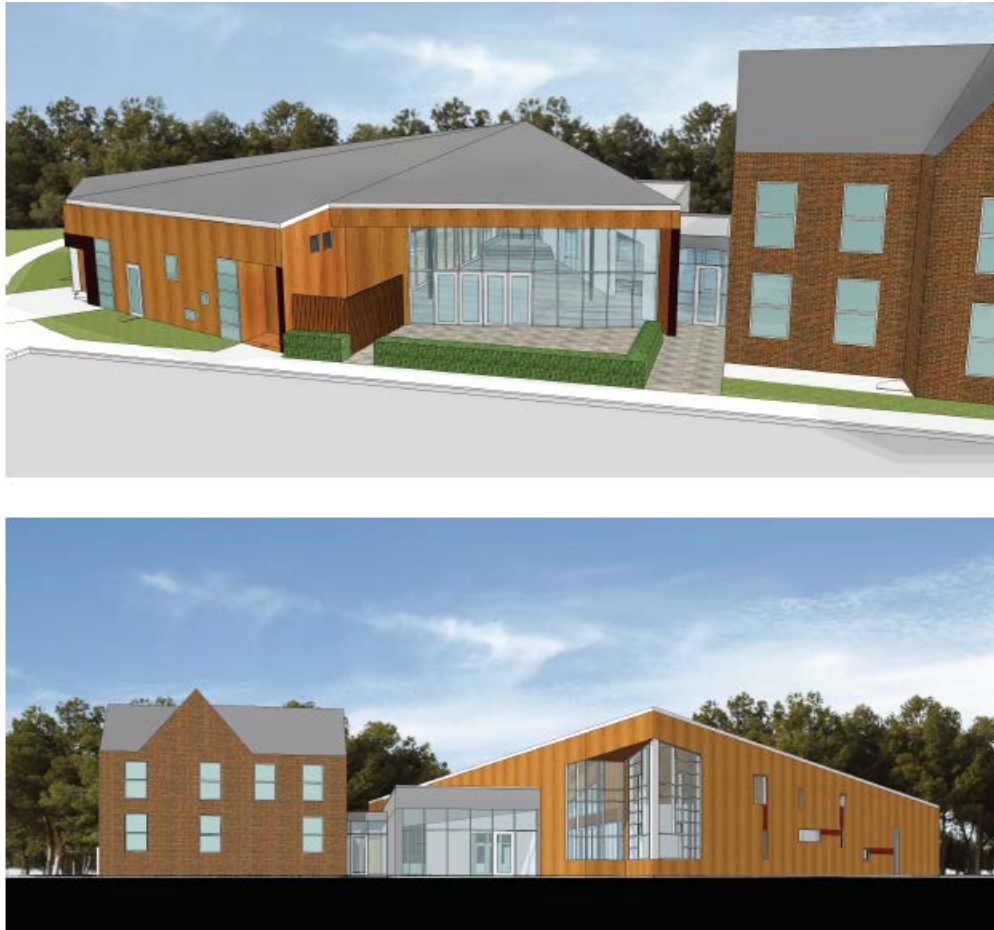
The proposed development consists of a combination of materials including Cedar panelling and glass. The vestibule is primarily glazing to allow for a subtle transition to the heritage building.

*Figures 32 & 33: (Above) Rendering of proposed development looking south-east; (Below) Rendering of the proposed development looking north (C.Y. Lee Architect Inc., 2019)*

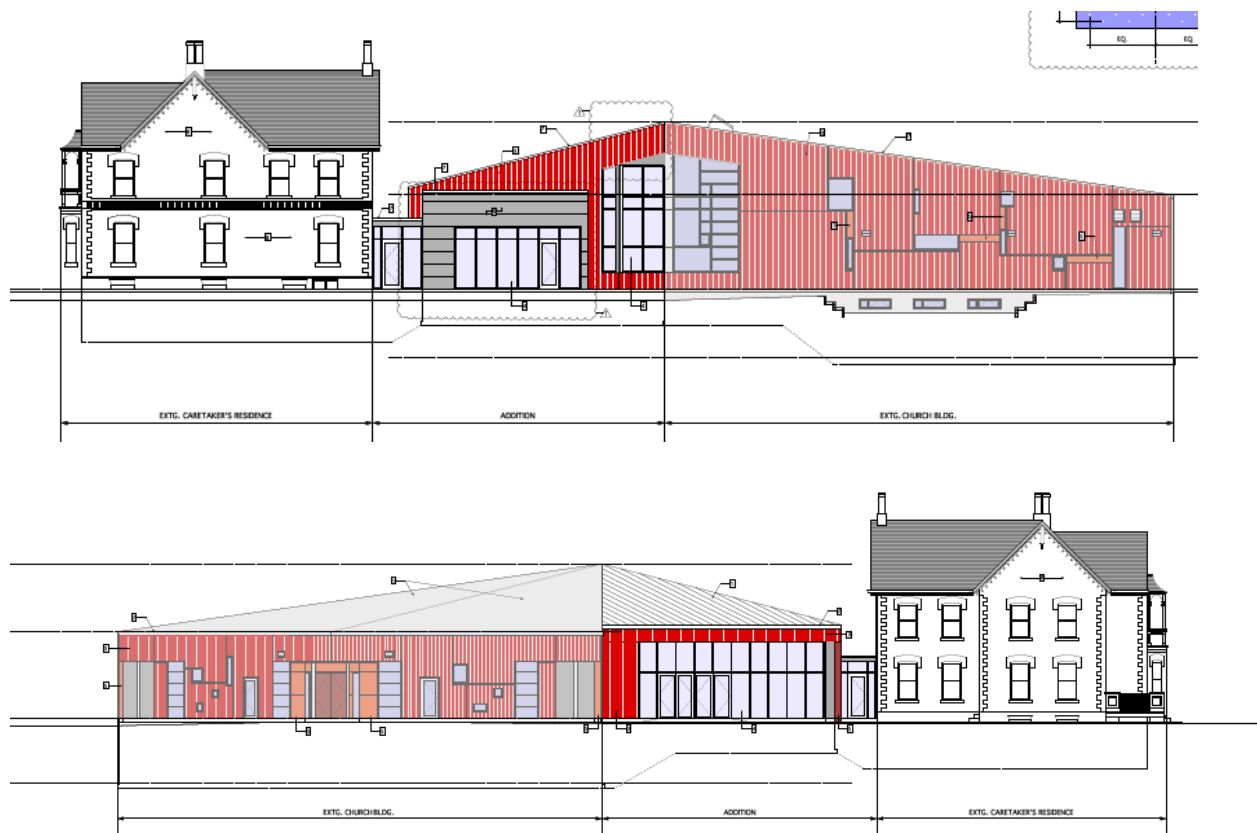
Figure 35 & 36: (Above) Architectural drawing of the south elevation of Rock Community Church (proposed development in deeper red colour) in relation to the heritage building; (Below) Architectural drawing of the north elevation of the Rock Community Church (proposed development in deeper red colour) in relation to the heritage building (C.Y. Lee Architect Inc, 2019)

The architectural elevations of the proposed development demonstrate that while, the new construction is abutting the heritage house, it is lower in height and subordinate to the building (see Figures 35 & 36). Furthermore, due to its linkage at the rear of the building, the new construction does not impact the overall presence of the building from the Clarence Street streetscape.

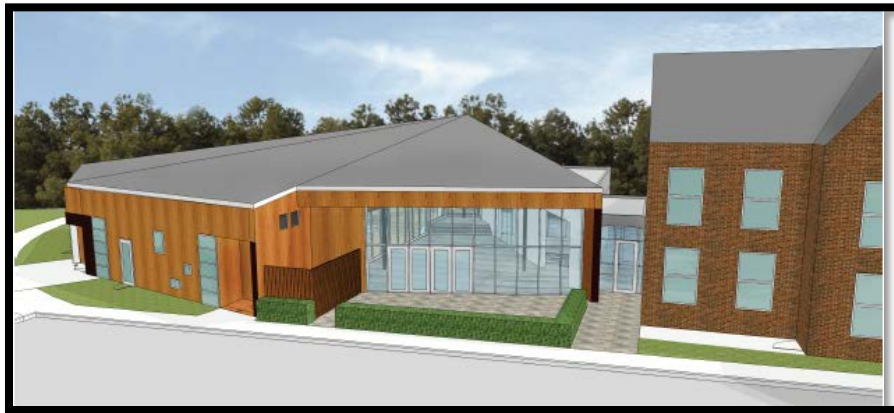
*Figure 37: Rendering of addition and vestibule looking south-east (C.Y. Lee Architect Inc., 2019)*

The vestibule is one storey and is subordinate and distinguishable from the heritage building. The proposed vestibule is primarily composed of glazing, however, it is not in the view of the public realm and the glazing allows for building elements of the north elevation to be visible (i.e. door brick header). The vestibule is of a smaller scale and mass than both the church and heritage building and includes simplistic details so as to not detract from the heritage building as being a point of focal interest.

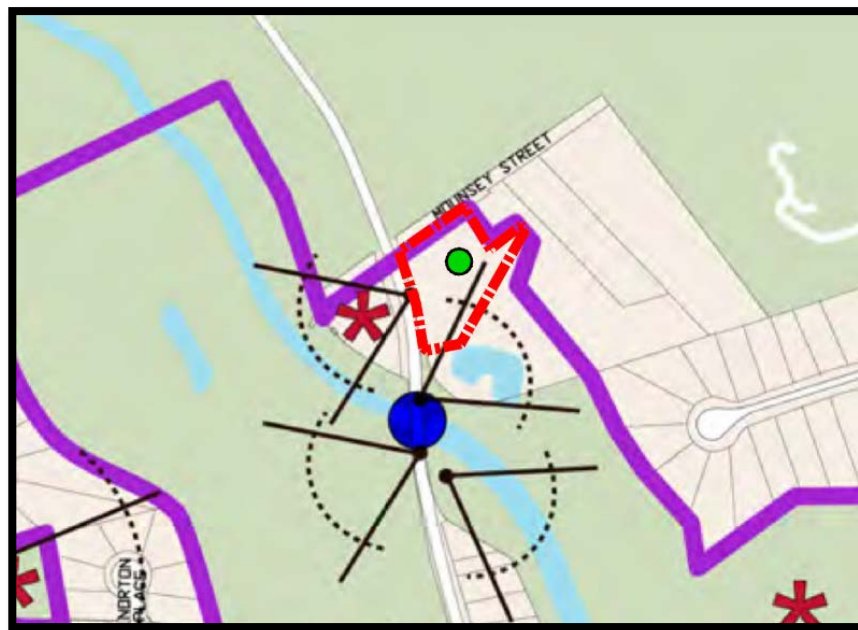
Figure 38: Excerpt of Schedule 19 of the Woodbridge HCD Study and Plan (2009); red dotted line indicates the location of the subject land; Green dot indicates approximate location of heritage house (MHBC, 2019)

Appendix 'A' of this report shows an overlay of Schedule 19 of the HCD Study and Plan (2009) on the subject land exhibited in Figure 38 to identify the subject property in relation to identified views, landmarks and bridges in the HCD. The property adjacent (non-contiguous) to the west of the subject property is identified as special landmark, open space. The Humber River Bridge is also within close proximity of the subject property.
