**CITY OF VAUGHAN  
HERITAGE VAUGHAN COMMITTEE  
AGENDA**

**Wednesday, January 15, 2020**

**TITLE: DE-LISTING APPLICATION FOR PROPERTY AT 7141 HWY.50,  
VICINITY OF HWY.50 AND HWY.407**

"Nathaniel Clark Wallace House"  
249 Clarence Street,  
Woodbridge, Vaughan, ON

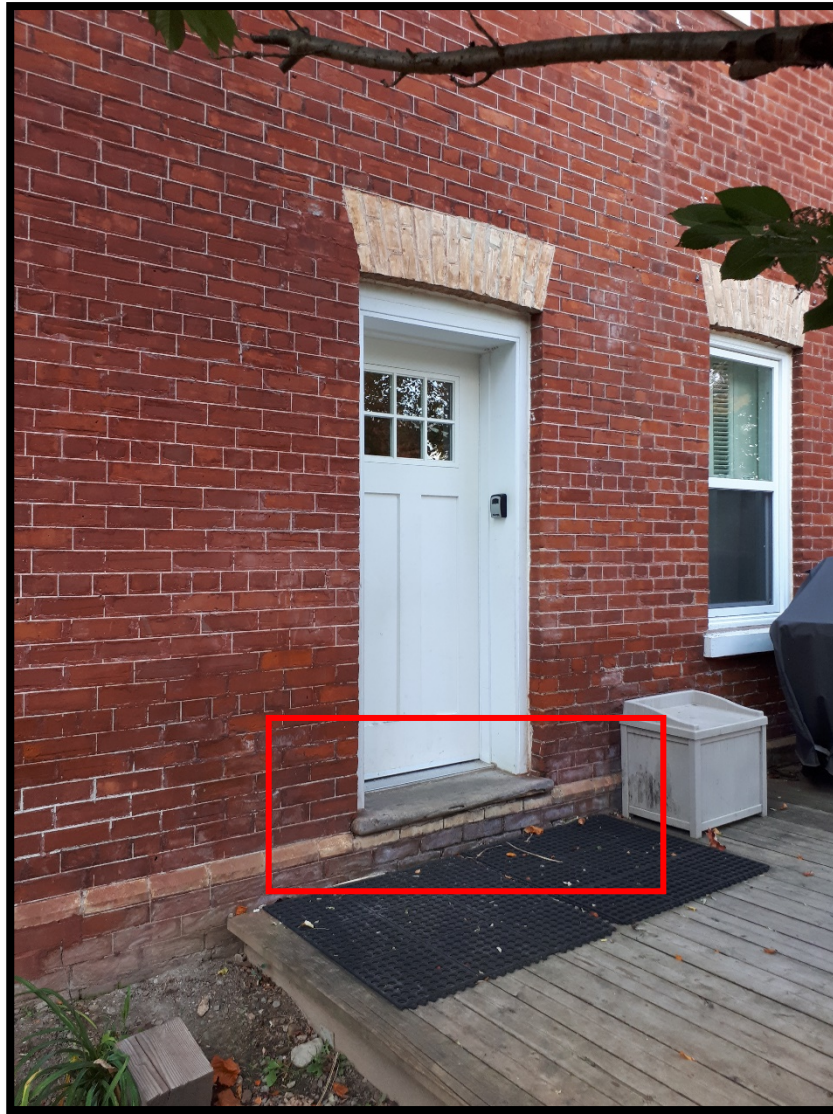
The new construction proposes to retain the original wooden threshold which is above grade. During the new construction, the wooden threshold should be repaired in accordance with Section 4.5.2 Guidelines for Wood and Wood Products (See Appendix G).

*Figure 42: View of rear door opening which will provide passage from the vestibule to the heritage house; red box identifies the wooden threshold of the door opening that may require repair doing new construction (MHBC, 2019)*

- The addition retains the original wooden threshold which is above grade. As part of the construction of the addition, the existing wooden threshold of the church will be repaired in accordance with *Standards and Guidelines for the Conservation of Historic Places in Canada -Section 4.5.2, Guidelines for Wood and Wood Products*

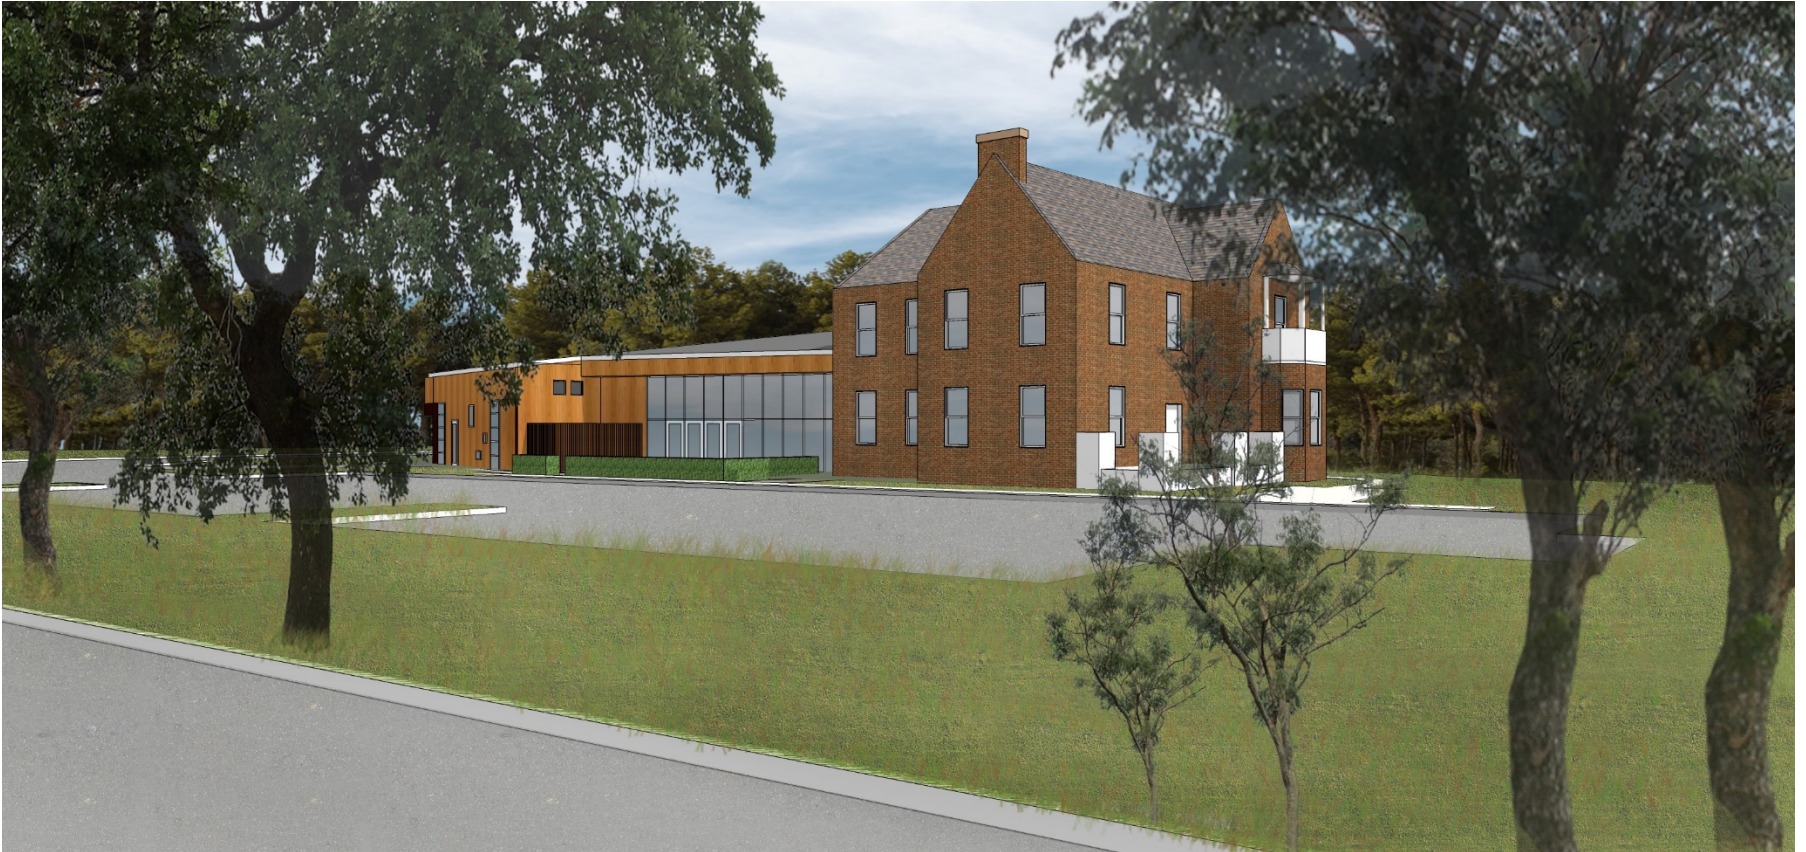
*Rendering from Mounsey Street*

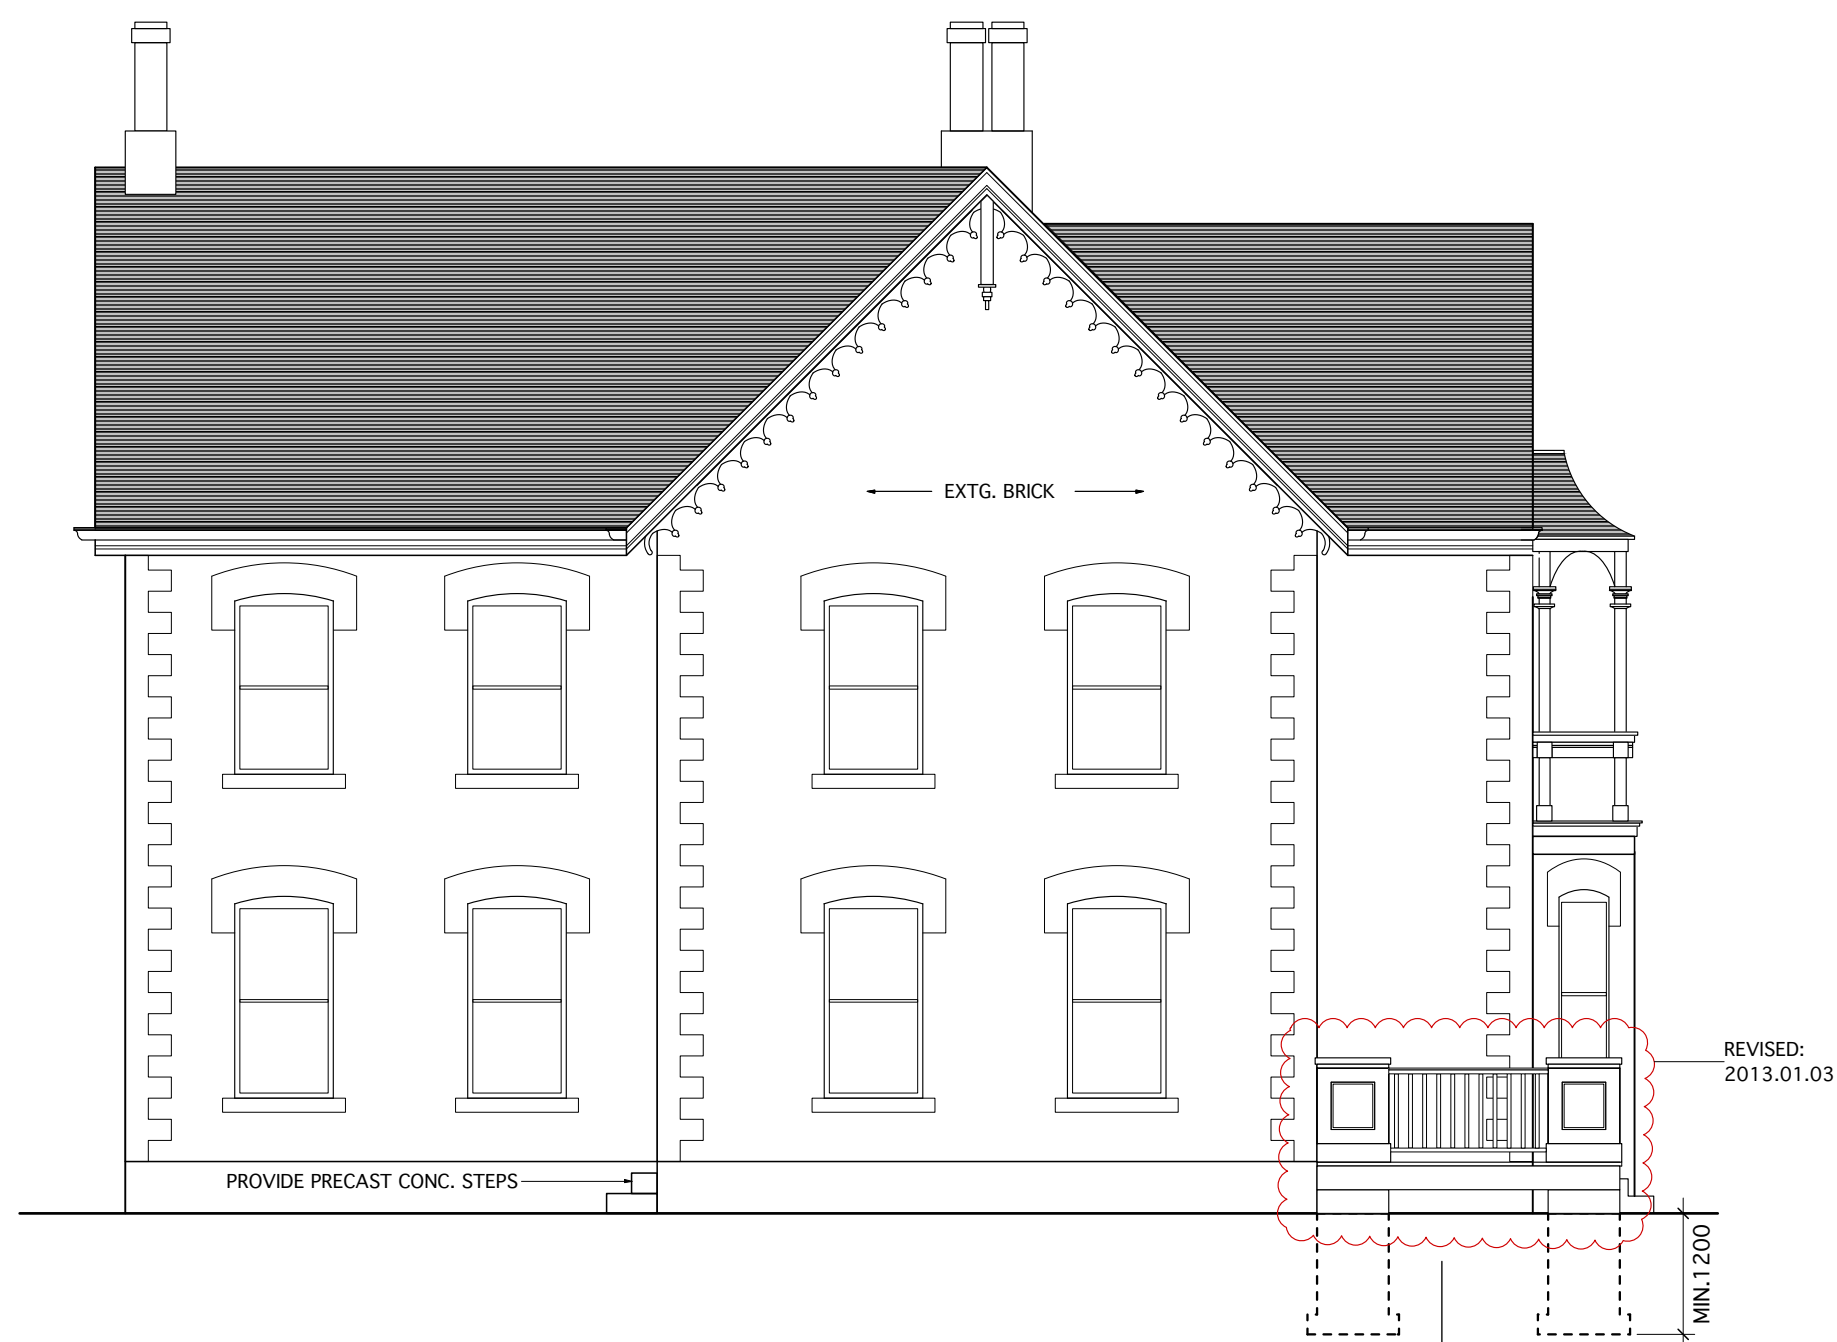
5 NORTH ELEVATION  
A4.1 Scale: 1:75

RECONSTRUCT PORCH TO MATCH ORIGINAL DESIGN IN STYLE, MATERIALS AND SIZE BASED ON ARCHIVAL PICTURES.  
WEATHER RESISTANT PAINT COLOUR TO MATCH EXISTING. BENJAMIN MOORE; "HISTORICAL COLOURS OR TORONTO HERITAGE COLLECTION"; WHITE COLOUR TO MATCH EXISTING.  
REFERENCE: WOODBRIDGE HERITAGE CONSERVATION DISTRICT GUIDELINES SECTION 7.1.10 & SECTION 7.1.12

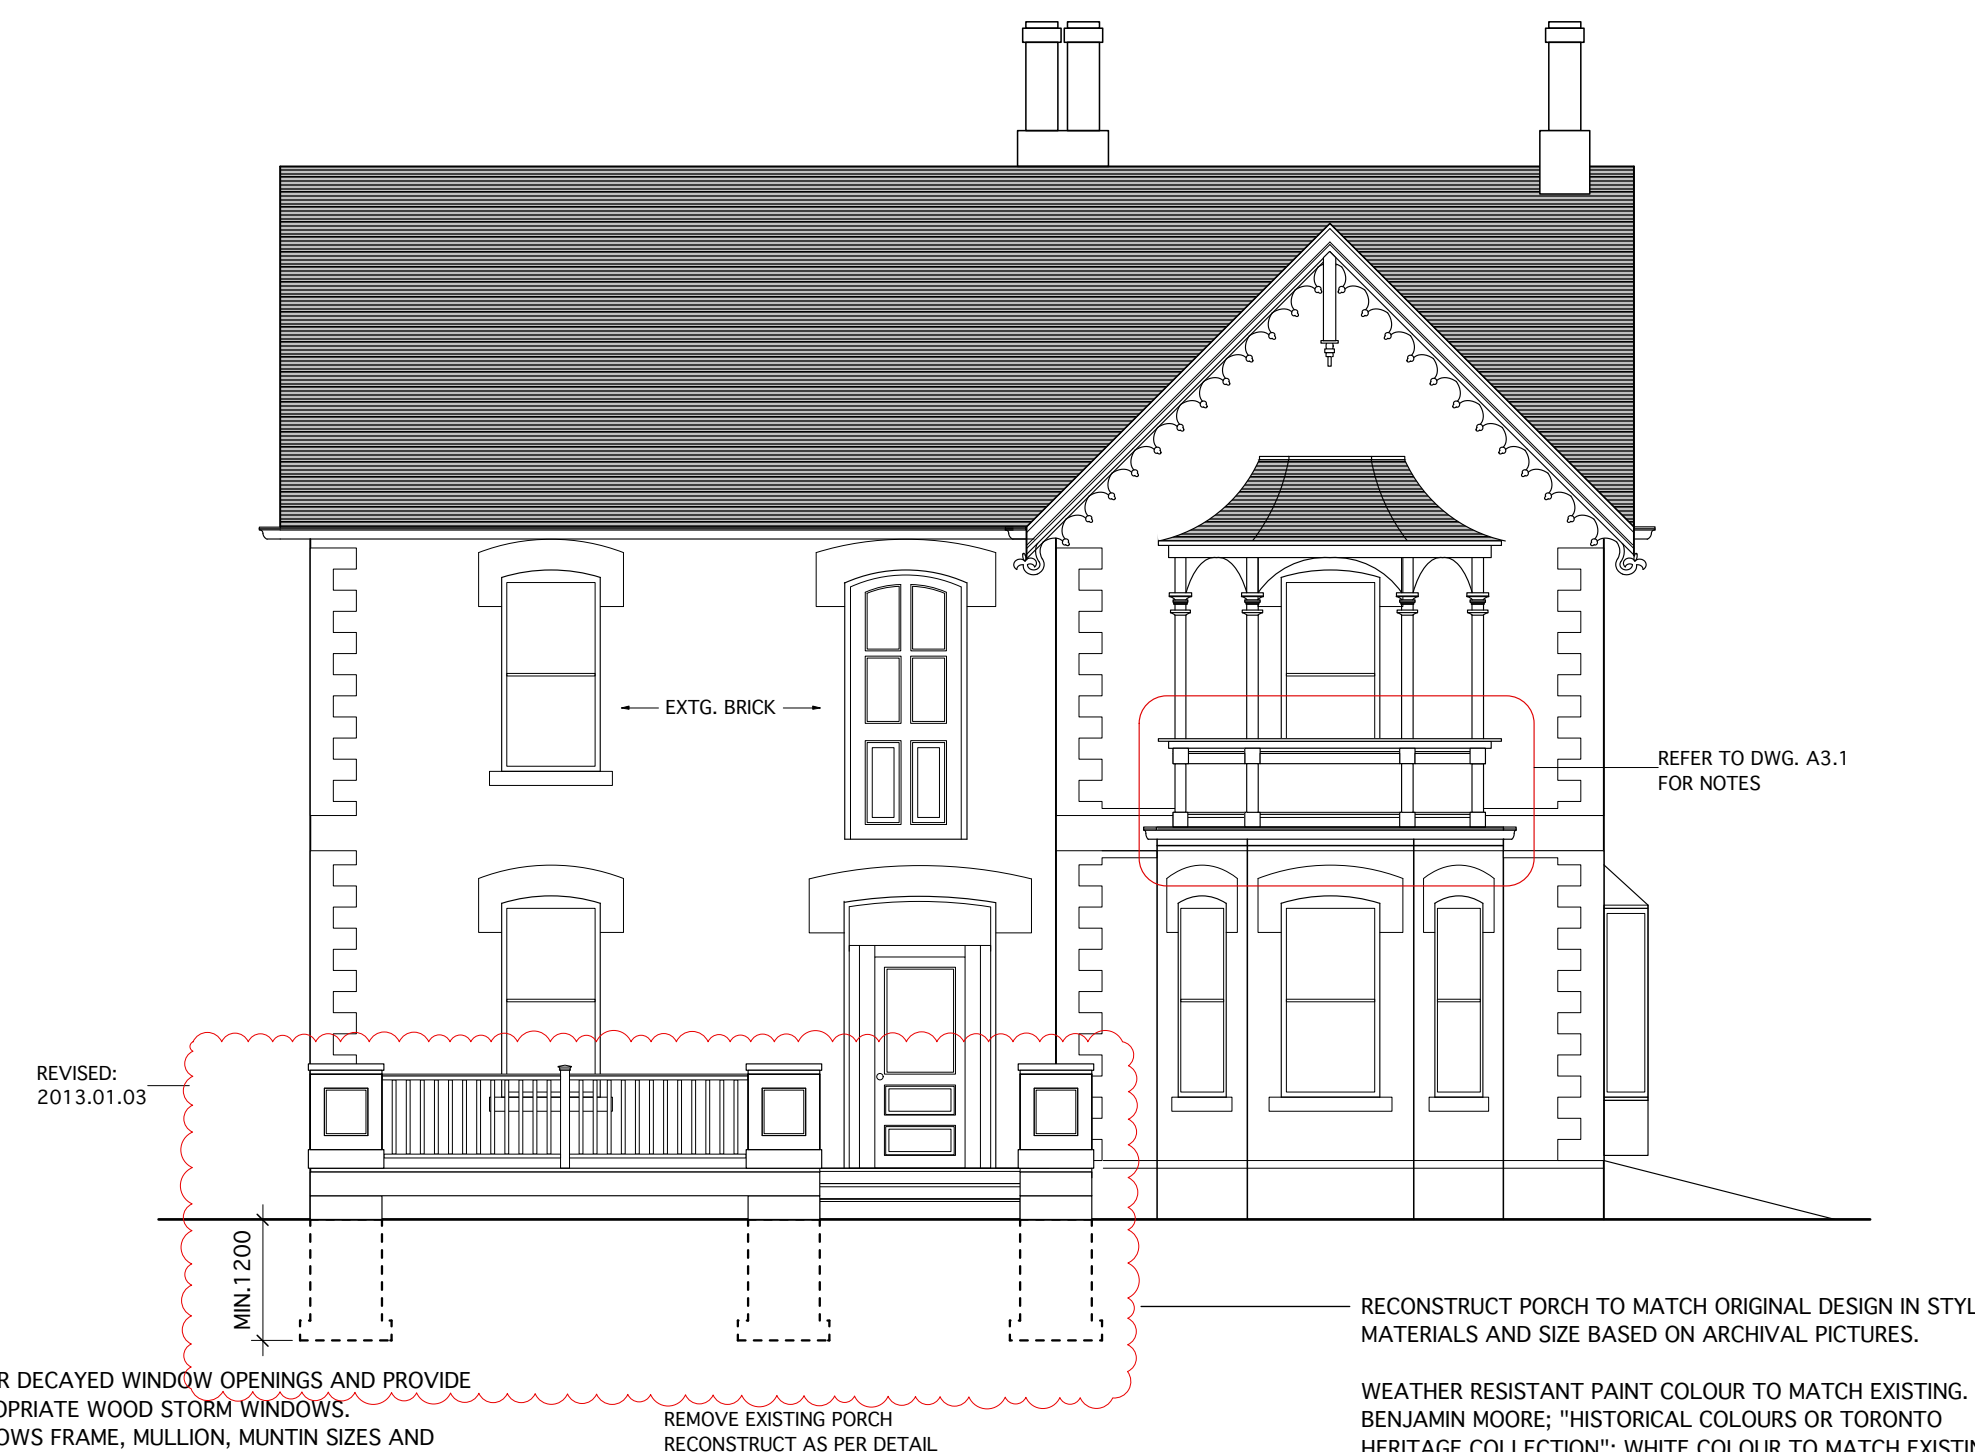
2 WEST ELEVATION  
A4.1 Scale: 1:75

REPAIR DECAYED WINDOW OPENINGS AND PROVIDE APPROPRIATE WOOD STORM WINDOWS. WINDOWS FRAME, MULLION, MUNTIN SIZES AND PROFILES SHALL MATCH THE EXISTING WINDOWS. WOOD WINDOW BY "FIELD-WIN" OR "LOWEN" OR PVC WINDOW BY "WINDOW CITY"  
WEATHER RESISTANT PAINT COLOUR TO MATCH THE EXISTING WINDOWS. BENJAMIN MOORE; "HISTORICAL COLOURS OR TORONTO HERITAGE COLLECTION"; WHITE COLOUR TO MATCH EXISTING.  
REFERENCE: WOODBRIDGE HERITAGE CONSERVATION DISTRICT GUIDELINES SECTION 6.2.8, SECTION 7.1.8 AND SECTION 7.1.12

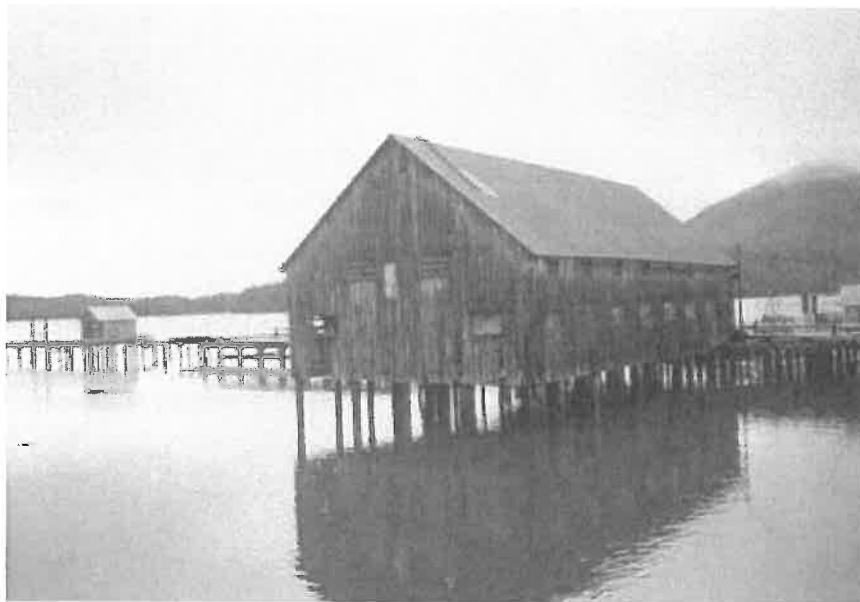
It is important to identify the cause of any damage to a wooden building element before beginning a Preservation treatment. For the former machine shop of the North Pacific Cannery in Port Edward BC, exposure to marine conditions caused the exterior wood cladding to deteriorate.

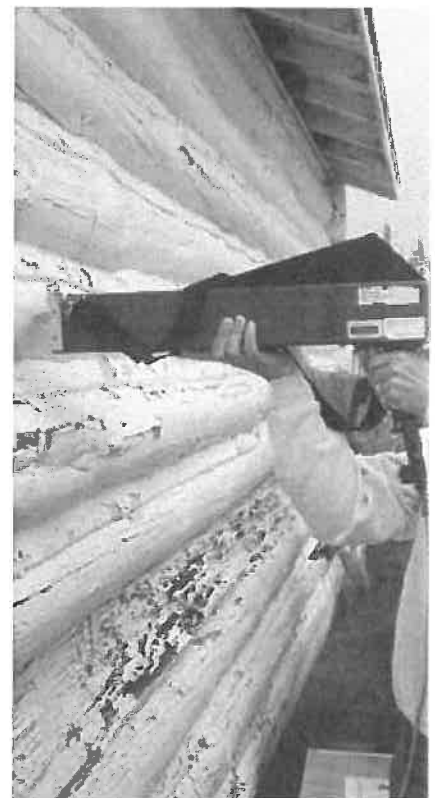
Using minimally destructive testing methods can help evaluate the condition of wood without damaging it. Here a resistance measuring micro drill is being used to evaluate the condition of a log wall at Fort Walsh, NHSC in Saskatchewan. A drilling needle penetrates the wood at a constant speed and measures the resistance encountered to advance the drill bit. The resistance the wood offers indicates its condition: low resistance can indicate decay.

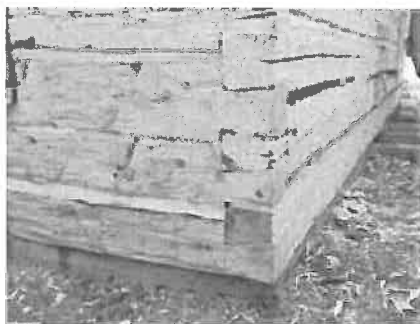
Deteriorated logs at the John Walter Historic Site in Edmonton were replaced in kind with hewn logs that used the originals as templates to reproduce tooling marks on visible surfaces. On close inspection, this distinguishes the new materials if the logs are separated in the future.

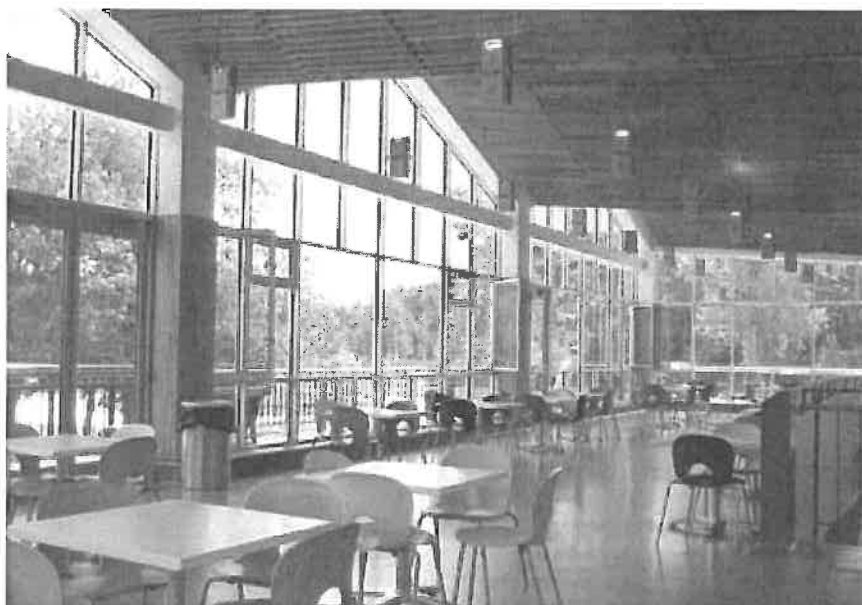
Wood was often used in modern buildings as a finish to contrast with more industrial materials, or as part of an acoustical treatment on ceilings and walls. The wood ceiling and column claddings of the Beaver Lake Pavilion in Montreal were carefully preserved as part of the recent rehabilitation of the pavilion.

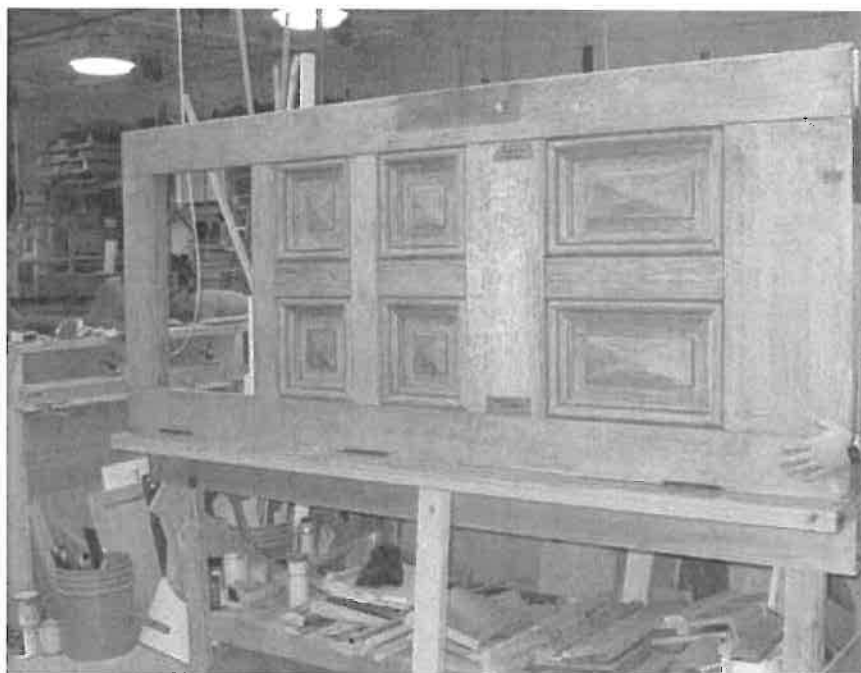
Preserving the wood doors of the Langevin Block in Ottawa included carefully dismantling the doors to permit the damaged and decayed wood to be repaired.

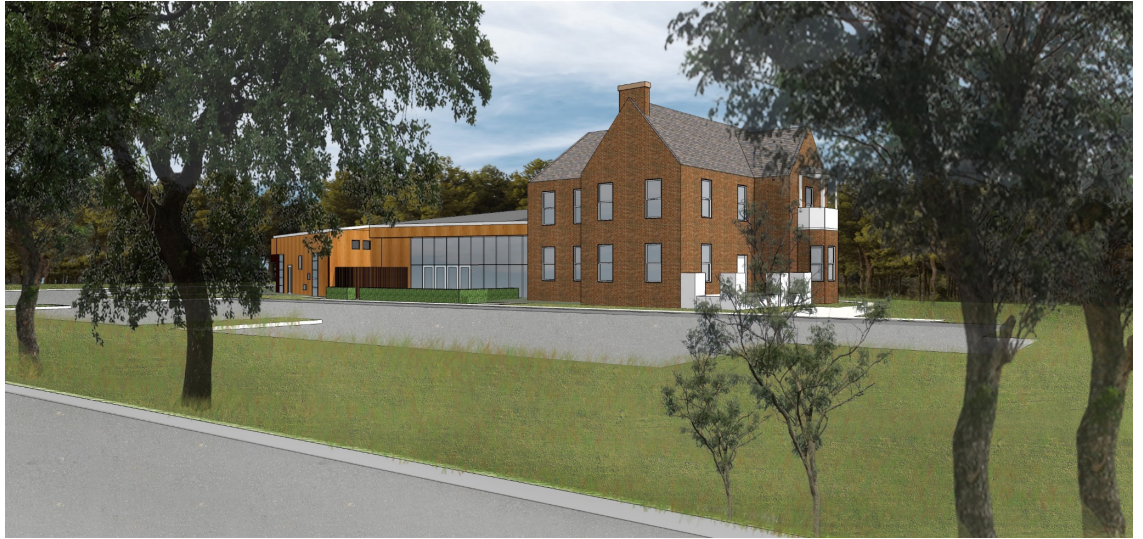
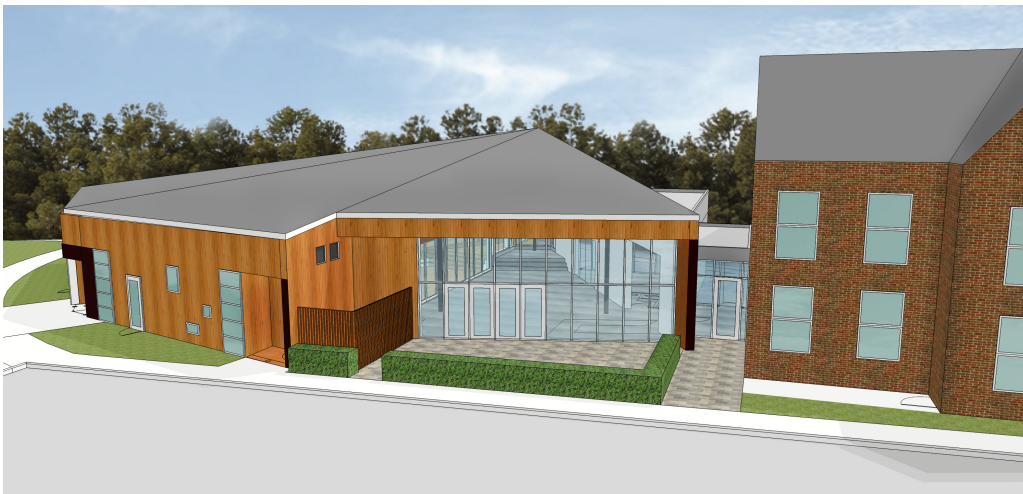
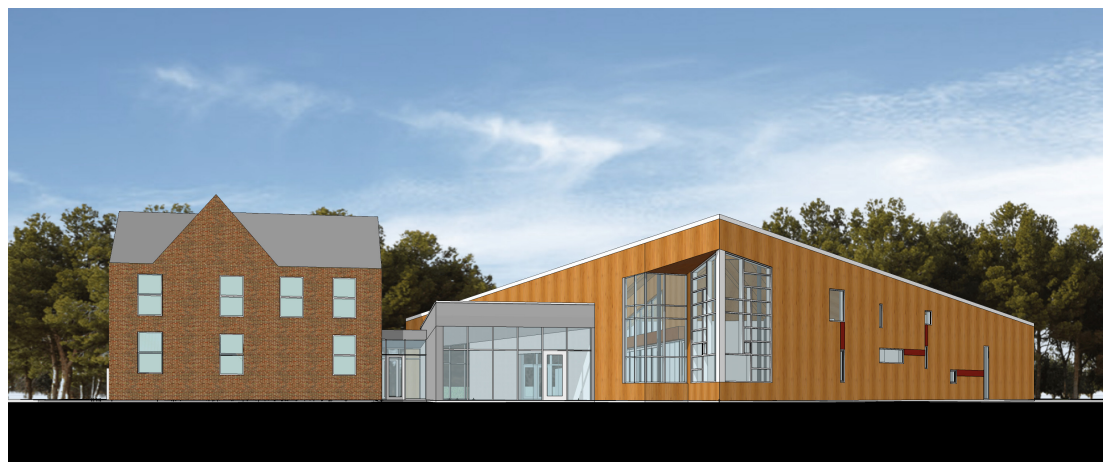
**PERSPECTIVE DRAWINGS**

- LEGEND
- 1. GALV. STANDING SEAM METAL ROOF
  - 2. PREFIN. METAL EAVESTROUGH
  - 3. CLEAR CEDAR SIDING
  - 4. ALUM. & GLASS WINDOW/CURTAIN WALL
  - 5. PREFIN. WOOD PANEL
  - 6. CEMENT FIBRE BOARD
  - 7. GALV. METAL FLASHING TO MATCH METAL ROOF
  - 8. EXTG. BRICKS

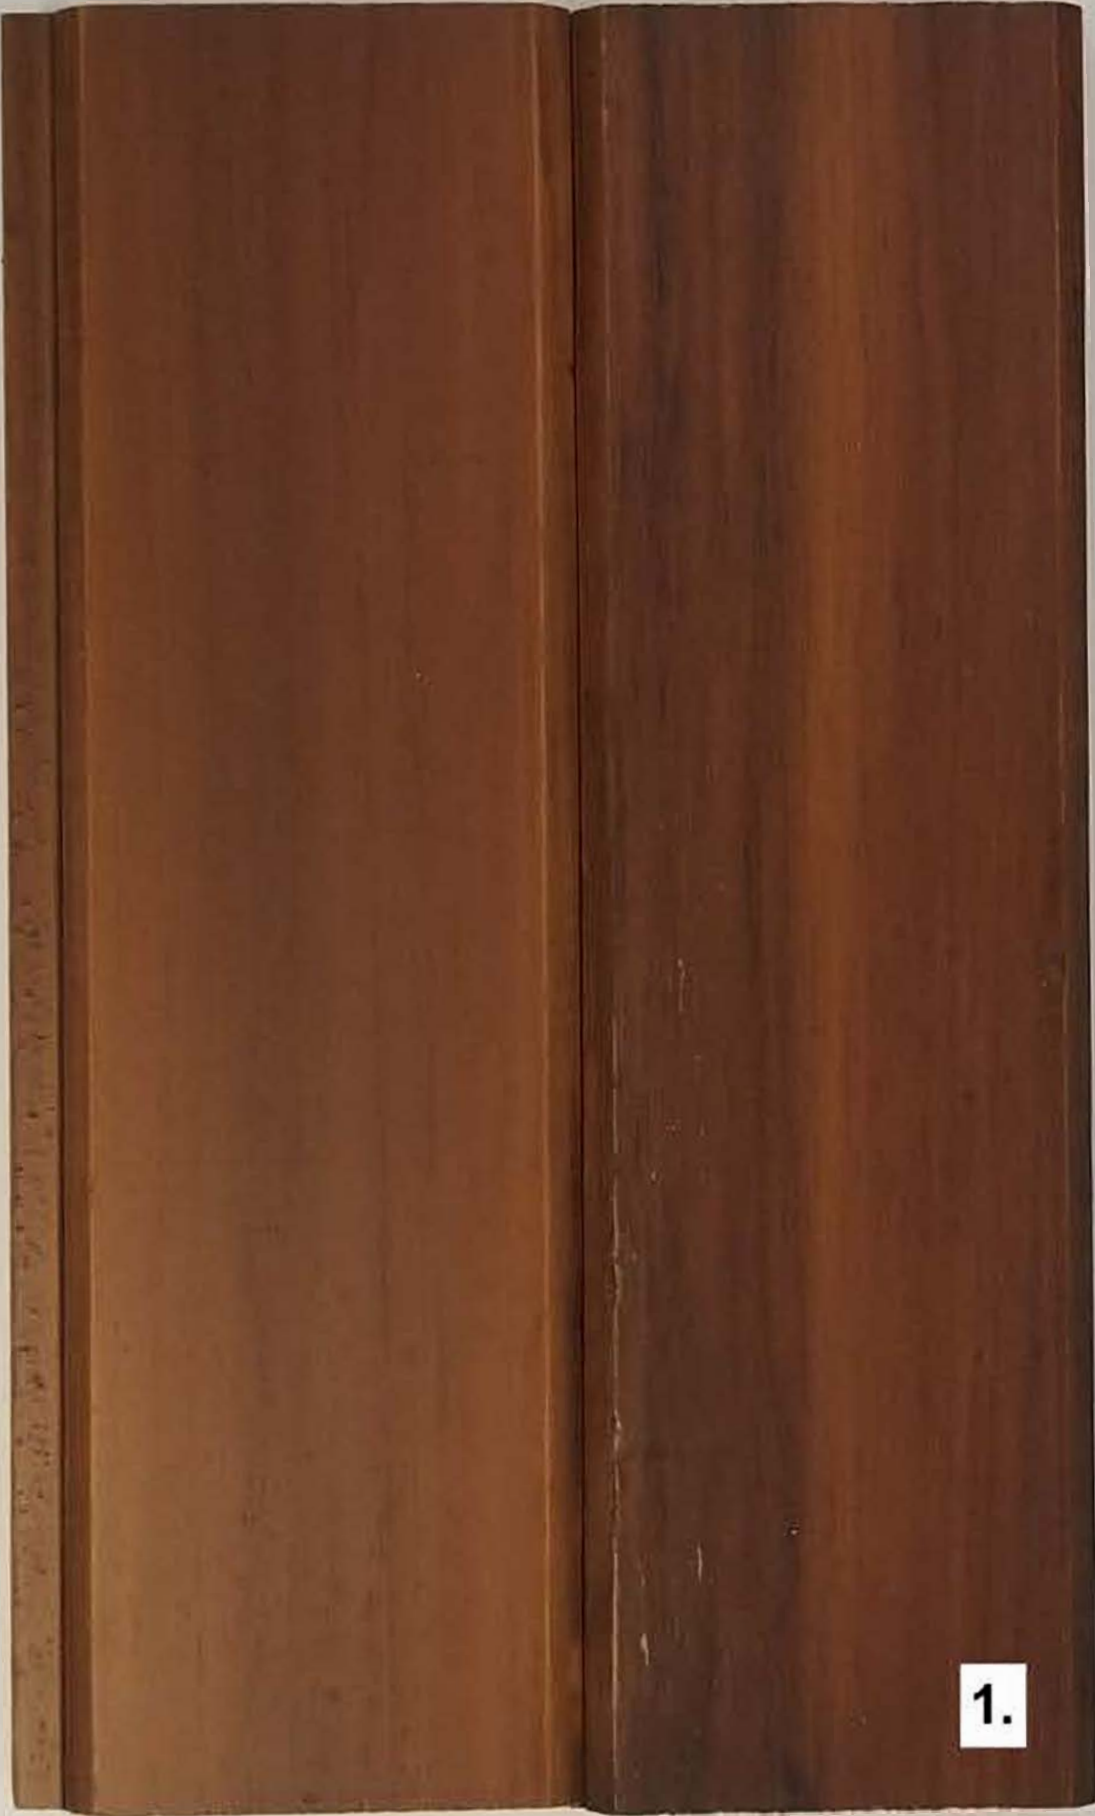
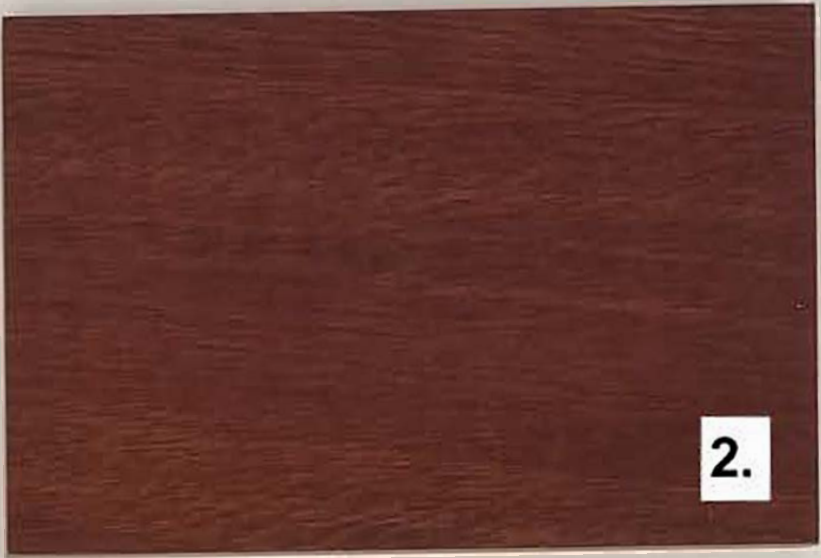
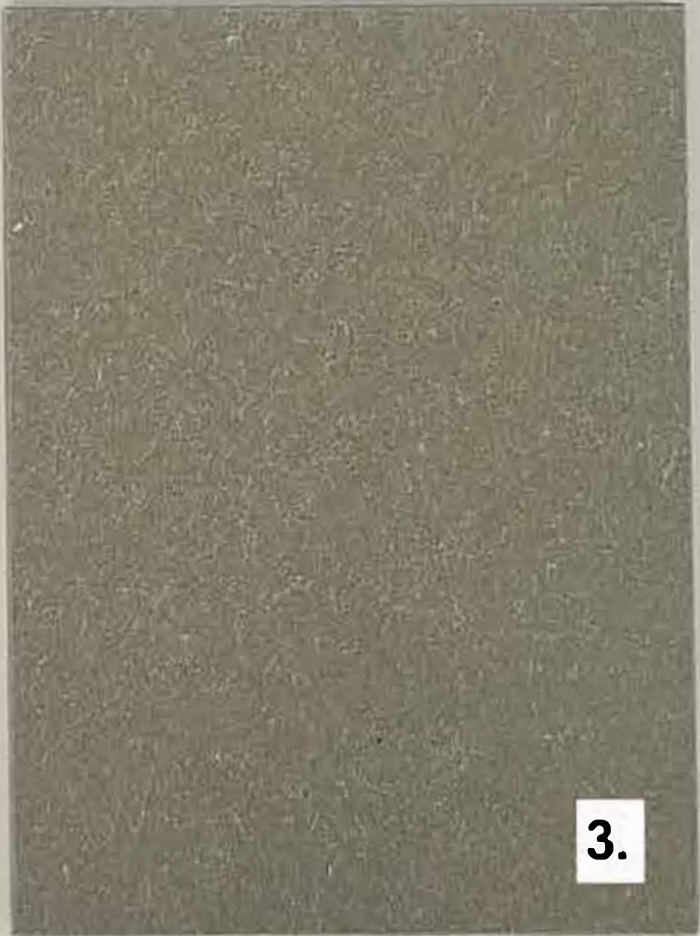
**1. CEDAR WOOD SIDING**

19x89 “V” JOINT TONGUE AND GROOVE  
CEDAR, CETOL FINISH BY CEDARONE,  
WEYERHAUESER

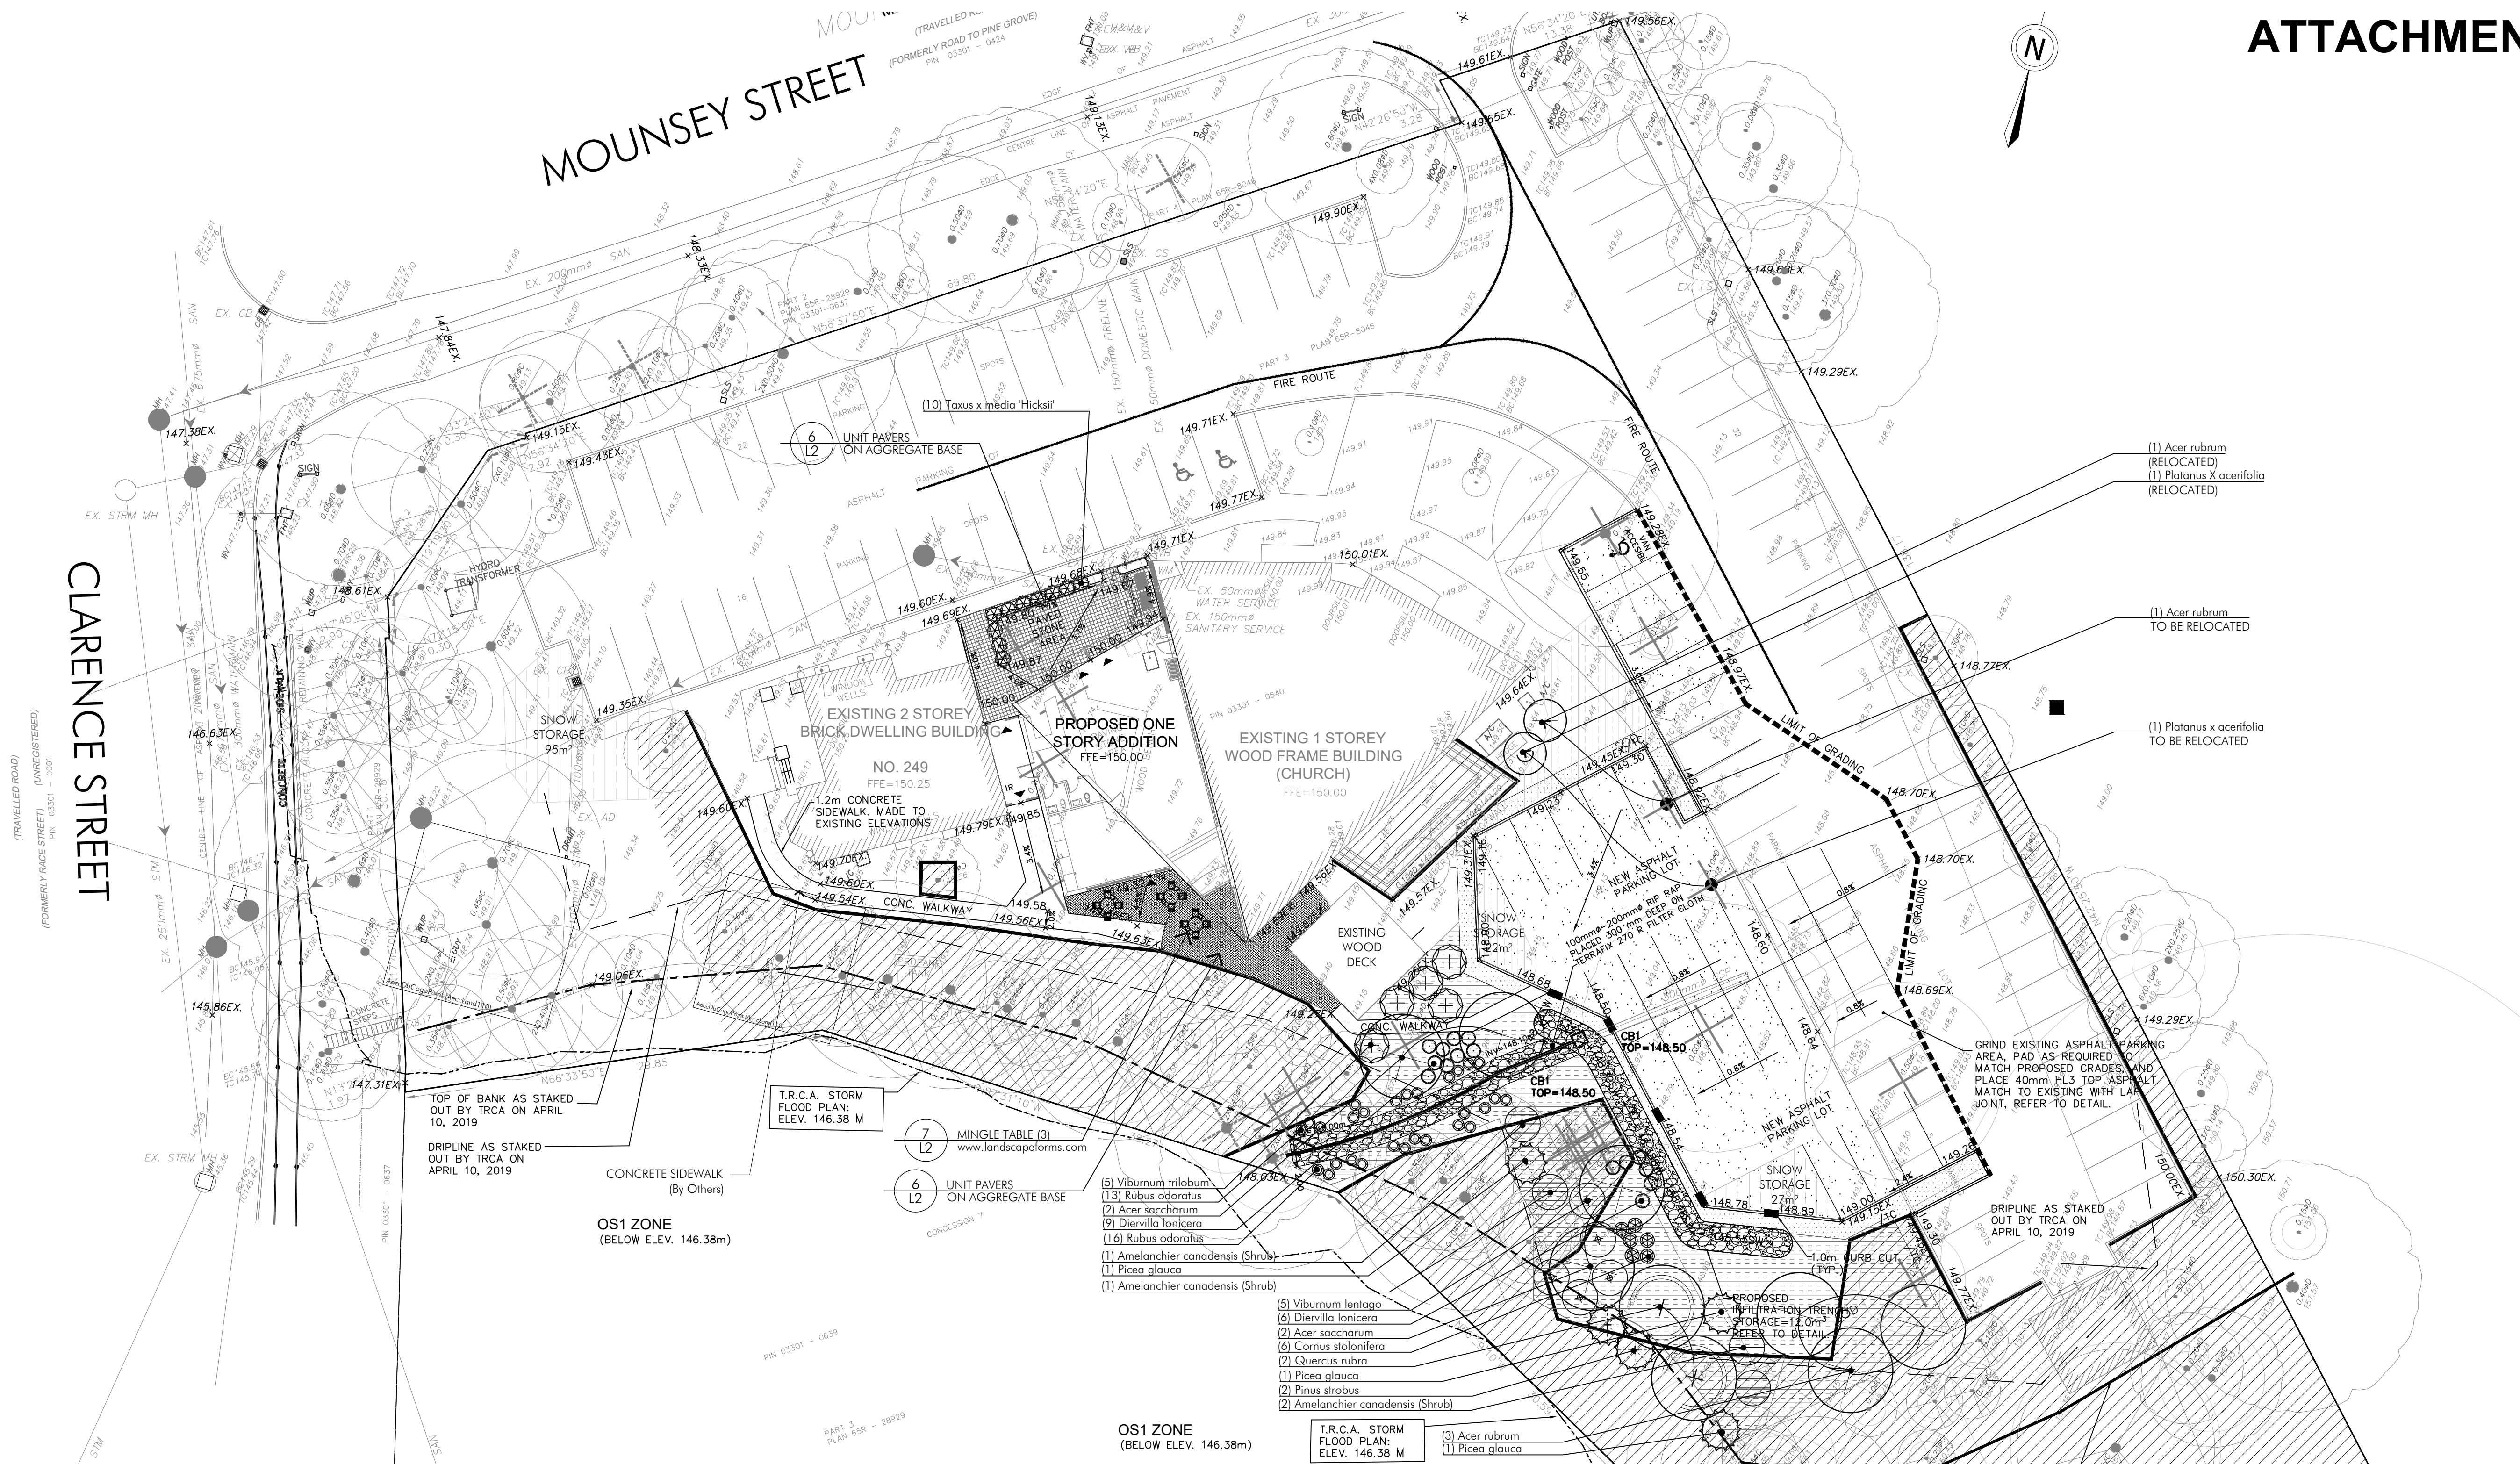
1 LANDSCAPE PLAN  
1:250

DECIDUOUS TREES						
QUANTITY	BOTANICAL NAME	COMMON NAME	SIZE-CAL	ROOT	REMARKS	NATIVE
3	Acer rubrum	Red Maple	70mm Cal.	W.B.	Straight trunk, evenly branched heads	YES
4	Acer saccharum	Sugar Maple	70mm Cal.	W.B.	Straight trunk, evenly branched heads	YES
2	Quercus rubra	Red Oak	70mm Cal.	W.B.	Straight trunk, evenly branched heads	YES
CONIFEROUS TREES						
QUANTITY	BOTANICAL NAME	COMMON NAME	SIZE-CAL	ROOT	REMARKS	NATIVE
2	Pinus strobus	White Pine	200cm ht.	W.B.	Straight, evenly branched, dense plants	YES
3	Picea glauca	White Spruce	200cm ht.	W.B.	Straight, evenly branched, dense plants	YES
DECIDUOUS SHRUBS						
QUANTITY	BOTANICAL NAME	COMMON NAME	SIZE-CAL	ROOT	REMARKS	NATIVE
4	Amelanchier canadensis (Shrub)	Shadblow Serviceberry Clump	80cm Ht./5 Gallon min.	Cont.	Evenly branched, Min 3 canes	YES
6	Cornus stolonifera	Red Osier Dogwood	50cm Ht./3 Gallon min.	Cont.	Full, dense plant	YES
15	Diervilla lonicera	Bush Honeysuckle	40cm Ht./3 Gallon min.	Cont.	Full, dense plant	YES

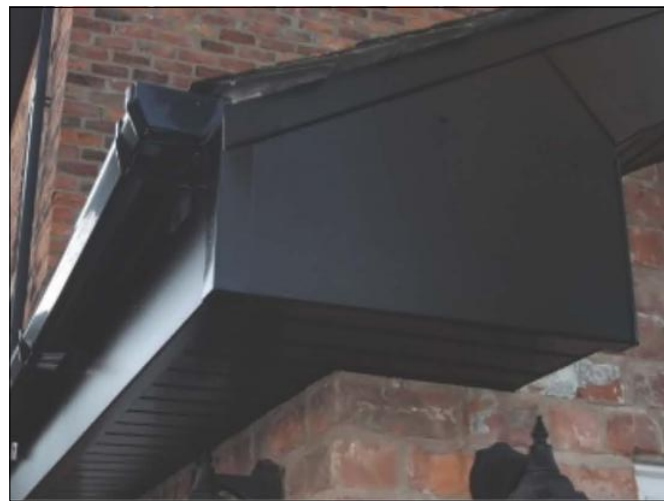
SOFFIT AND FASCIA (BLACK)

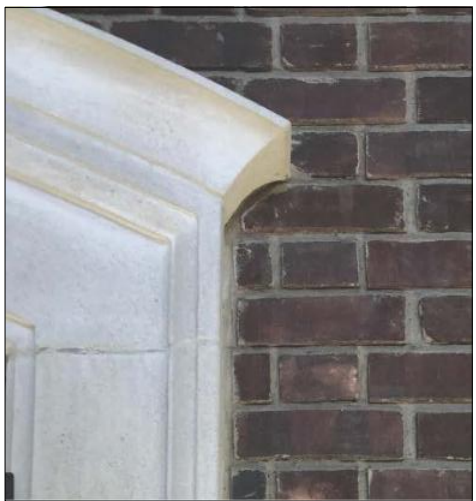
NATURAL MAN-MADE STONE OR  
EQUIVALENT PRE-CAST FIN.  
CORNICE MOLDINGS, SURROUNDS,  
HEADERS & SILLS AT BACK AND  
SIDE ELEVATIONS (TYP). AS  
SPEC'D.

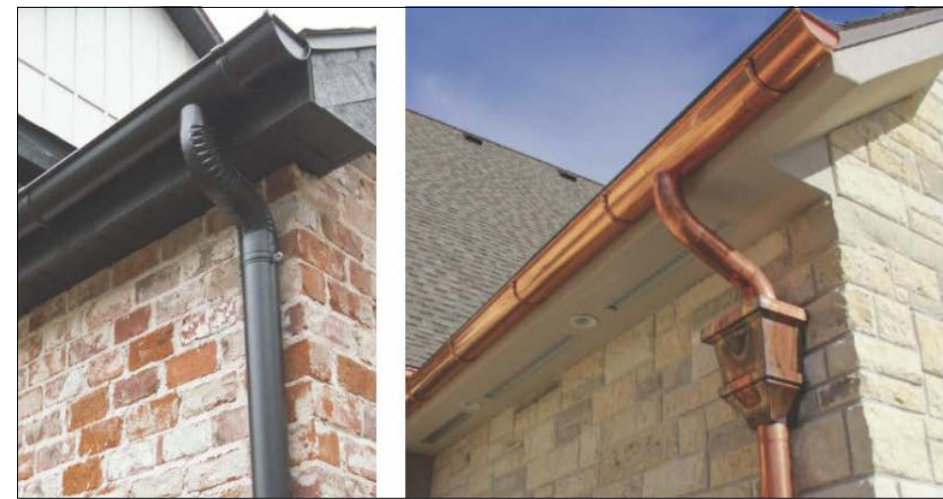
HALF ROUND GUTTERS AND LEADERS (BLACK)

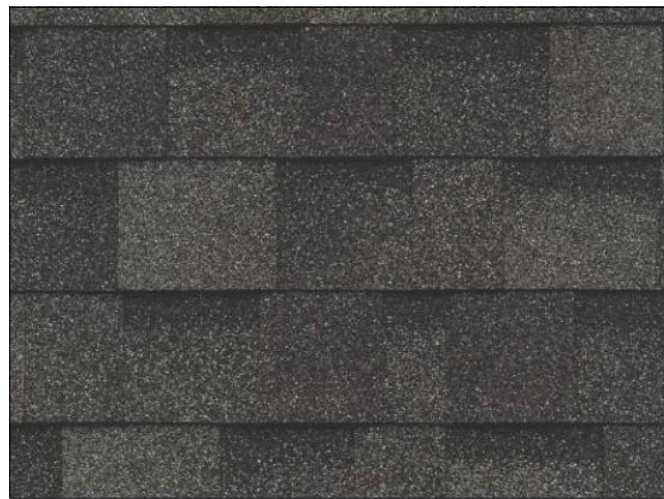
ROOF SHINGLES:  
IKO ASPHALT CAMBRIDGE

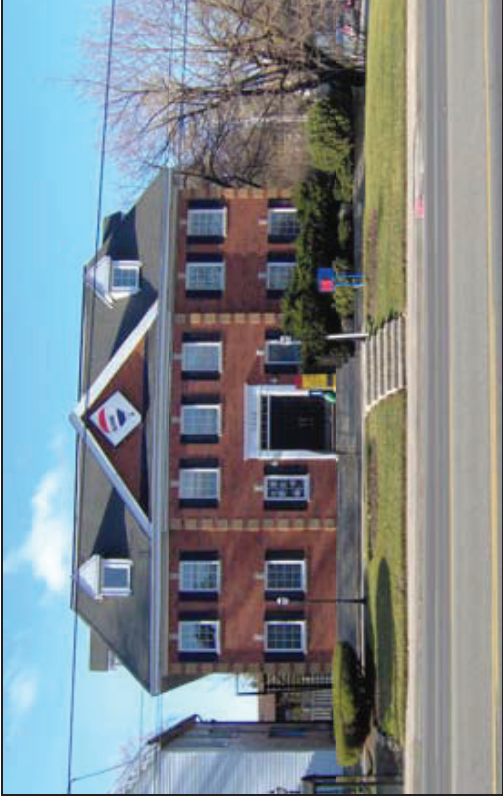
Location: 7646 Yonge Street  
Year Built: 1987  
Style: Modern Neo-Classical  
Stores: 2 1/2  
Classification:

Cladding: Polychrome Brick  
Roof: Hipped, with central gable and dormers, asphalt shingles.  
Windows: Fixed, with muntins mimicking double-hung 6/6

Description: Symmetrical 3-part composition with slightly projecting 3-bay centre section having moderate slope front gable roof with a closed pediment. Entry is flanked by two narrow windows, and has double doors with a divided transom above, set in a classical surround. Side sections each have two bays, and dormers sit above the inner bays. There are also dormers on the side roofs. Windows are of equal size, except for the two flanking the entry, and the dormer windows. All windows have shutters and flat brick arches with rock-faced keystones. All corners of brickwork are quoined. Corner lot. Front lawn and maturing landscaping including foundation shrubs and trees on the right front and right side.
