ATTACHMENT 4

RE: Commemoration Options for Henry Burton House 8811 Huntington Road, Vaughan, Ontario

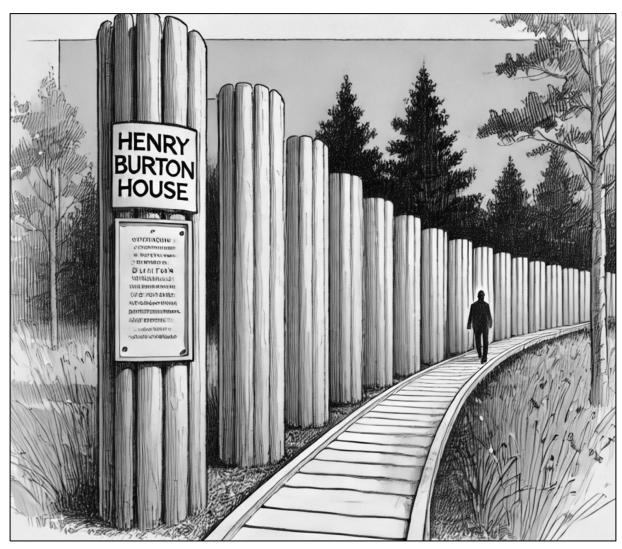
Figure 1 - Artistic Rendering of Option 2 (Vertical Log Display)

• **Description**: This option involves selective salvaging of sound, non-rotted logs from the house, which would then be incorporated into an interactive vertical display along the planned future trail network. The logs could be arranged upright in a way that reflects the house's original structure or design, allowing visitors to engage with the materials in a meaningful way. Figure 1 below provides an artistic rendering (created using generative artificial intelligence) of how some of the logs can be displayed along the future trail. Note that the artistic rendering below in Figure 1 shows many longs along a trail, and only a few logs may be required to create this display.

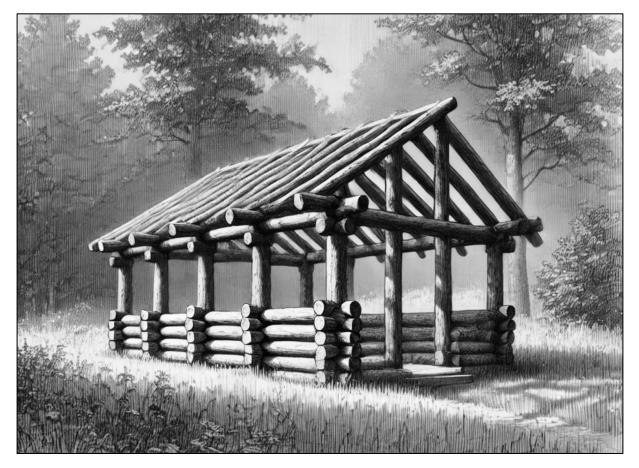
Figure 2 - Artistic Rendering of Option 3 (Gazebo or Pergola)

- **Description**: This option involves stripping the Henry Burton House down to its base logs, which would be cleaned and used to construct a gazebo or open-air shelter off an offshoot from the planned trail network in its current location. This gazebo would provide a functional and unique space for visitors while using materials from the original house. Figure 2 below provides an artistic rendering (created using generative artificial intelligence) of how the Henry Burton House could be repurposed into a free-standing gazebo / pergola structure in place.
- Key Benefits:
 - **Functional Public Space**: A gazebo / pergola offers both commemorative and practical value, providing a unique historical shelter that can serve as a focal point for visitors.
