# Vaughan Humber Trail

**Boyd Conservation Area  
to Steeles Avenue**

**Feasibility Study**

Schollen & Company Inc.

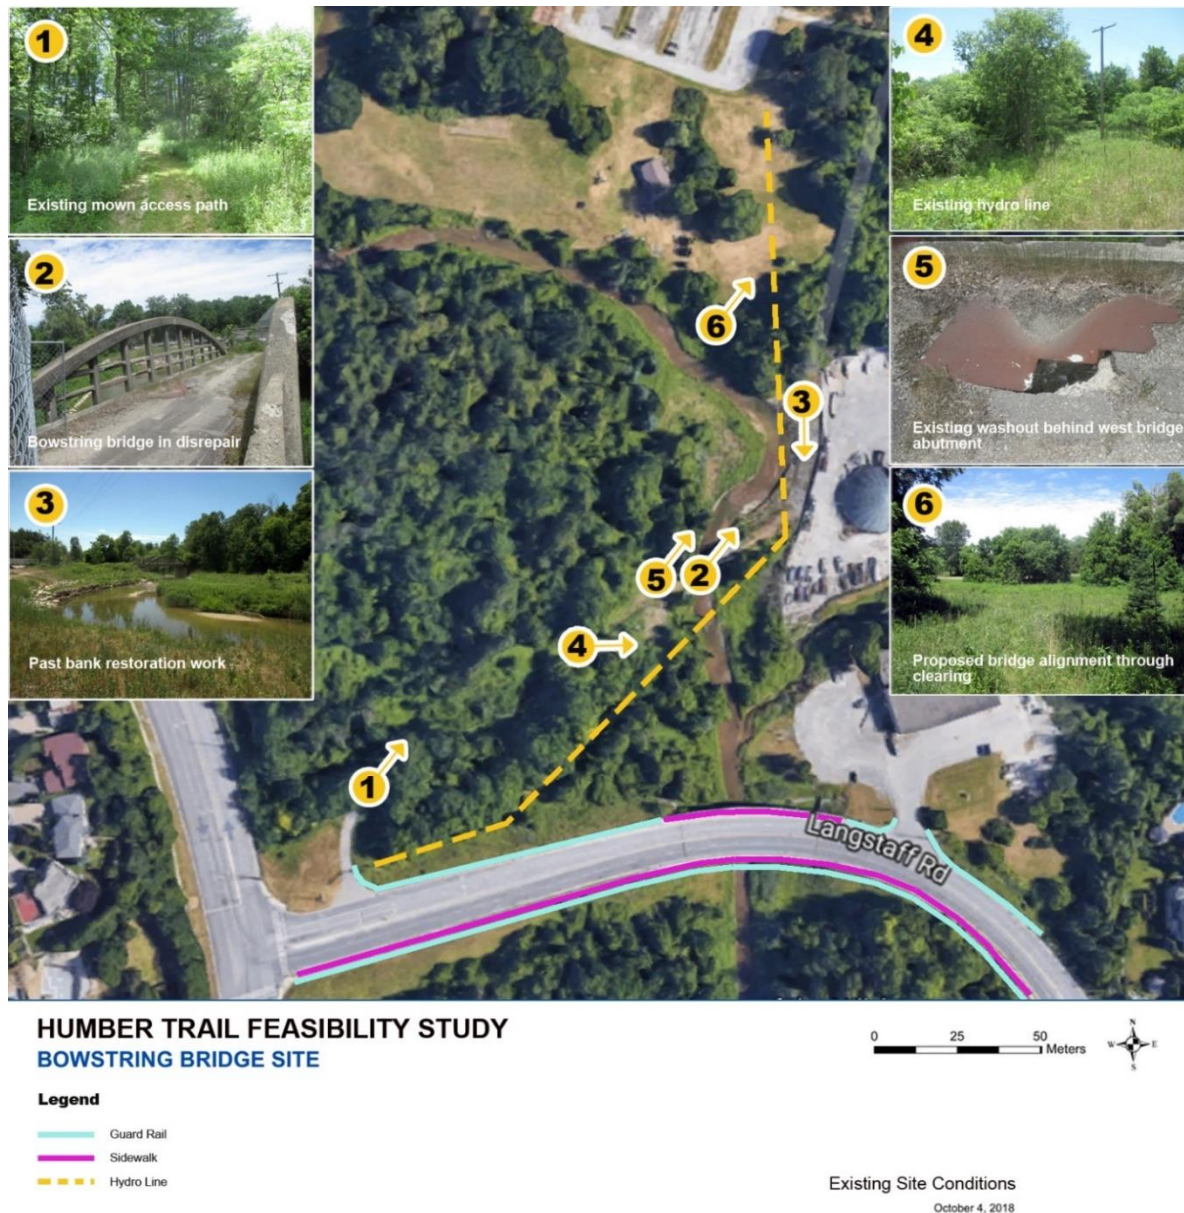
**Figure 5: Focus Area 2 - Existing Conditions Plan Enlargement**

Another challenging site with respect to trail alignment is located north of Langstaff Road at the south end of the Boyd Conservation Area. An historical bowstring bridge that crosses the Humber River has fallen into disrepair and has been barricaded to public access due to safety concerns (Refer to Photos 38-40, Figure A-1.1, Appendix A). The bridge is located within the TRCA owned and managed Boyd Conservation Area lands and is not a City of Vaughan asset. The bridge designed by Charles Mattaini in the 1920s is considered to be one of a remaining few good examples of bowstring bridge construction within the Greater Toronto Area (Brennan, 2018). A preliminary engineering review conducted as part of this Study is included at Appendix C. This study presents and sets out potential options for removal or rehabilitation of the bridge. This particular site is complex and this is the rationale for identifying this site as **Focus Area 2** as illustrated on Figure 2. A summary of the issues and opportunities for consideration in the process of generating the trail plan in this area was considered:

- Structural deterioration
- Closed due to safety concerns
- Unsuitable crossing location (at bend in river side)
- Redside Dace habitat
- Bridge has cultural heritage value

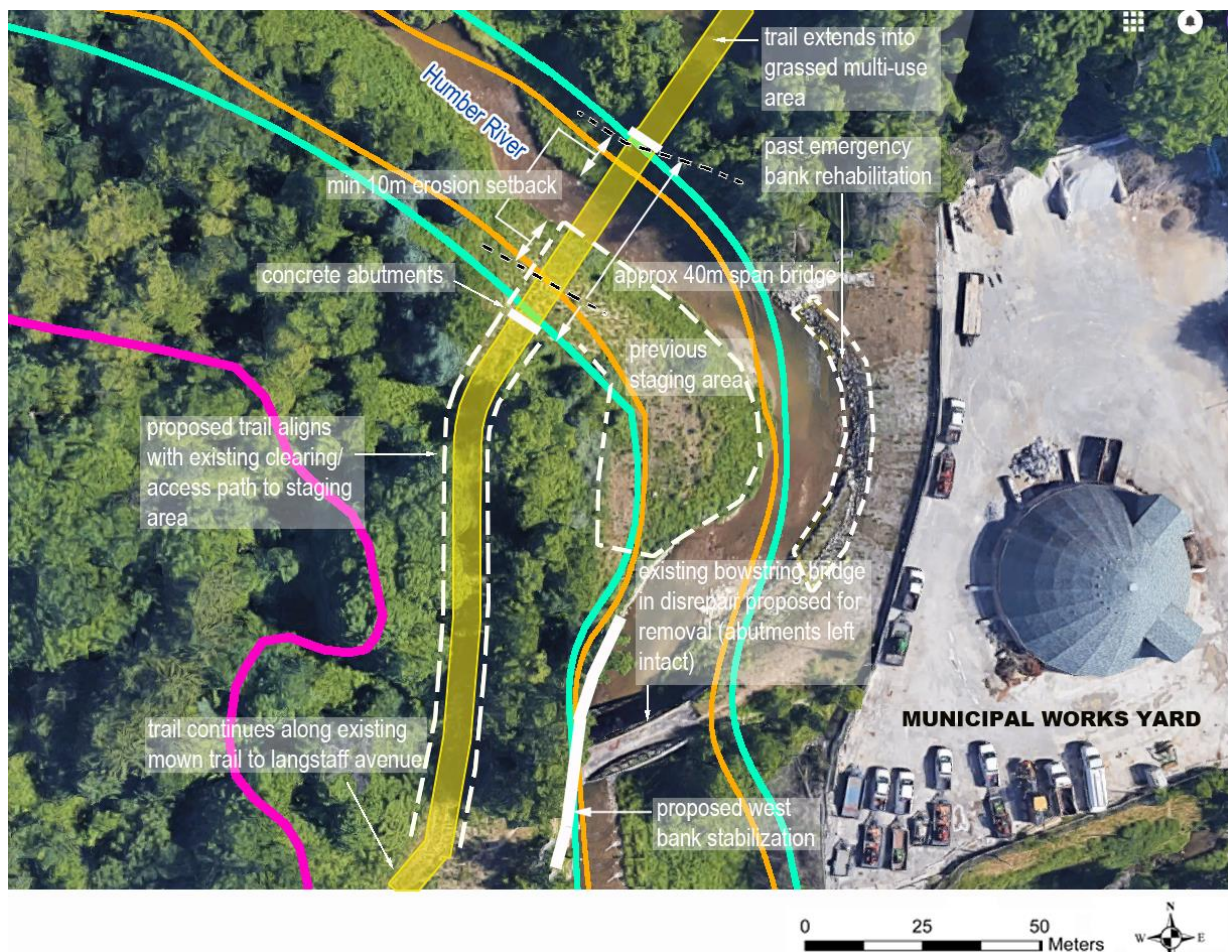
**Figure 6:** Focus Area 2 Concept Plan Enlargement

- New bridge in a new position
- Existing cleared path provides a route with limited new disturbance
- Restoration to improve stability of the river is possible
- Direct connection to open spaces and main parking lot

- A more direct connection to the picnic sites within the Conservation Area across the river;
- A favourable position away from the erosion-prone outer bend in the river, which is subject to greater erosion;
- Avoids potential conflict with the City Works Yard;
- Affords more space in which to adequately span the river to suit current regulations and best practices; and,
- Affords space in which to stabilize and restore the creek banks.
