**CITY OF VAUGHAN
HERITAGE VAUGHAN COMMITTEE
AGENDA**

Heritage Vaughan Committee Report

TITLE: REDEVELOPMENT OF HERITAGE PROPERTY AND NEW INFILL DEVELOPMENT LOCATED AT 2291 MAJOR MACKENZIE DRIVE, MAPLE HERITAGE CONSERVATION DISTRICT (REFERRED)

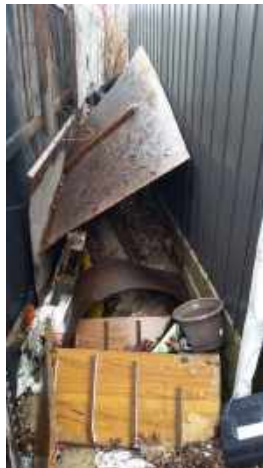
Storage of material / debris on site

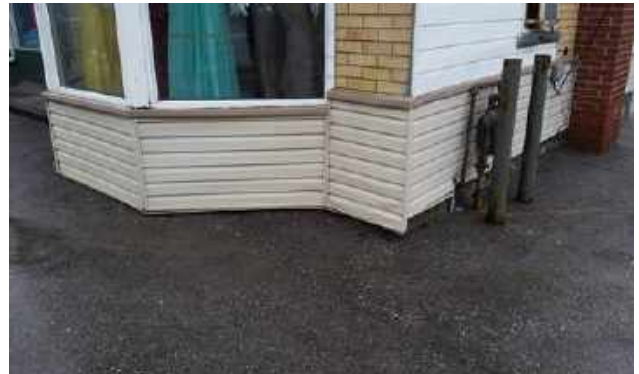
Siding extends to grade at front of dwelling

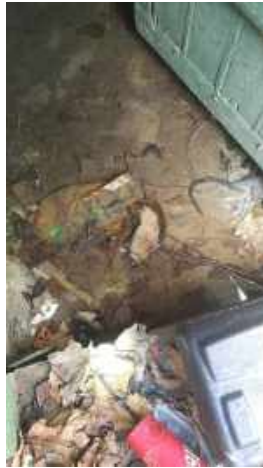
Standing water at bottom of walkout. Note dead rat floating in water.

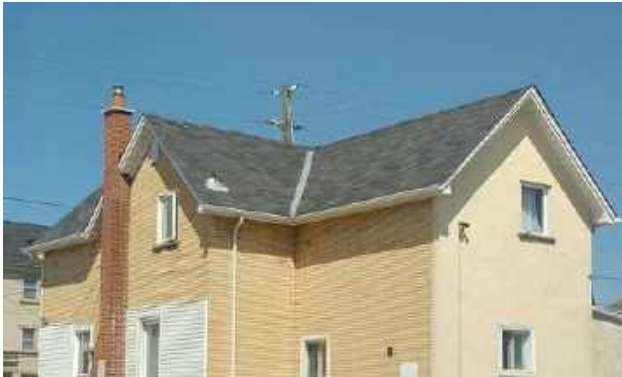
Gable roof type

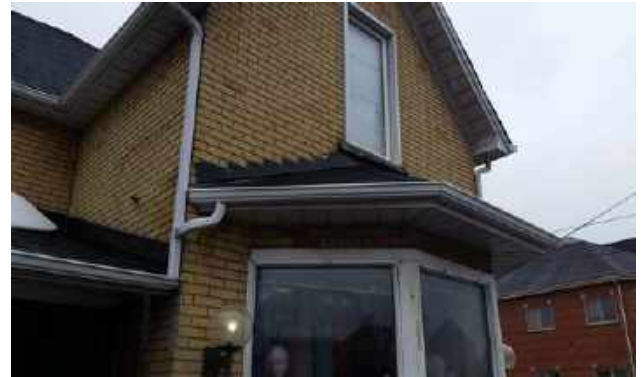
Lower roof areas also noted as shingled

The owner is advised to budget to replace the roof covering on lower roof planes within the next 3 - 5 years
based on the anticipated life cycle. Replacement of the covering should include evaluation of roof sheathing
(and replacement as required) which may have sustained damage in areas reliant on wall flashing to
maintain water tightness. Consult with a qualified roofing contractor.

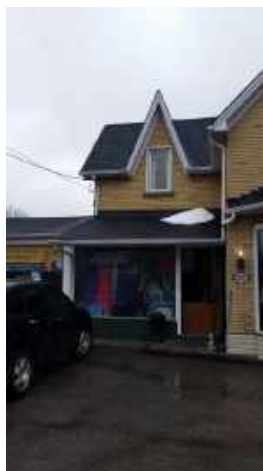
Various roof planes / slopes noted

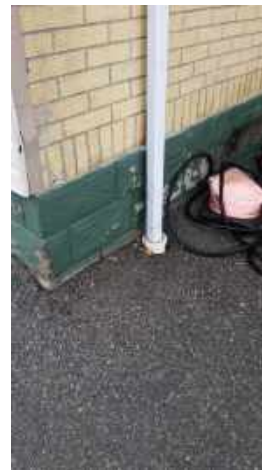
Downspout below grade discharge

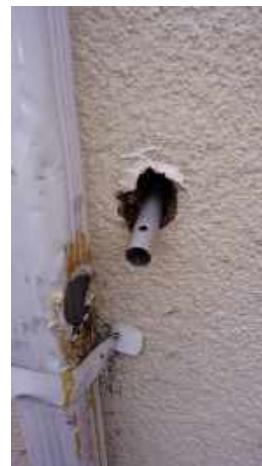
Damaged / perforated downspout

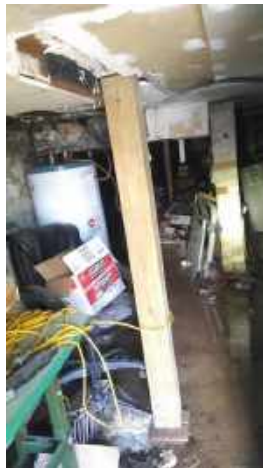
Interior view of basement

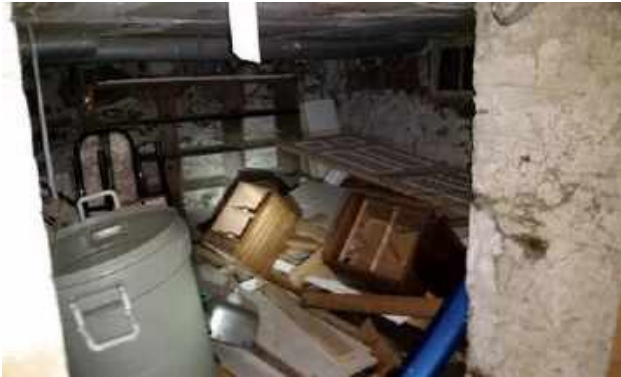
Material storage within the basement prevented complete visual access to all floor and wall areas.

Storage of material in basement noted

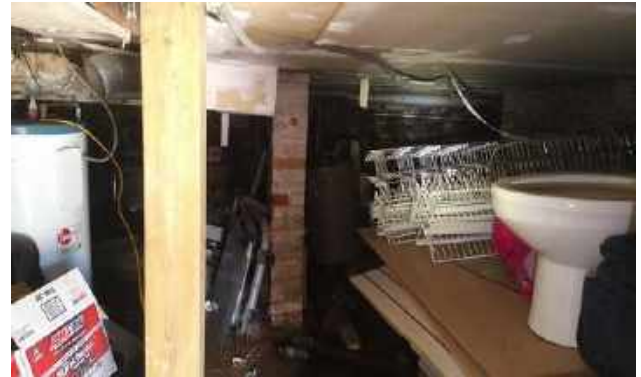
More stored material

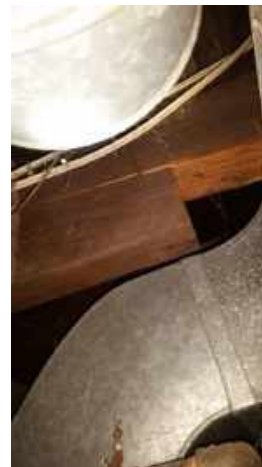
In addition, some of the floor joists were noted as cracked / damaged.

Cracked / compromised floor joist

Removal of all drywall as part of the required mould remediation.
Consultation with a mould remediation contractor and then a professional engineer / designer to evaluate the condition of the wood floor structure in addressing any structural damage / alterations in place intended to modify the original structure.

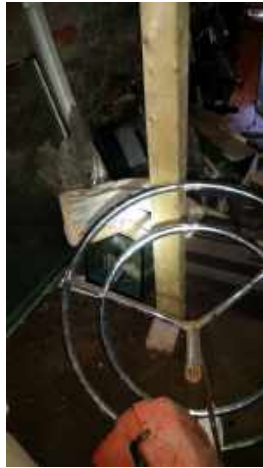
A masonry load bearing wall was noted within the middle of the basement which did not appear structurally compromised. However, some additional vertical support elements were noted comprising of pressure treated 4" x 4" posts that support structural steel angle-irons placed directly below and perpendicular to the span of the floor joists, which suggest they are intended to support the structure above them. These posts are placed on a base of stone pavers but there is no physical connection / fastening of the posts to the angle-iron or the stone base / footing.

Wood post supported on stone paver units

The design and condition of the vertical wood posts installed in the basement needs to be evaluated by a professional engineer / designer to determine the appropriateness / effectiveness in facilitating their intended purpose.

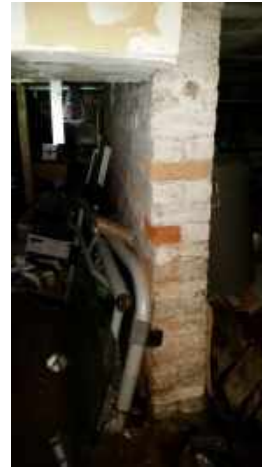
Brick load bearing wall

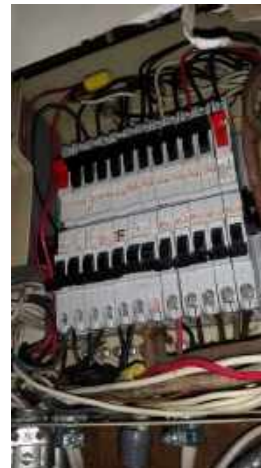
As well, a number of breakers were noted as double tapped within the panel (mostly 15 amp) which suggests the number of breakers is not sufficient. As well, no markings were available to determine what these circuits serve within the dwelling.

Panel noted as full. No spare circuits / breakers available

Consult with a qualified professional electrician to evaluate the breaker panel as well as the double tapping noted and effect required repairs in accordance with applicable standards / regulation to make it safe.

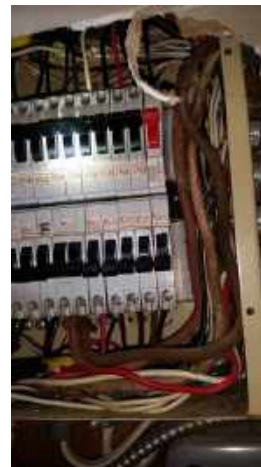
Old cloth sheathed wiring noted in panel servicing the stove still in place

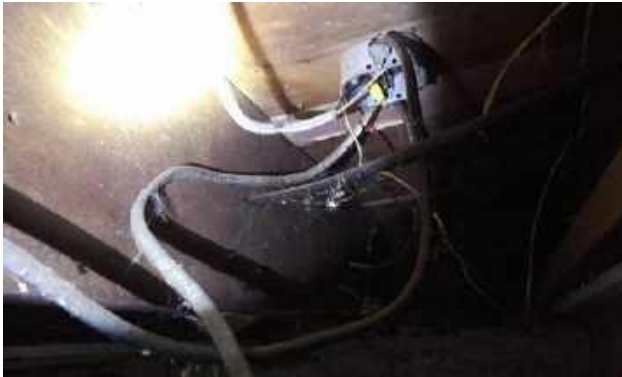
The wiring in the dwelling is a mix of old ungrounded 2-wire type mixed with newer 3-wire type. As such, the circuits are not grounded. Although most of the old wiring is cloth sheathed type, some knob and tube was also noted in the basement which was still live at the time of inspection.

Old wires spliced with new in open junction box

use, as it relates to the electrical demand placed by on them in conjunction with an evaluation of the entire system to effect the required changes / upgrades that enable use by current standards.

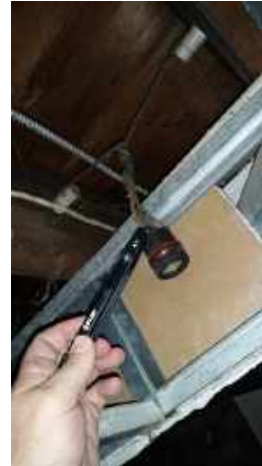
Old active knob and tube wiring

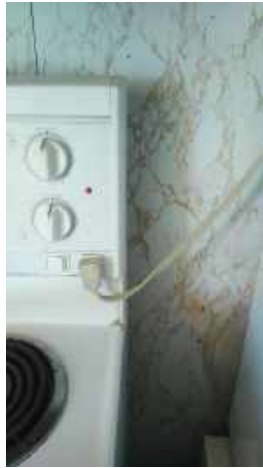
Stove outlet also used for small appliance

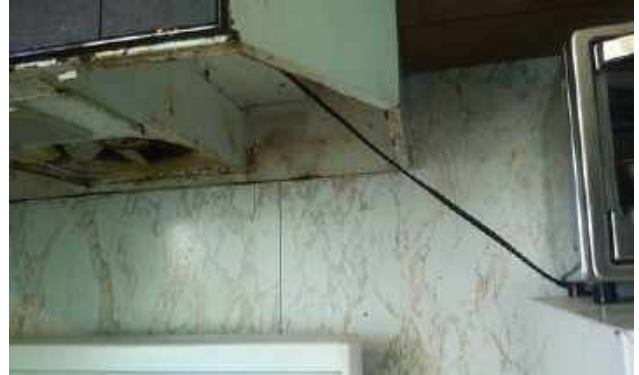
Kitchen fan connection to outlet

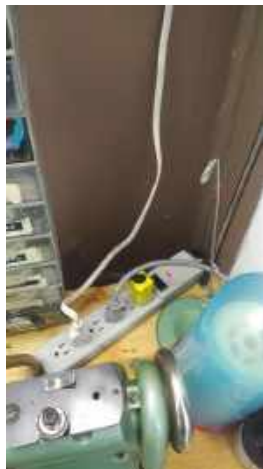
Inordinate number of power bars in use

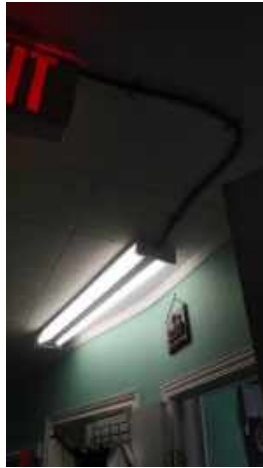
Inoperative and broken fixture were noted within the dwelling. Some fixtures were noted without covers over fluorescent bulbs, which pose a hazard to occupants who may come in direct contact with them resulting in breakage and the release of toxic gases.

Exposed fluorescent bulbs

Replace any broken / inoperative light fixture throughout the dwelling as required in conjunction with other recommended electrical work to be conducted by a qualified professional electrician.

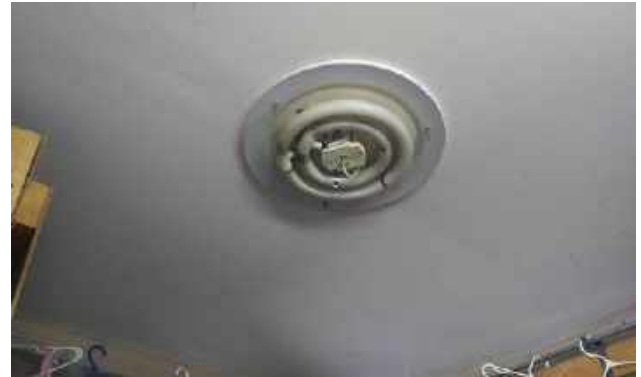
Inoperative fixture

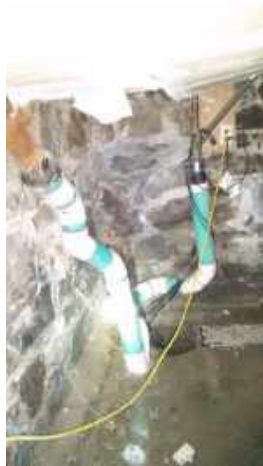
Cast iron and brass connection to newer PVC type drain pipe in basement

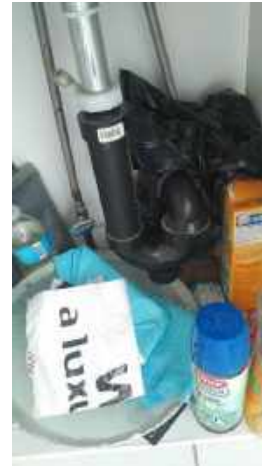
S-Trap drain configuration under second floor bathroom sink

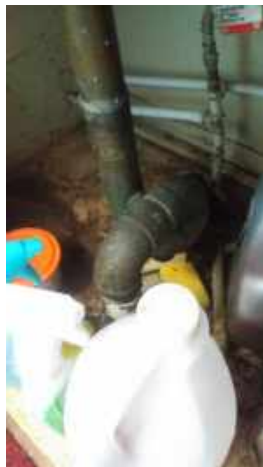
S-Trap drain configuration under main kitchen bathroom sink

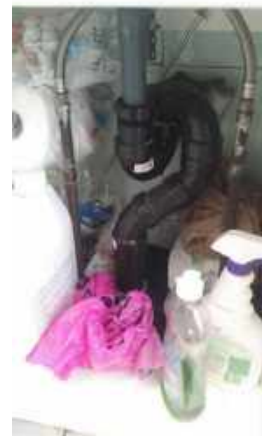
S-Trap drain configuration under main floor bathroom sink

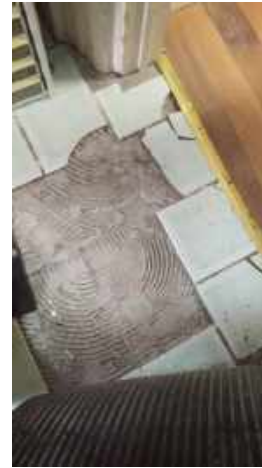
Cracked / broken floor tile

Consult with a qualified flooring contractor as required.

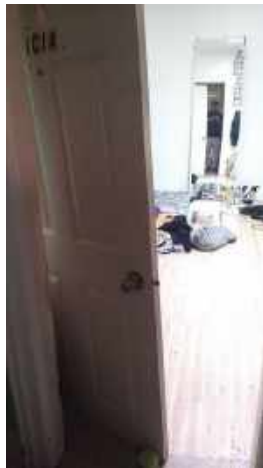
Door removed from hinges

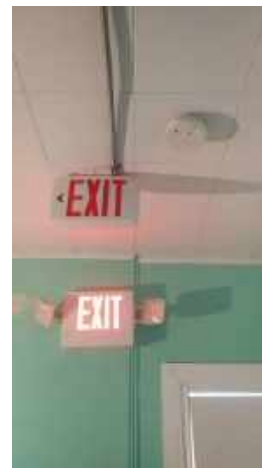
Second floor level detector

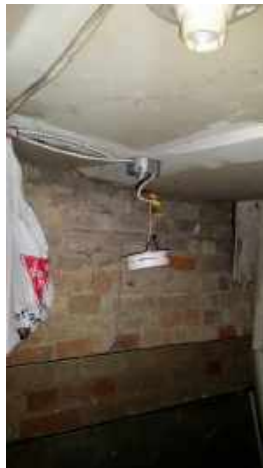
Smoke detector in basement hanging from junction box

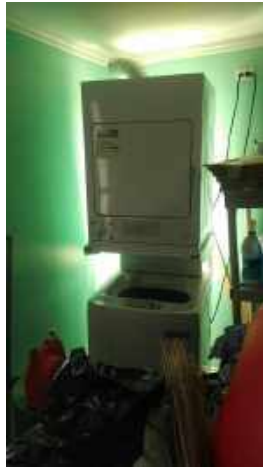
Stacked washer / dryer enclosed porch

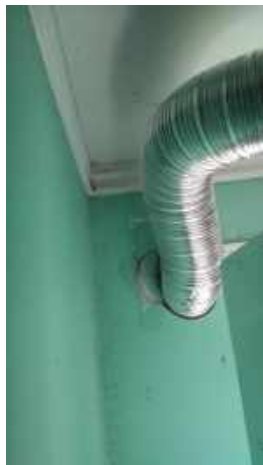
Dryer venting

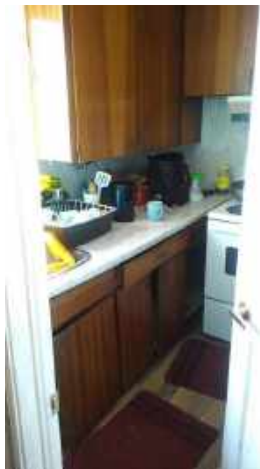
Nonetheless, the condition of the kitchen was found to be in a general state of disrepair. Cupboards, counters and appliances are old and in need of renewal.

Main floor kitchen

Renew / renovate kitchen as required to bring it back to a usable state.

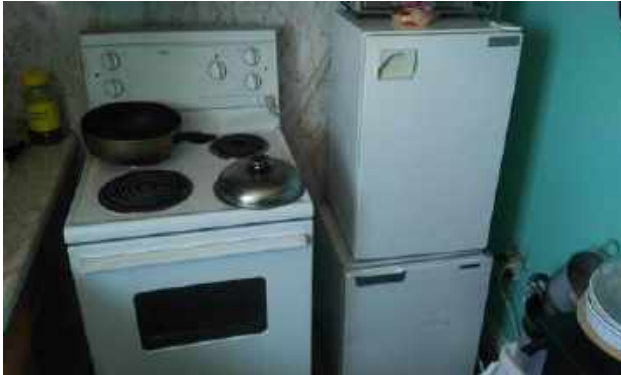
Appliances noted in place

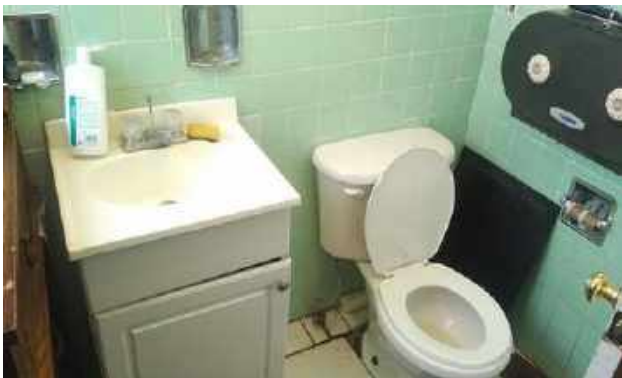
The condition of the bathrooms was found to be in a general state of disrepair. All fixtures are old and in need of renewal.

Main floor bathroom

Renew / renovate bathrooms as required to bring them back to a usable state.

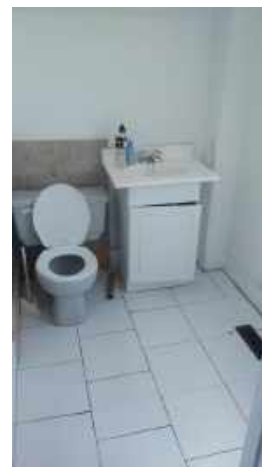
Second floor bathroom

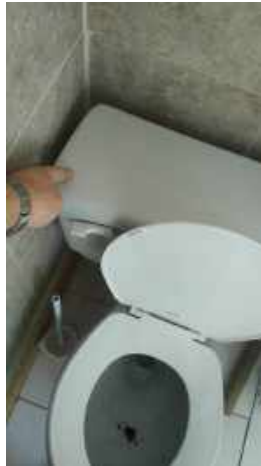
Toilet in second floor bathroom was noted as a loose and requiring tightening / re-securing to floor. In doing so ensure flange gasket is not damaged / compromised.

Loose toilet in second floor bathroom

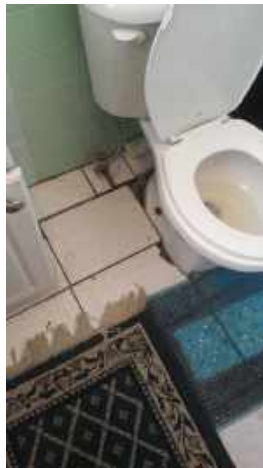
The floor within the bathroom was noted as old / deteriorated with significant water penetration noted in substrate material with the aid of a moisture sensor.

Toilet does not sit on tile but below it. Tile not fitted around toilet leaving gaps.
