### **EXTRACT FROM COUNCIL MEETING MINUTES OF OCTOBER 21, 2020**

#### **6. PRESERVATION AND REHABILITATION OF THE HENRY BURTON HOUSE, LISTED UNDER PART IV, LOCATED AT 8811 HUNTINGTON ROAD**

In September 2018, Anatolia Capital Corporation (ACC) retained Golder Associates Ltd. (Golder) to conduct a Cultural Heritage Impact Assessment (CHIA) for the property at 8811 Huntington Road, part of the west half of Lot 13, Concession 9, in the City of Vaughan, Regional Municipality of York, Ontario. The 32.98-hectare property includes a storey-and-a-half Georgian-style vernacular log house known as Henry Burton House, two barns, the stone foundation of a barn, outbuildings, and agricultural and natural lands, and is listed on the City's *Heritage Register*.

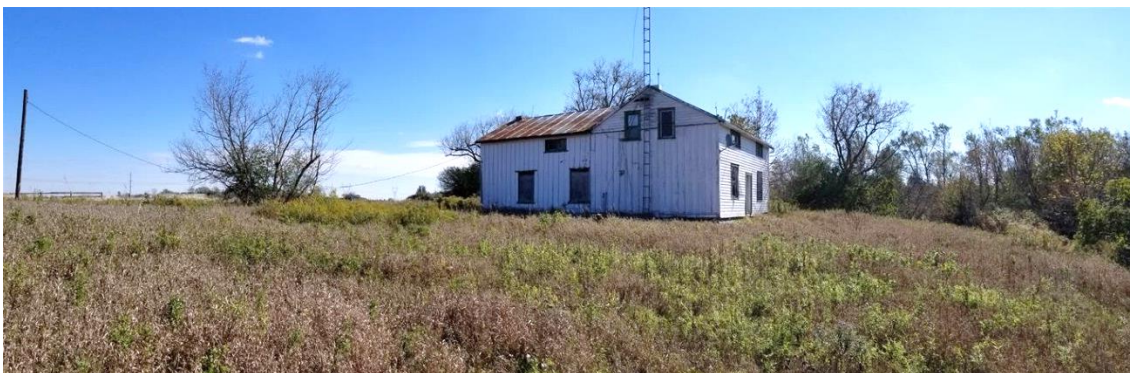
Figure 10: View facing south, just north of Henry Burton House.

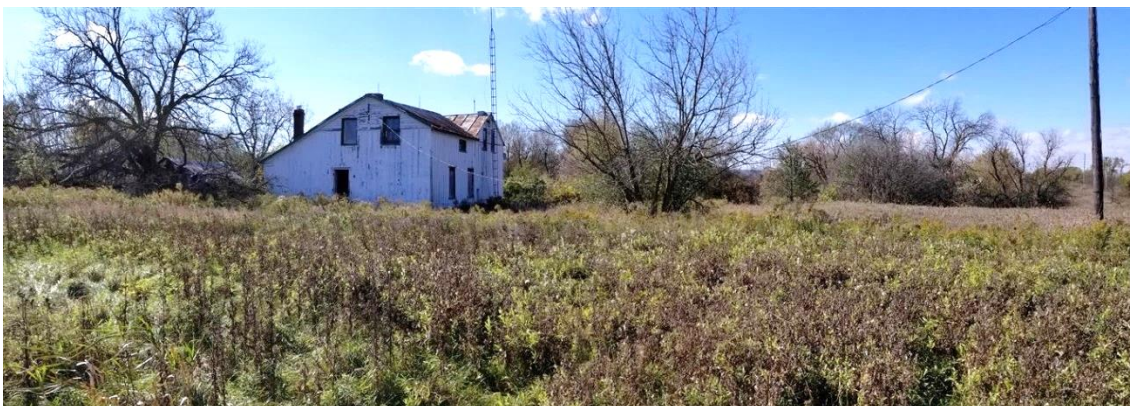
Figure 11: View facing west, from east of the residence

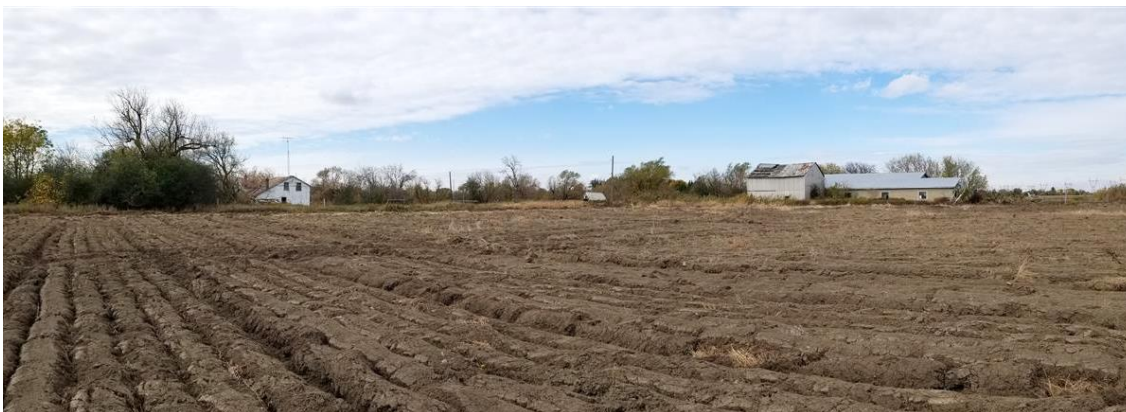
**Figure 12: View of residence, outbuildings, and barns from the east side of the property.**

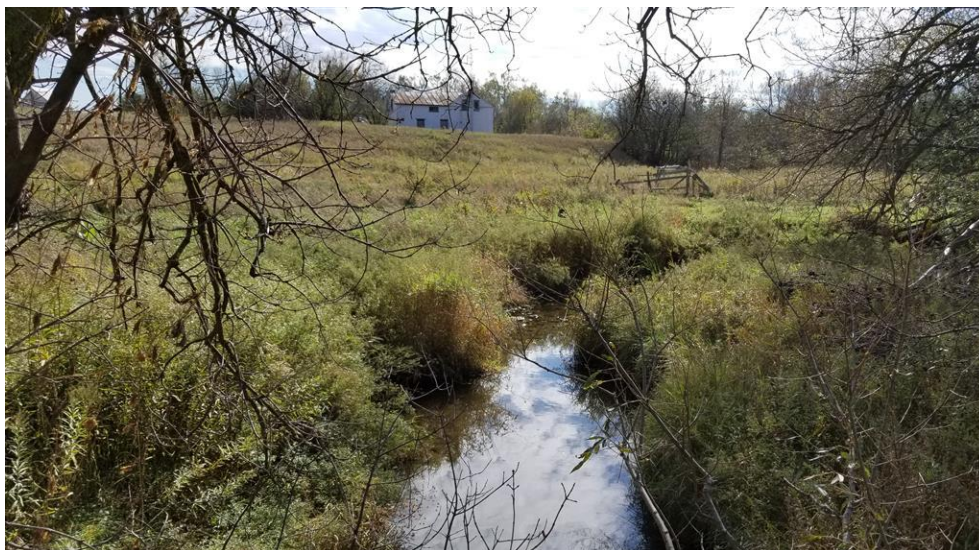
**Figure 13: View facing south, with Rainbow Creek in the foreground.**

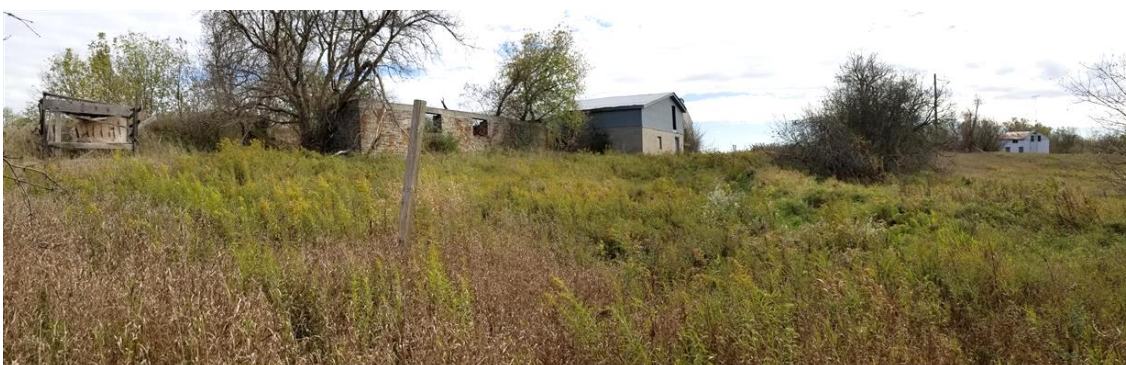
**Figure 14: View of stone barn foundation and barns, facing south. Residence is in the background.**

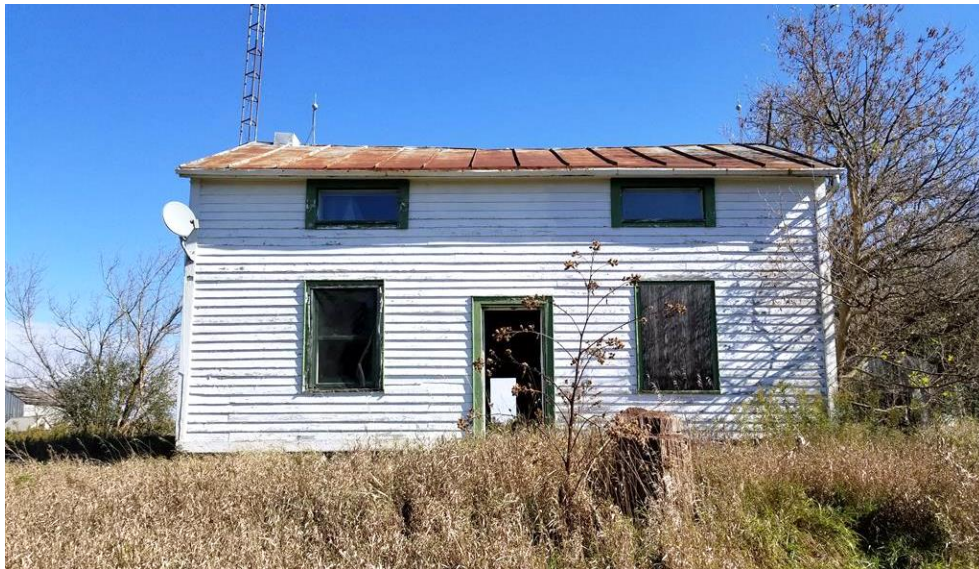
Located on the west half of the property, the Main Block has a rectangular footprint. It is a single-detached, storey-and-a-half, three-bay residence with a rectangular plan oriented north-south. The structure stands on a coursed rubble foundation. Exterior walls are covered by board and batten on the north, south, and west sides, and thin horizontal wood clapboard siding on the main façade (Figure 16 to Figure 21).

**Figure 16: West façade of Henry Burton House.**

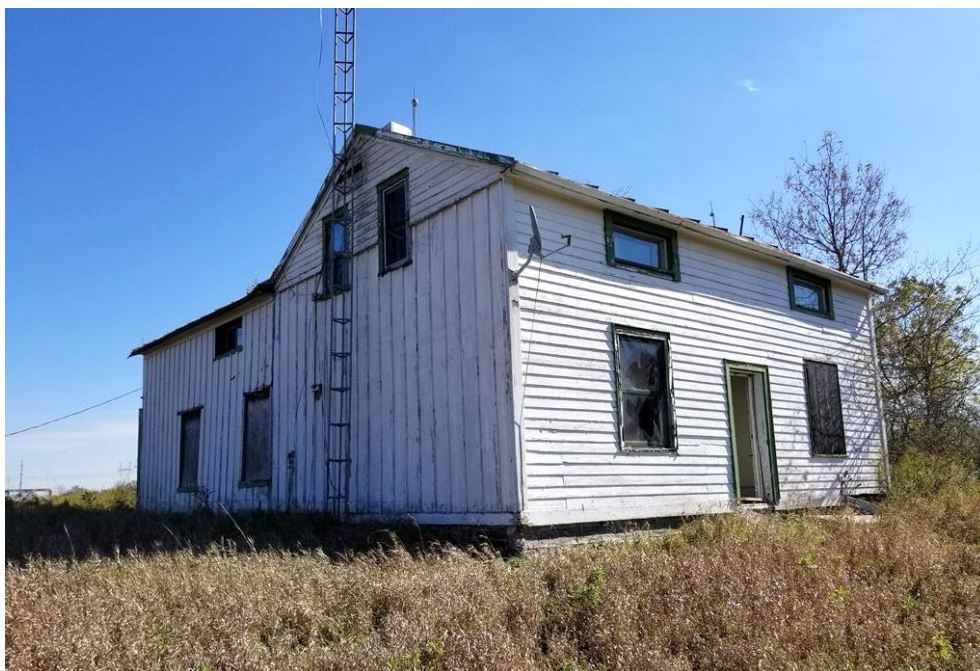
**Figure 17: West and north façades.**

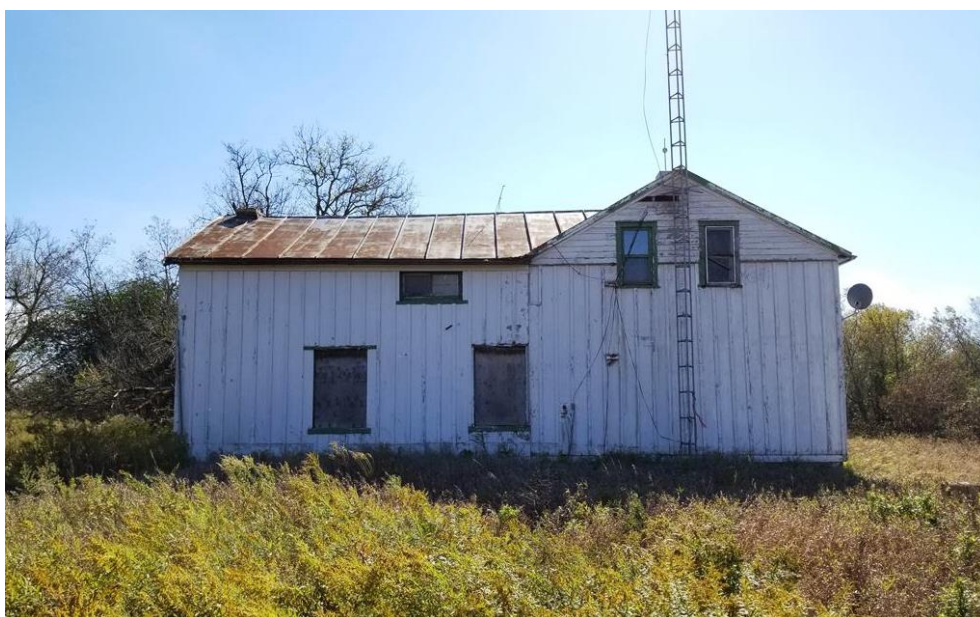
**Figure 18: North façade.**

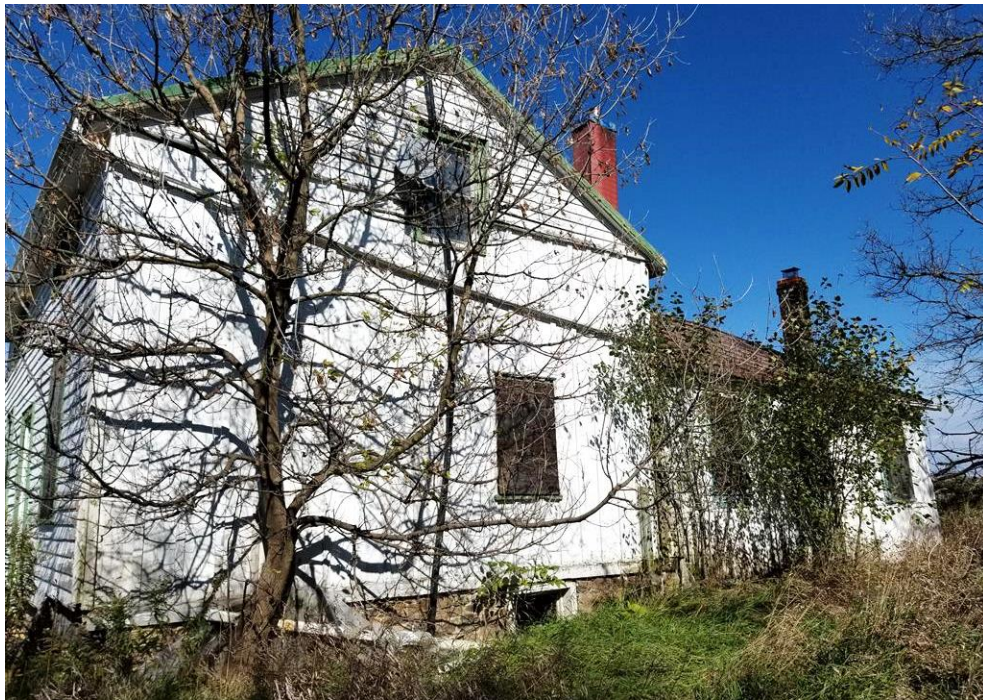
**Figure 19: South façade.**

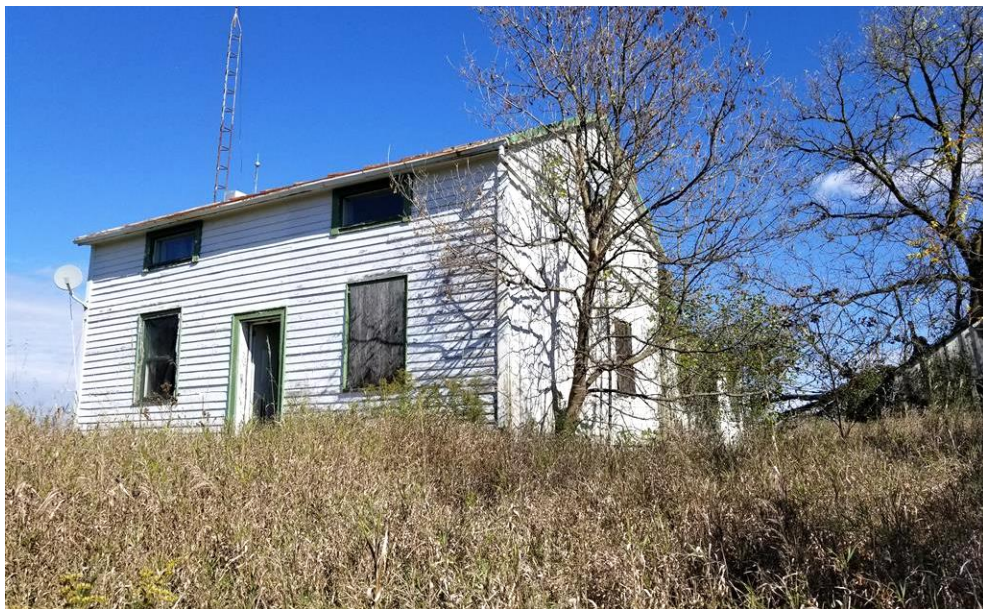
**Figure 20: South and west façades.**

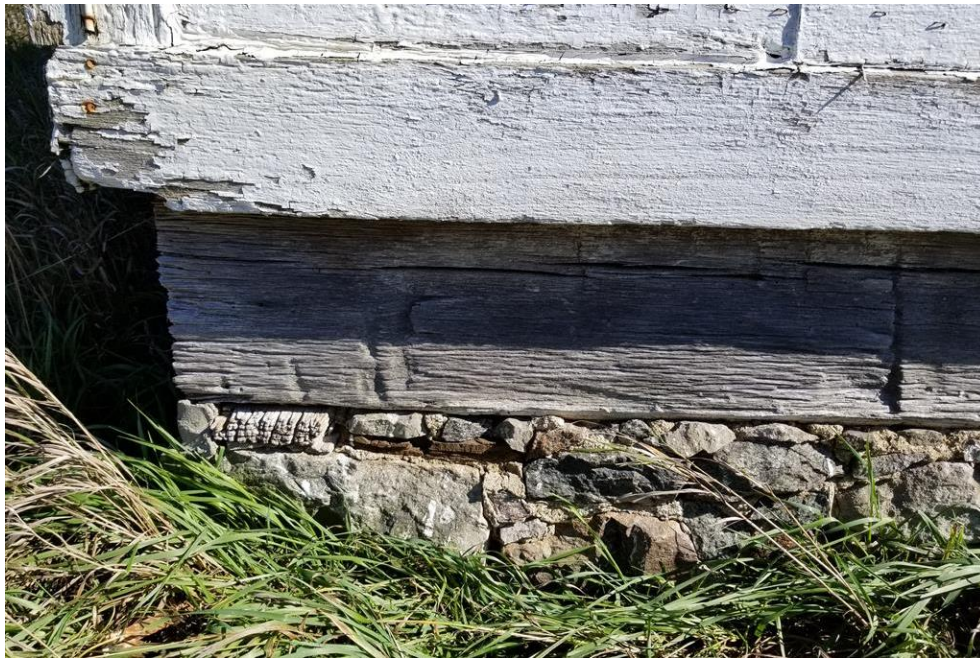
**Figure 21: Coursed rubble foundation of the Main Block.**

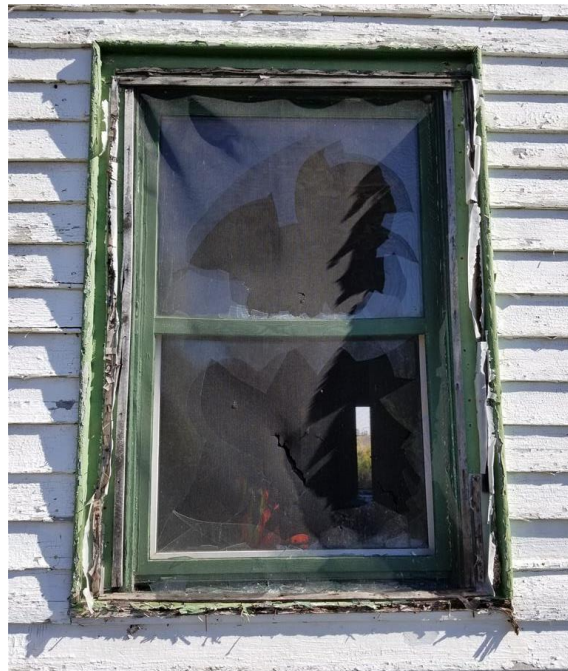
Fenestration is symmetrical, with a central flat-head door with a moulded frame flanked by two tall, one-over-one flat head single-hung windows with a plain exterior wood frame and no sill, on the principal southwest façade with plain wood exterior frames (Figure 22). The door is undecorated with a plain exterior frame. Second storey windows on the main façade are wide single-pane with plain wood frames and no sills, which are symmetrical with ground-floor windows. Visible in the basement foundation are several additional wide two-pane, small wood-frame flat-head windows with no sills and plain exterior trim.

**Figure 22: Typical window on the ground floor, Main Block.**

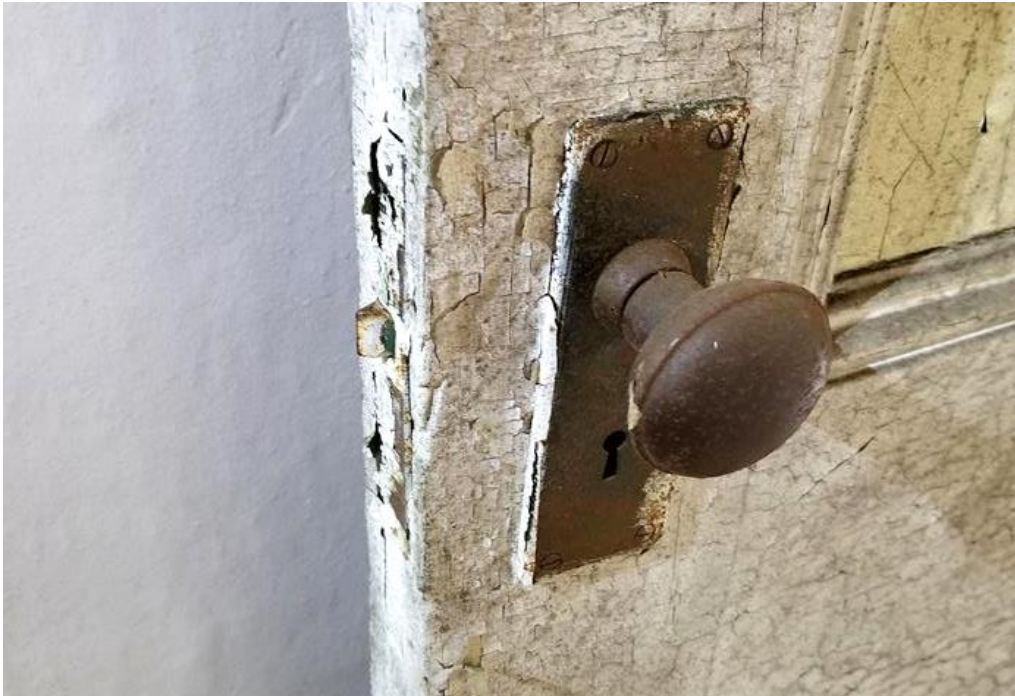
**Figure 28: Door handle on bathroom door.**

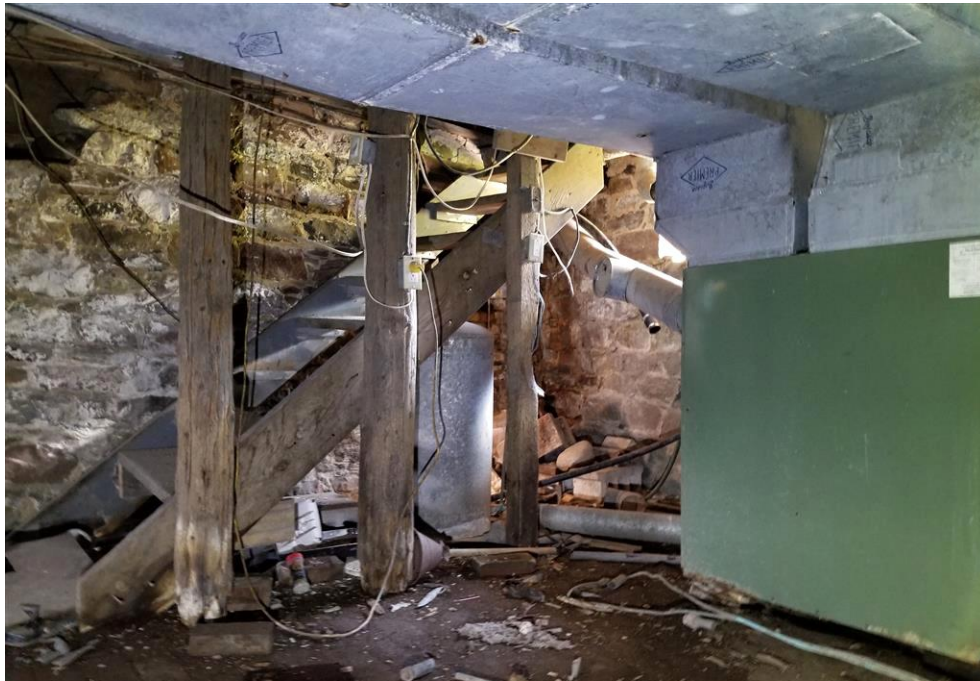
The basement is located beneath the Main Block of the residence and consists of a single full-height room with coursed stone rubble walls. A simple wood staircase leads downstairs from the exterior southeast corner, and three tree trunks are braced alongside the stairs, creating support for the floor above (Figure 38). An interesting feature of the basement is its brick floor, which spans the entire room (Figure 39). There are three wide single-pane, flat-head windows set into the stone walls, one on the north wall, one west, and one facing south, although the west window was filled in with stone rubble. At the north end of the basement, a large stone fireplace with a wood lintel is built into the foundation and would have extended into the ground and second storey at one point (Figure 40).

Figure 38: Stairs in the southeast corner of the basement, with three support posts.

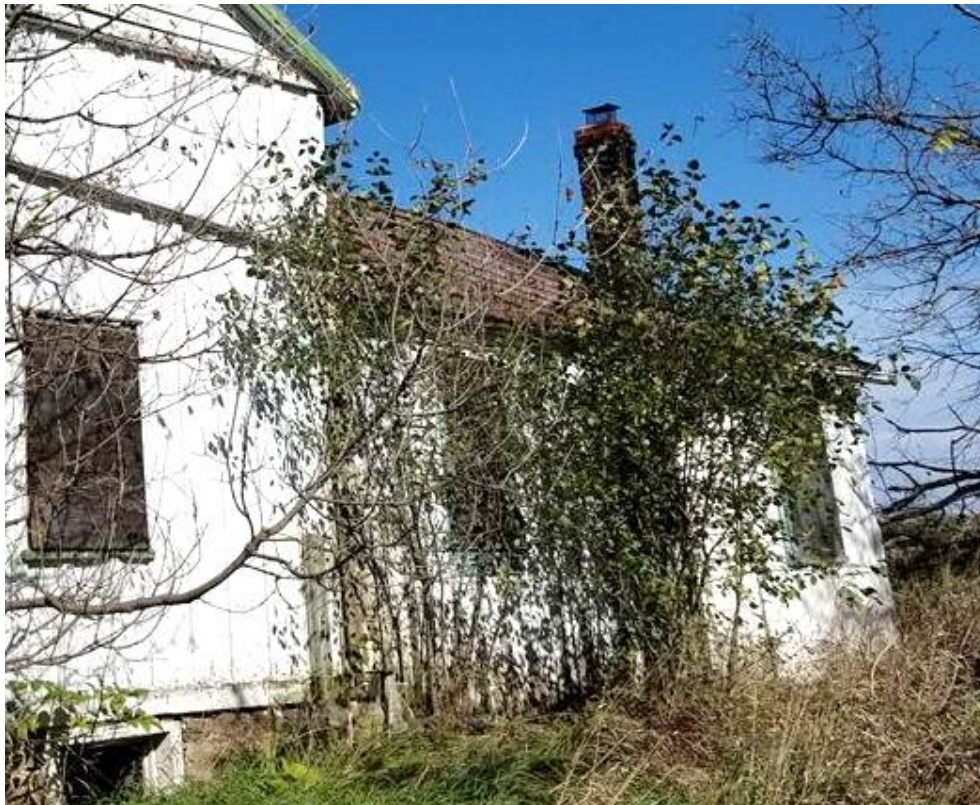
**Figure 61: South façade of South Addition, obscured by bushes.**

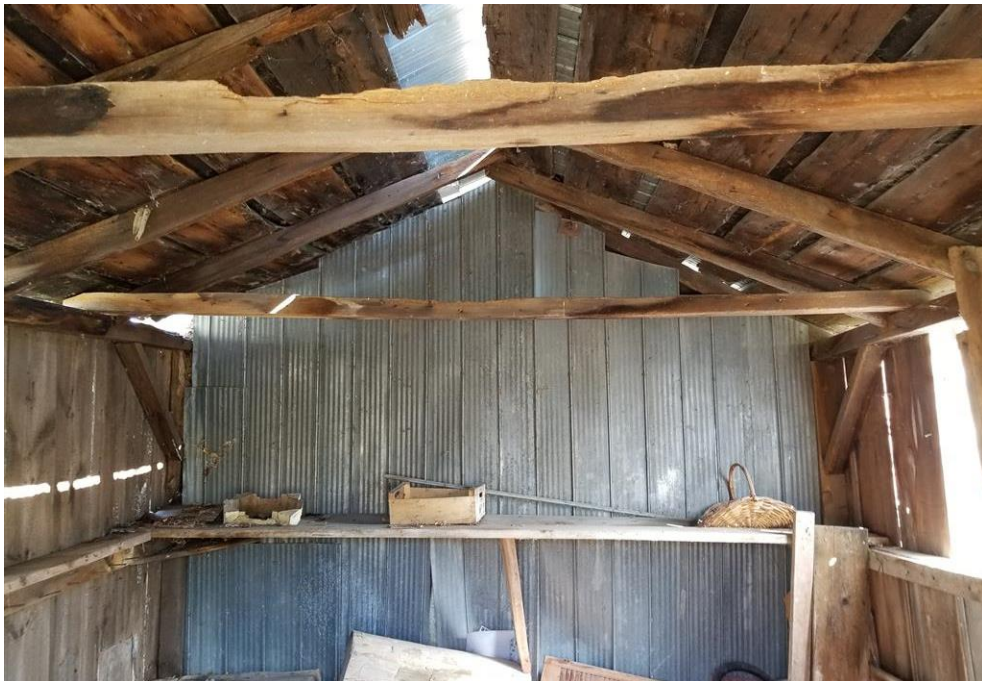
To the south of the residence is a small wood frame shed in poor physical condition. It is a one storey, one bay structure with a low gable roof covered by metal sheeting (Figure 67). The east interior wall of the structure is aluminum sheeting, and the main door on the west façade of the structure is no longer present. Vertical board and batten siding to match the majority of the residence, but has been left unpainted, and the structure appears to have been used for storage. Machined wood beams make up the interior frame, indicating that the outbuilding was constructed sometime after the main house (Figure 68).

**Figure 68: Interior of the outbuilding, facing east.**

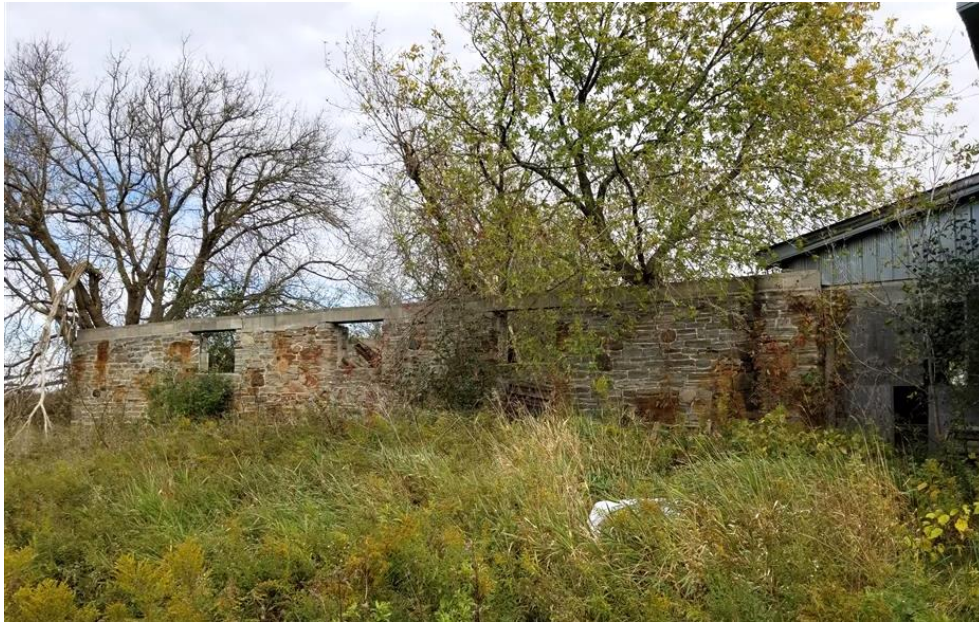
North of the outbuildings is the foundation of the 'Old Barn', made from coursed rubble with a three-bay west façade (Figure 76). This structure is all that is left of the barn which was originally associated with Henry Burton House, prior to its collapse. Significant areas of iron staining are visible on the exterior walls, and no evidence of the upper frame construction remain intact.

Figure 76: West façade.
