**CULTURAL HERITAGE
IMPACT ASSESSMENT
And
HERITAGE DISTRICT
CONFORMITY
REPORT**

**2291 Major Mackenzie Drive West
Maple Heritage District,
Vaughan, Ontario, Canada**

19 October 2020

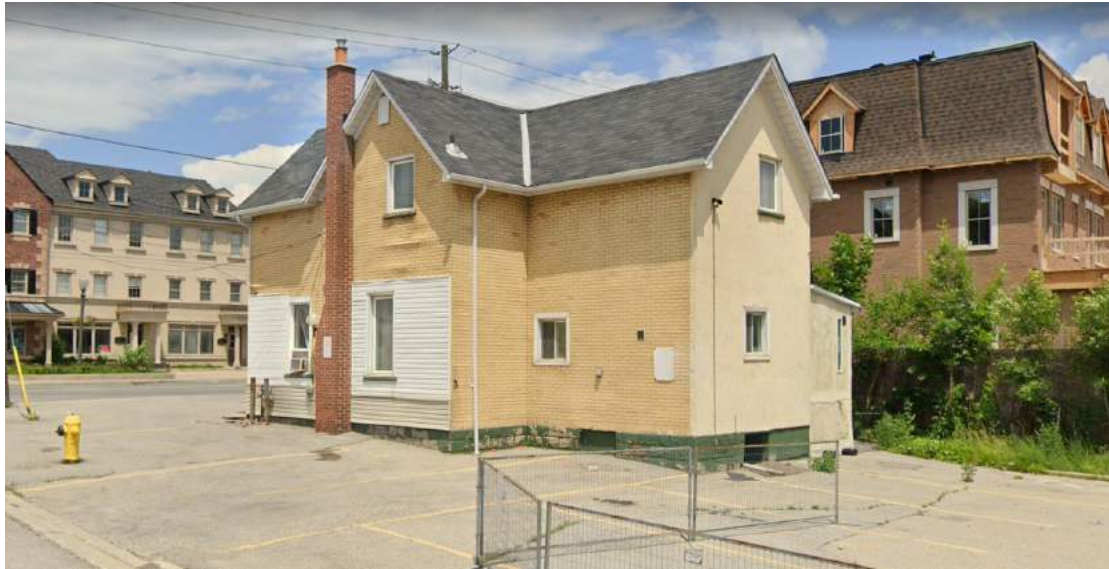
Google Street View
Rear of Building

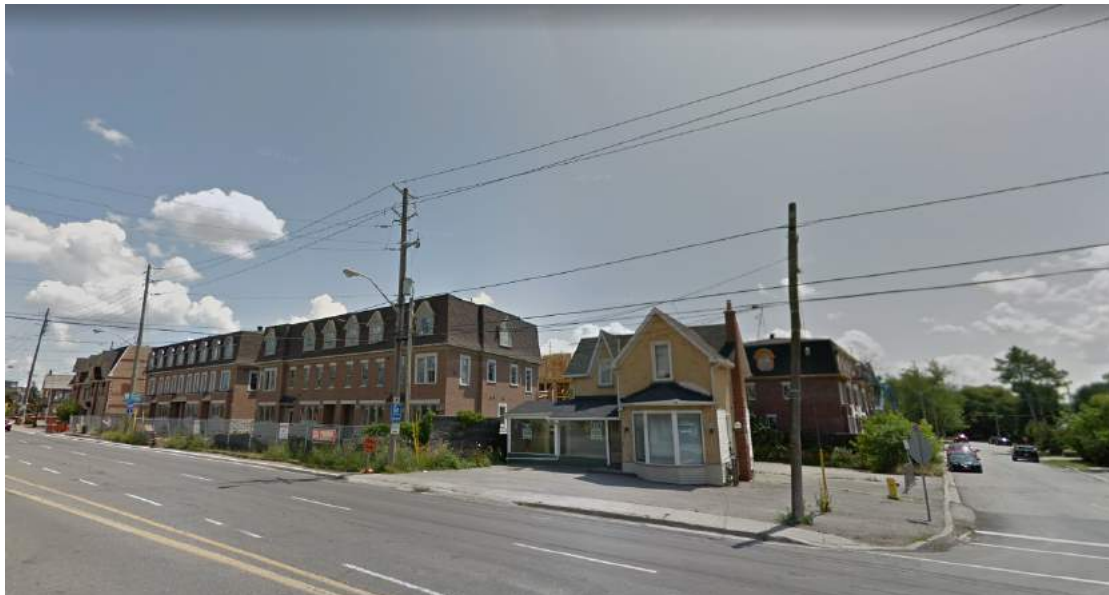
Google Street View
Front of Building

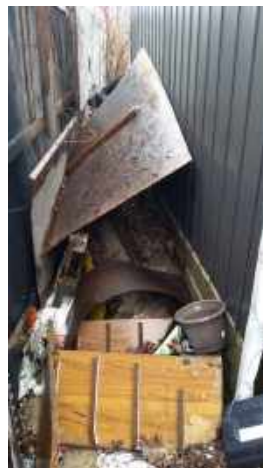
Storage of material / debris on site

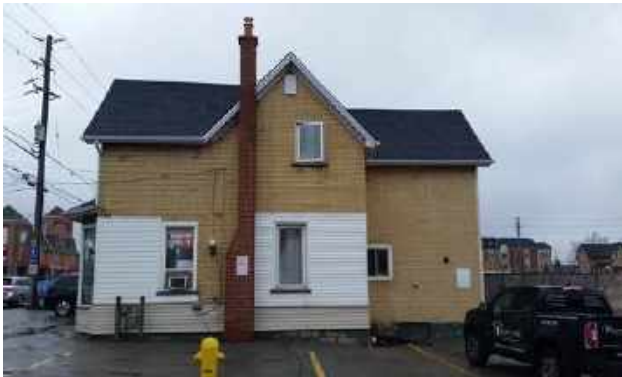
The lot grading was noted as continuously sloping from the north boundary / front of the property until the south most / rear boundary. The street line was noted at a higher elevation point then the grading around the dwelling.

As such, the walls of the dwelling and foundation walls are constantly subject to run-off that originates from the boulevard / front yard. No significant provisions for management of run-off to protect the front / sides of the dwelling were noted in place.

grading slopes from the front of the property continuously to the rear

Part of the solution to manage run-off is to re-grade the front and side yard so as to direct water away from the foundation walls. In addition, some form of exterior drainage system / area drain to collect water in the front yard is also likely required. Consultation with a qualified landscape designer to discuss options to solve this issue is recommended.

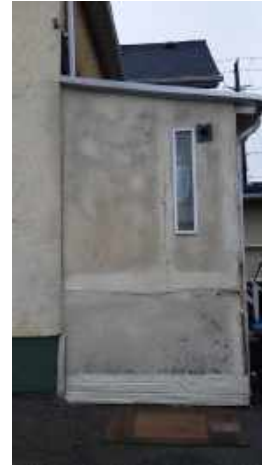
The condition of the exterior wall suggests that moisture has penetrated underneath the sheathing / stucco causing water related damage. The finish is peeling off and mould has formed on the surface.

Also noted were issues related to roof flashing which is not installed in a workmanlike manner and as such its condition is likely contributing to the issue of moisture penetration into the walls.

Rear wall of porch enclosure. Dark areas indicate water penetration into substrate material.

The only way to repair this structure is to remove the damaged exterior finish, evaluate the underlying wood structure, repair / replace any deteriorated components and then replace the sheathing and finish materials. In addition, doing so will likely require a mould remediation effort. Consultation with a qualified contractor specializing in mould remediation and restoration is required.

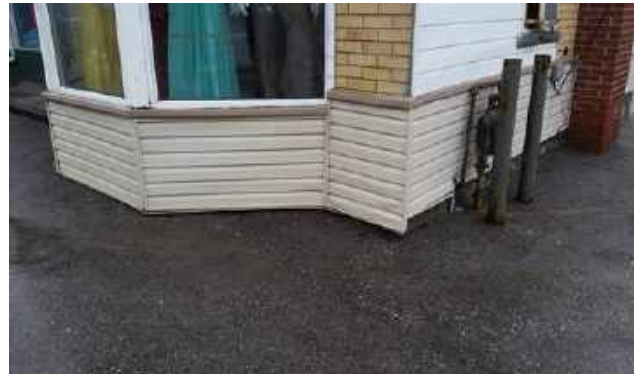
The exterior wall finishes extend to grade level along the front and a portion of the side walls as well and as such the foundation wall is not visible in these areas.

Siding extends to grade at front of dwelling

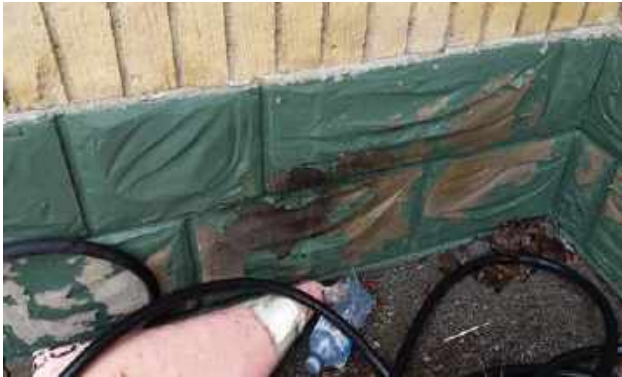
Nonetheless, significant issues were noted with the foundation wall that include cracks / holes as noted along the rear wall and on the interior of the foundation wall as viewed from within the basement. This damage has resulted in water penetration over a long period of time. Efflorescence and mould was noted present on the wall within the basement but also on the exterior block above grade level.

Concrete block above grade. Note surface mold on saturated block.

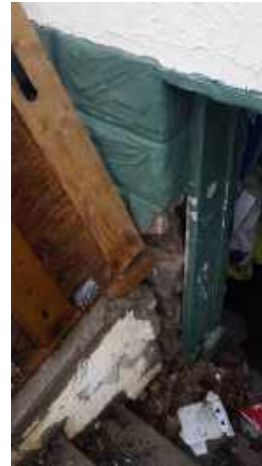
Cracked / broken foundation wall at basement walk-out

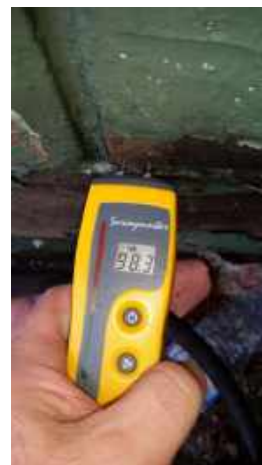
Water saturated block wall.

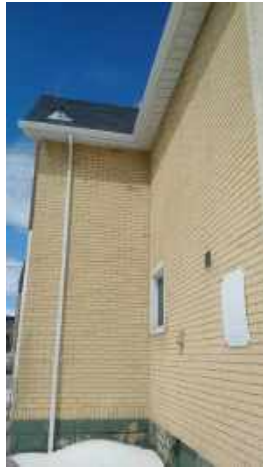
Although it is not known how long the brick tile finish has been in place, it has been a considerable time. Given its current state / condition, it appears the implications related to maintenance in choosing this material were not fully appreciated by the property owners over the years and as such restoration / replacement of the cladding and likely a significant amount of the underlying structure, is now required due to the extent of damage sustained.

Brick tile wall finish

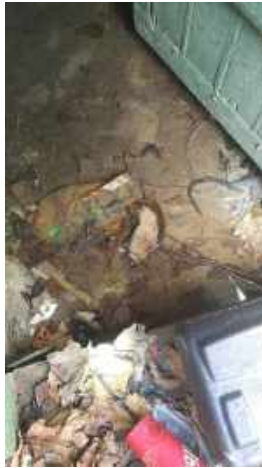
Standing water at bottom of walkout. Note dead rat floating in water.

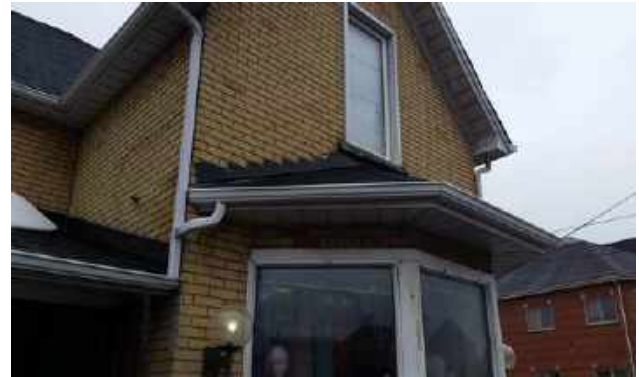
Lower roof areas also noted as shingled

The owner is advised to budget to replace the roof covering on lower roof planes within the next 3 - 5 years
based on the anticipated life cycle. Replacement of the covering should include evaluation of roof sheathing
(and replacement as required) which may have sustained damage in areas reliant on wall flashing to
maintain water tightness. Consult with a qualified roofing contractor.

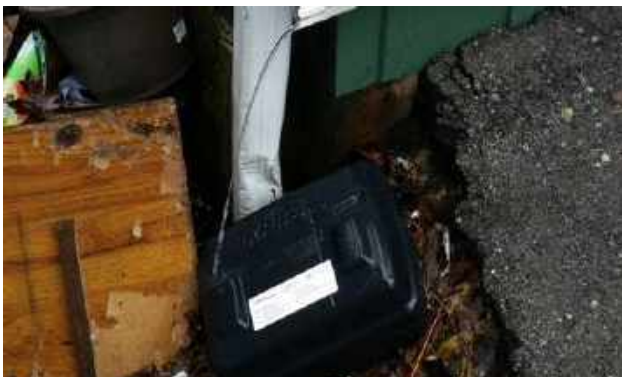
Downspout at front of building discharging at grade

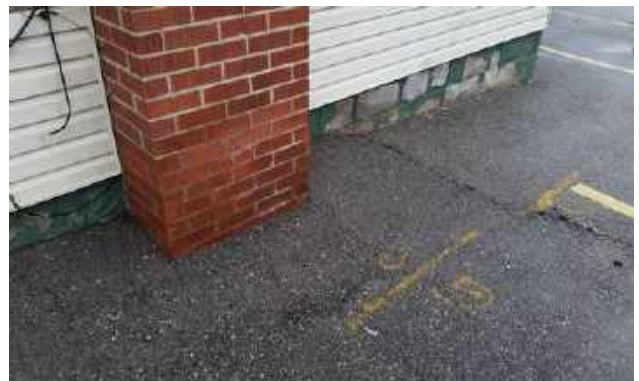
Brick chimney extends below grade

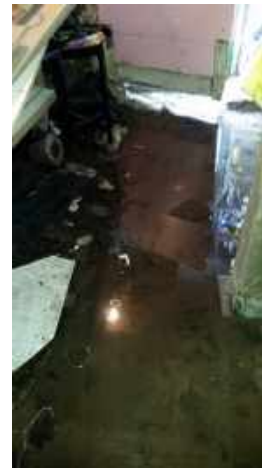
Standing water at rear portion of basement

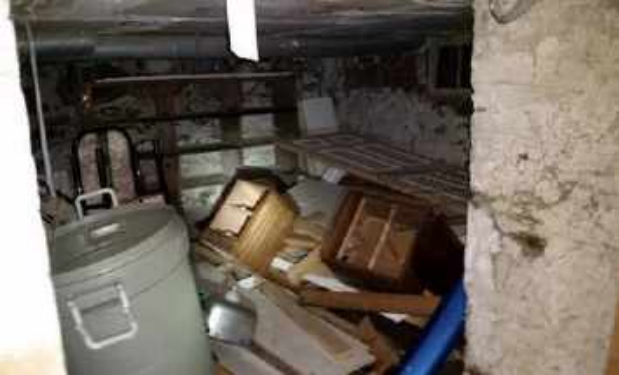
Material storage within the basement prevented complete visual access to all floor and wall areas.

Storage of material in basement noted

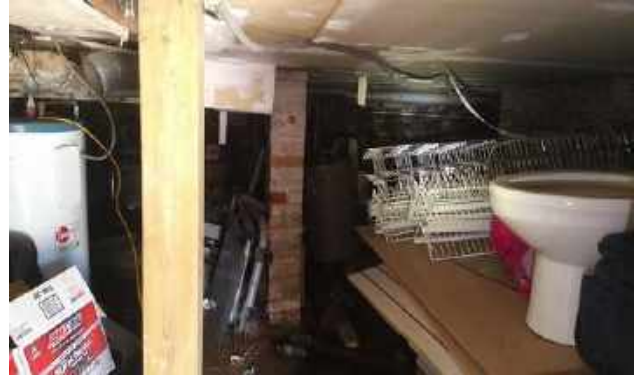
More stored material

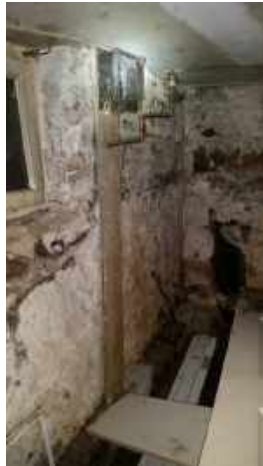
Interior of stone foundation wall - east side

See recommendation contained within the EXTERIOR section of this report related to the foundation wall. In addition to the scope of work specified within that section, the interior condition of the foundation also needs to be addressed, which should include crack / structural repair, mould remediation and cleaning.

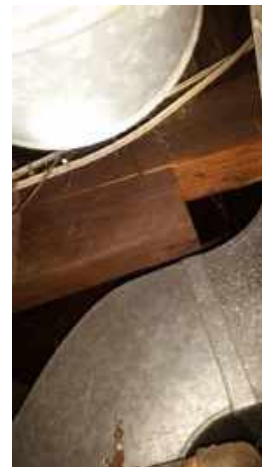
Cracked / compromised floor joist

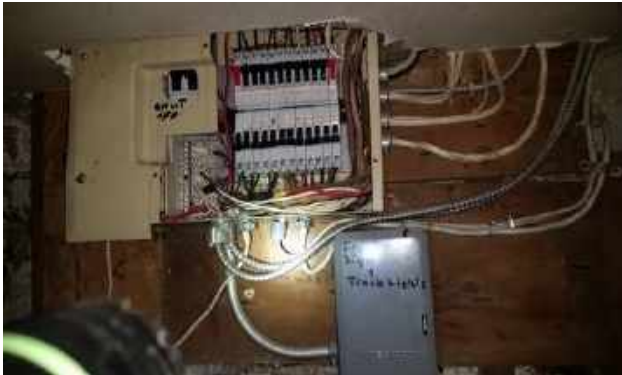
Main panel, no cover provided

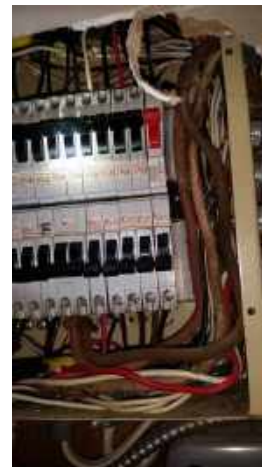
Old cloth sheathed wiring noted in panel servicing the stove still in place

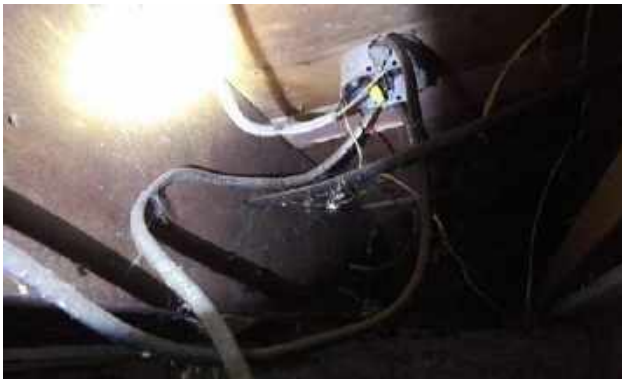
The wiring in the dwelling is a mix of old ungrounded 2-wire type mixed with newer 3-wire type. As such, the circuits are not grounded. Although most of the old wiring is cloth sheathed type, some knob and tube was also noted in the basement which was still live at the time of inspection.

Old wires spliced with new in open junction box

use, as it relates to the electrical demand placed by on them in conjunction with an evaluation of the entire system to effect the required changes / upgrades that enable use by current standards.

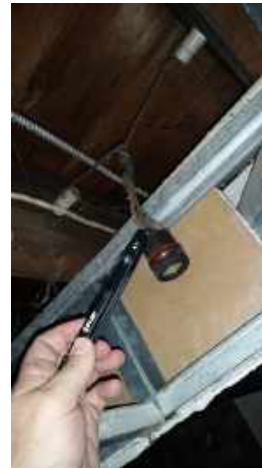
Old active knob and tube wiring

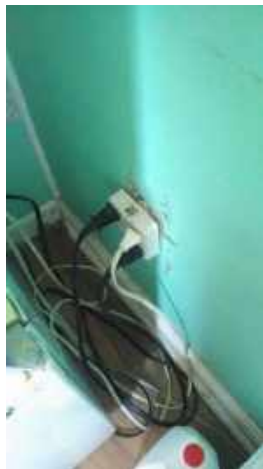
Wall outlet likely overloaded

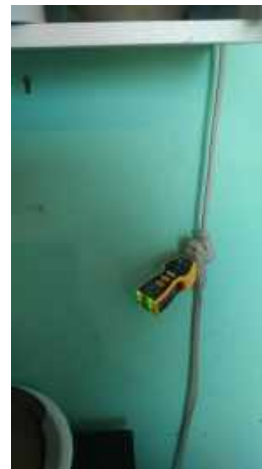
As well, throughout the dwelling wiring was noted as mounted over finished surfaces also creating an unsafe conditions with anyone inadvertently coming into contact with them. In addition, through each room electrical cords / power bars were in use as permanent wiring also creating a hazardous condition as the number of circuits were never intended to facilitate current demand for electricity in this day and age.

Extension cords used as permanent wiring

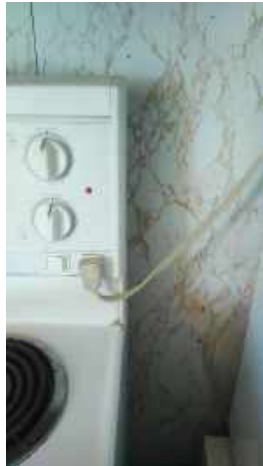
Stove outlet also used for small appliance

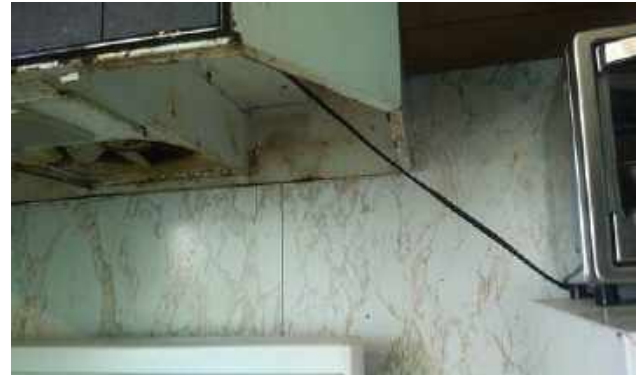
Kitchen fan connection to outlet

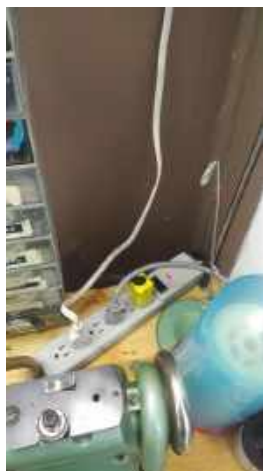
Inordinate number of power bars in use

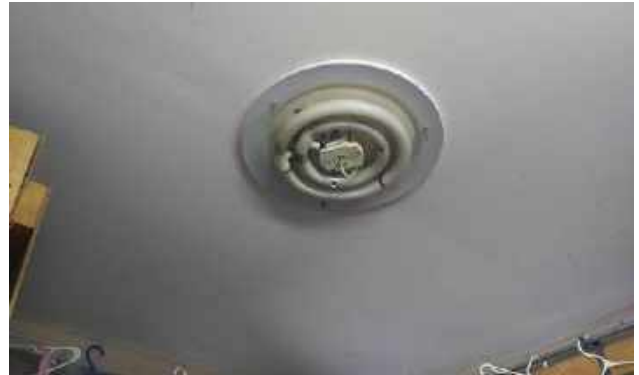
Inoperative and broken fixture were noted within the dwelling. Some fixtures were noted without covers over fluorescent bulbs, which pose a hazard to occupants who may come in direct contact with them resulting in breakage and the release of toxic gases.

Inoperative fixture

Replace any broken / inoperative light fixture throughout the dwelling as required in conjunction with other recommended electrical work to be conducted by a qualified professional electrician.

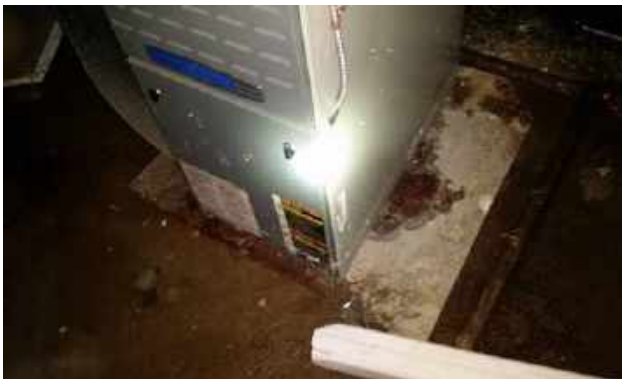
Also noted was the fact that the furnace sits on the floor slab and as such is subject deterioration and catastrophic failure in the event of a more severe basement flood.

Furnace sits on floor of basement

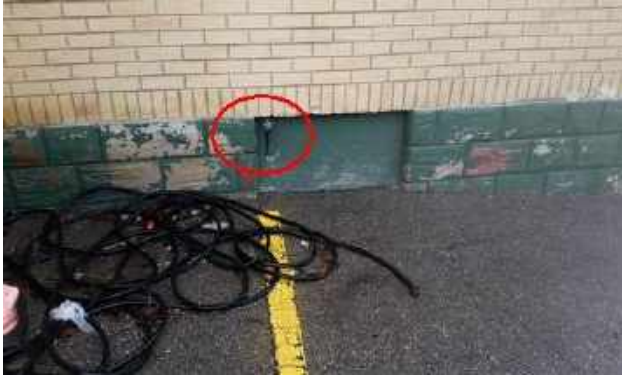
The hose bib was noted within the boarded-up opening that used to be a basement window.

Hose bib

Ensure valve are shut-off during winter months to prevent possible leaks / damage.

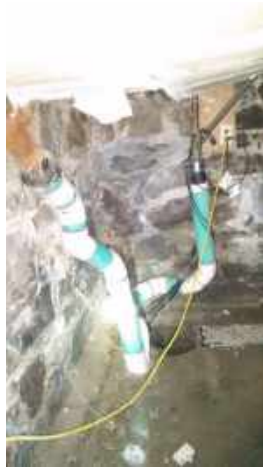
Cast iron and brass connection to newer PVC type drain pipe in basement

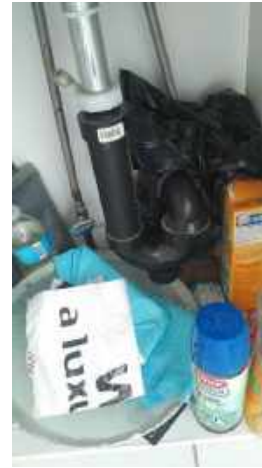
The P- traps for all the sinks in the dwelling were noted with an improper S - configuration which may result in siphoning that would leave the trap without water and unable to prevent sewer gases from entering the dwelling. A condition may in fact be hazardous to the occupants / users of the property.

S-Trap drain configuration under second floor bathroom sink

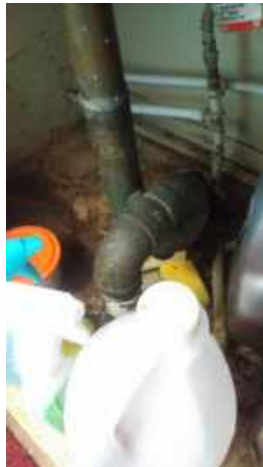
S-Trap drain configuration under main kitchen bathroom sink

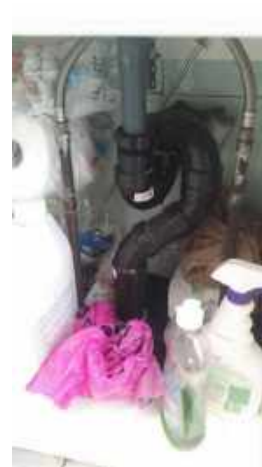
S-Trap drain configuration under main floor bathroom sink

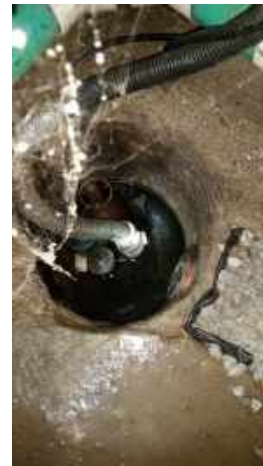
Also of note, the discharge was noted as directed through a pipe that appears to penetrate the foundation wall but the ultimate discharge point was not determinable.

Pump discharge tube runs into foundation

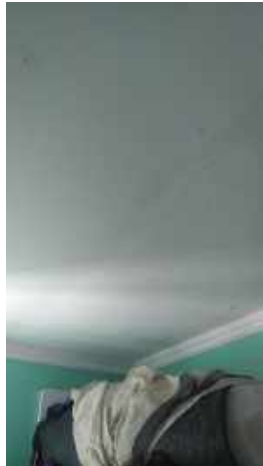
Water stained ceiling

Renew / replace damaged internal ceiling finishes and repair any plaster damage as well, as required.

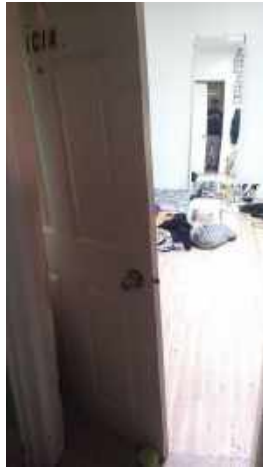
Door removed from hinges

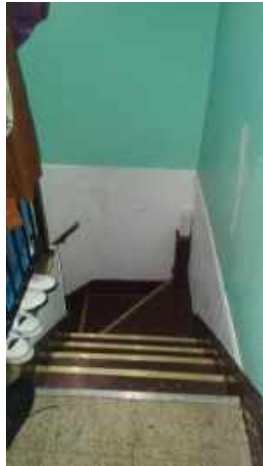
Section of stairs with missing handrail

Ensure that a continuously graspable handrail is installed on the main stairs for safe passage in accordance with current standards / regulation. Consult with a railing contractor as required.

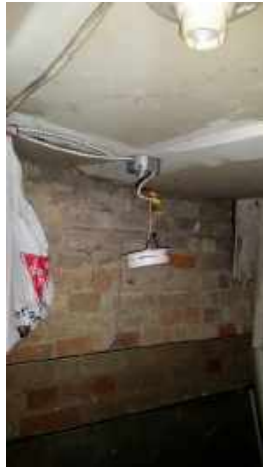
Smoke detector in basement hanging from junction box

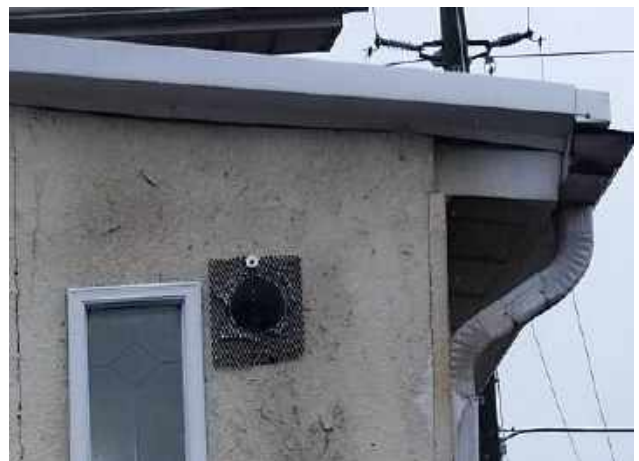
Exterior unprotected dryer vent

Install appropriate vent cover for dryer exhaust on exterior wall so as to prevent water penetration into the wall system.

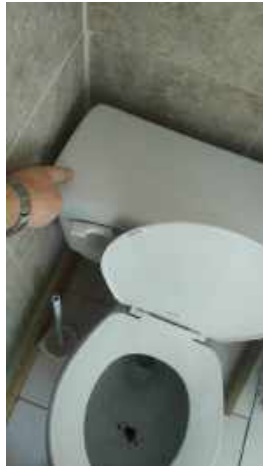
Loose toilet in second floor bathroom
