**CULTURAL HERITAGE
IMPACT ASSESSMENT
And
HERITAGE DISTRICT
CONFORMITY
REPORT**

**2291 Major Mackenzie Drive West
Maple Heritage District,
Vaughan, Ontario, Canada**

19 October 2020

CULTURAL HERITAGE IMPACT ASSESSMENT and HERITAGE DISTRICT CONFORMITY REPORT

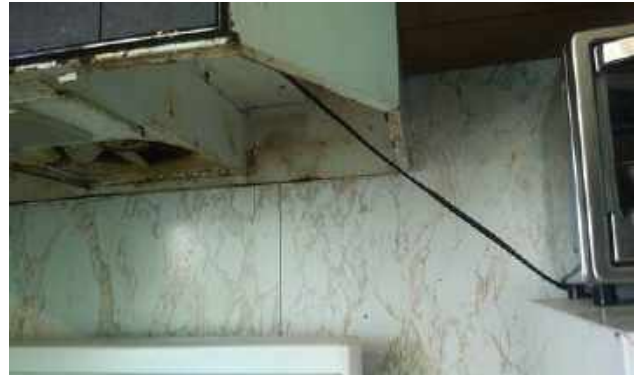
Kitchen fan connection to outlet

use, as it relates to the electrical demand placed by on them in conjunction with an evaluation of the entire system to effect the required changes / upgrades that enable use by current standards.

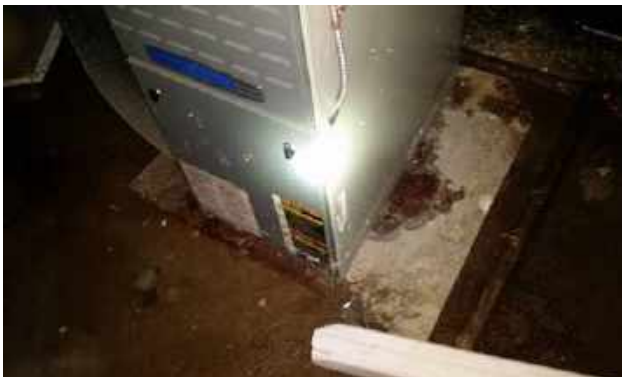
Also noted was the fact that the furnace sits on the floor slab and as such is subject deterioration and catastrophic failure in the event of a more severe basement flood.

Furnace sits on floor of basement

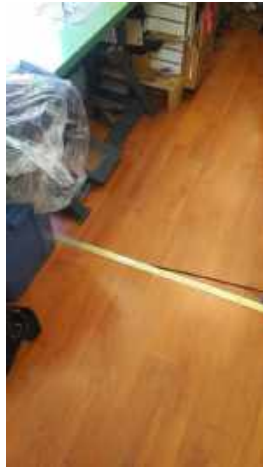
For the most part the floor finishes are worn and tiled areas are loose, cracked and badly deteriorated.

Laminate tile floor finish

Consult with a qualified flooring contractor as required.

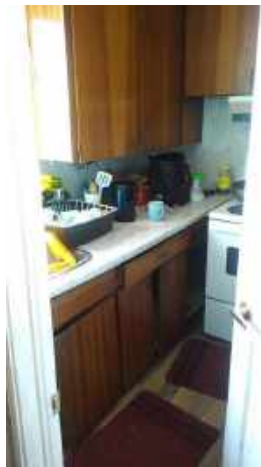
Main floor kitchen

Renew / renovate kitchen as required to bring it back to a usable state.
