**CULTURAL HERITAGE IMPACT ASSESSMENT
GEORGE BAILEY PUBLIC SCHOOL
COMMUNITY OF MAPLE, CITY OF VAUGHAN, ONTARIO**

York Region District School Board
Facilities Management Centre
1260 Gorham Street
Newmarket Ontario L3Y 8W4

ASI File: 20CH-118

September 2020 (updated May 2021)

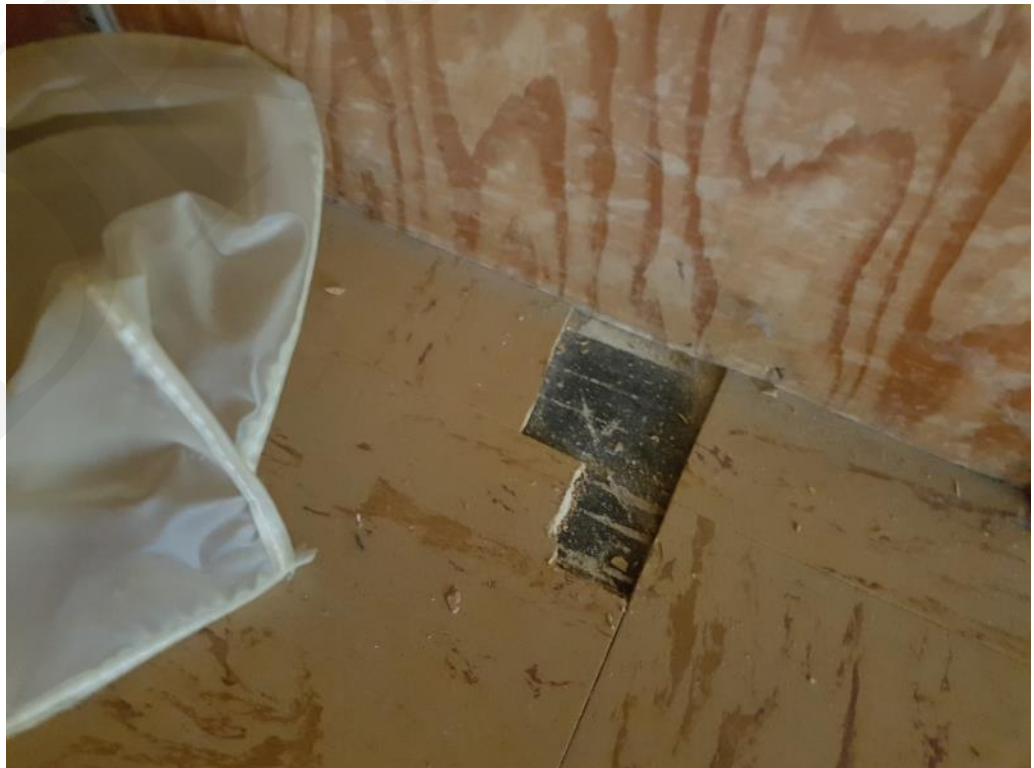
Photo No. 14.

Example of asbestos-containing vinyl floor tiles and asbestos-containing mastic under vinyl floor tiles in the storage closet (Location 42).

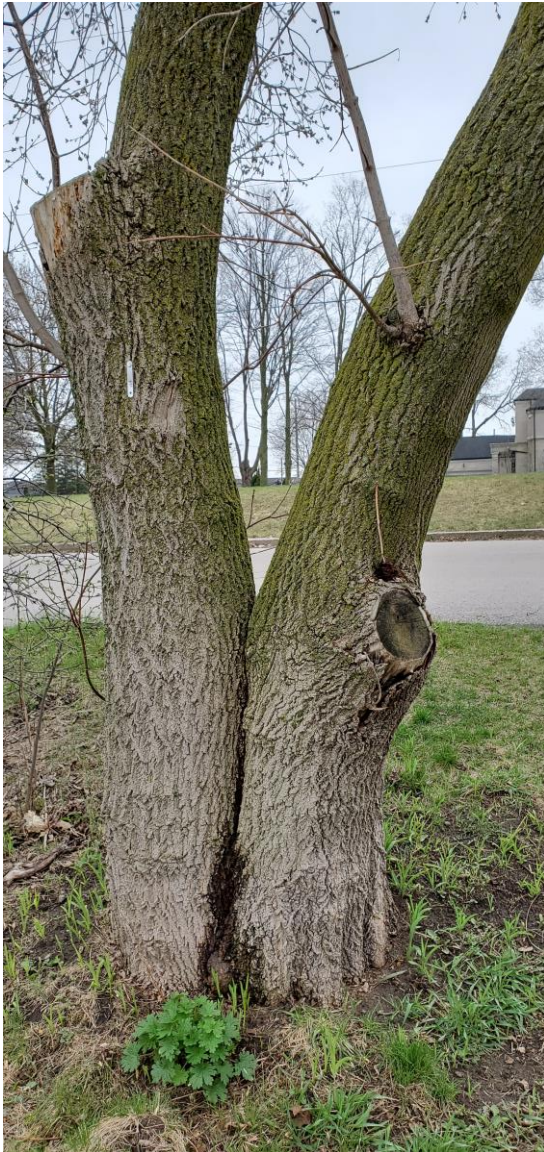
Image 3. Tree 909 – base

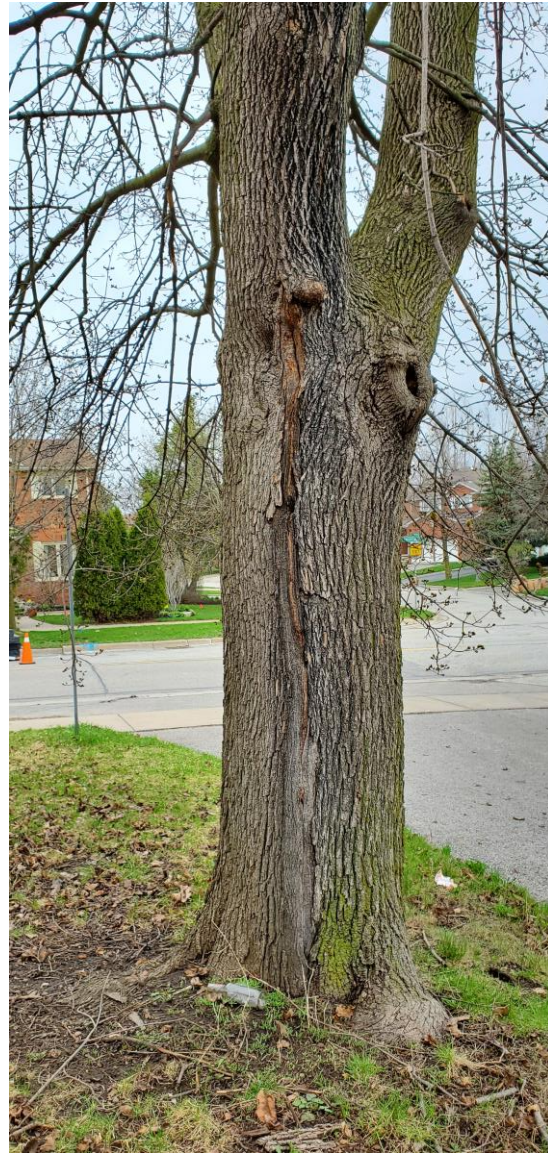
Image 15. Tree 933 – lower stem on south side

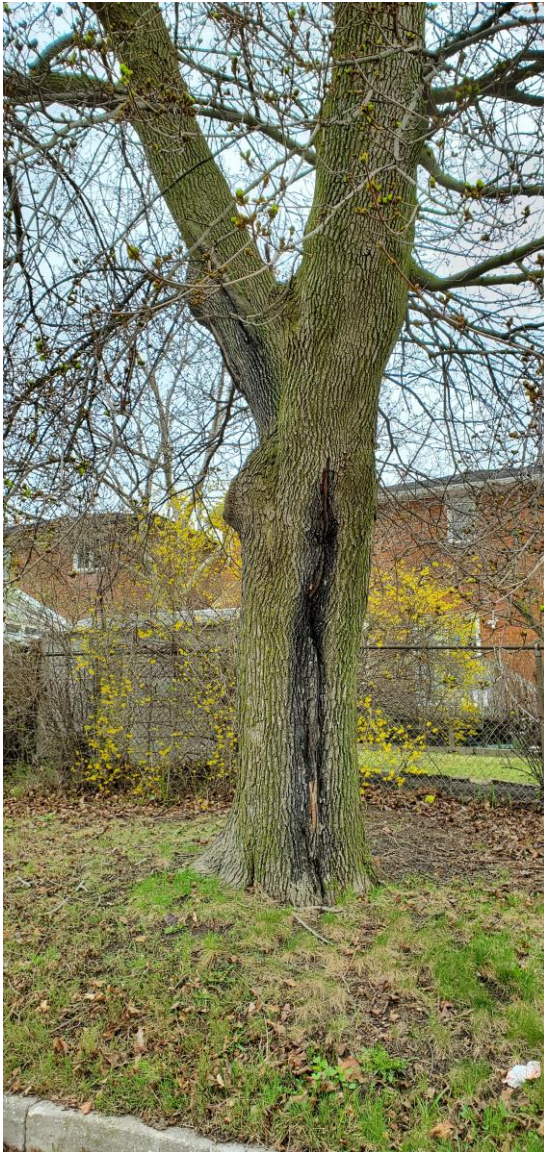
Image 16. Tree 933 – lower stem on east side

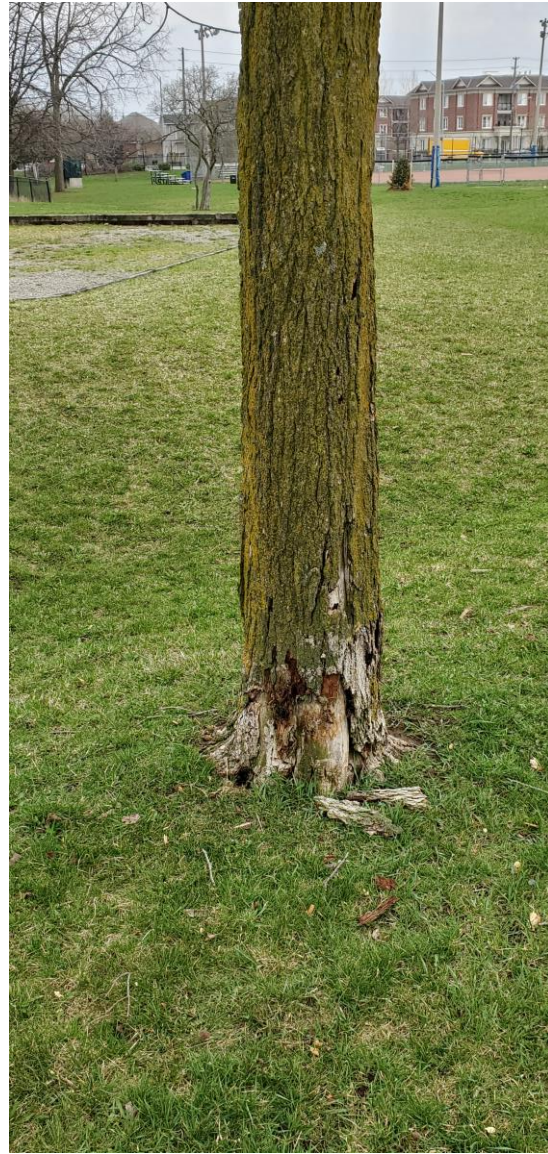
Image 23. Tree 946 – base on west side

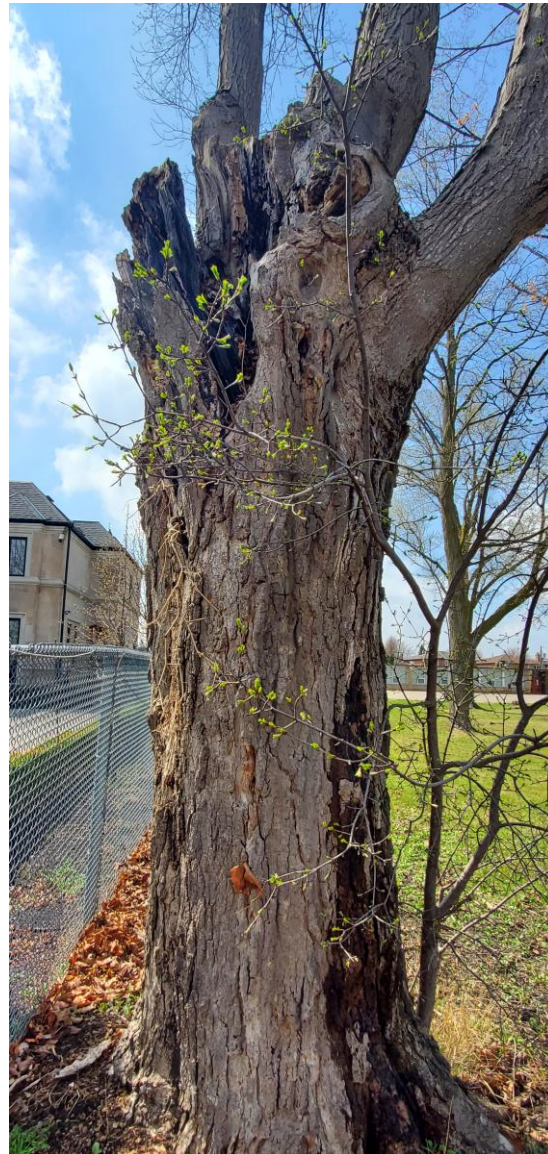
Image 33. Tree 957 – lower stem
